Contract #: 04-0120F4Cty: SF/ALA Rte: 80 PM: 13.2/13.9File #: 69.25B**QUALITY ASSURANCE -- NON-CONFORMANCE REPORT****Location:** Changxing Island, Shanghai, P.R. China**Report No:** NCR-000239**Prime Contractor:** American Bridge/Fluor Enterprises, a JV**Date:** 25-Mar-2009**Submitting Contractor:** Zhenhua Port Machinery Company, Ltd (ZPMC), Changxing Island**NCR #:** ZPMC-0213**Type of problem:****Welding****Concrete****Other****Welding****Curing****Procedural****Bridge No:** 34-0006**Joint fit-up****Coating****Other****Component:** OBG U-Rib Deck Panels**Procedural****Procedural****Description:****Reference Description:** Deck panel distortion due to excessive welding repair**Description of Non-Conformance:**

Reference Description: Deck panel distortion due to excessive welding repair

SAN FRANCISCO OAKLAND BAY BRIDGE, EAST SPAN SELF-ANCHORED SUSPENSION SPAN
 ROUTE 80 EAST OF YERBA BUENA ISLAND, DISTRICT 04, SF COUNTY, CA.
 BRIDGE Nos: 34-0008L PM B.2, KP 13.2 & 34-0008R PM B.7, KP 13.9
 STATE OF CALIFORNIA DEPT. OF TRANSPORTATION CONTRACT NO. 04-0120F4
 ENGINEER: CALTRANS --- T. YILIN / MOFFATT & NICHOL, JV.
 CONTRACTOR: AMERICAN BRIDGE / FLUOR ENTERPRISES, JV.
 repair procedu

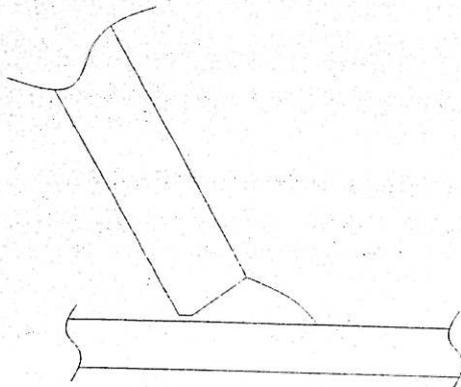
Draft of welding discontinuity:

- 1) The defect moved upward for several repair and enlarged groove and caused undercut, so increase weld pass.
- 2) welder operated inadequately.

1. 利用打磨的方法去除裂纹;
 2. 按照焊接返修工艺规程(WPS)准备焊缝接头形式;
 3. 返修前对坡口作100%VT与MT检查, 确保缺陷完全去除;
 4. 按照批准的焊缝返修工艺规程(WPS)进行预热和焊接修补;
 5. 打磨焊缝区域使其与邻近焊缝平齐;
 6. 对修补区域作100%VT与MT检测;
-
1. Remove the defects by means of grinding cleanly.
 2. Prepare excavation in accordance with an approved repair WPS.
 3. Perform VT and MT to the groove to ensure the removal of the defects before repairing.
 4. Preheat and weld according to the relevant repair WPS.
 5. Grind the weld flush with adjacent welds.
 6. Perform 100% VT and MT to the repair area.

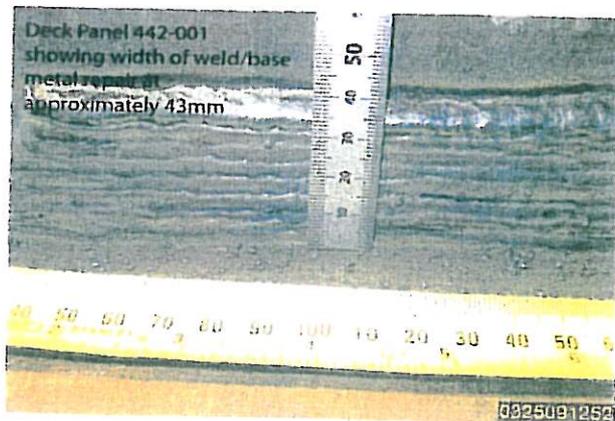
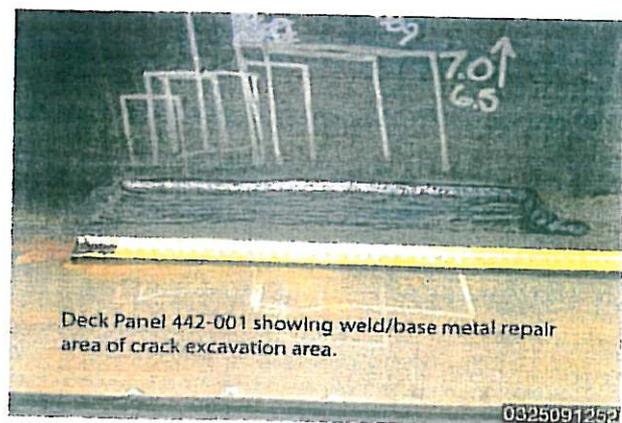
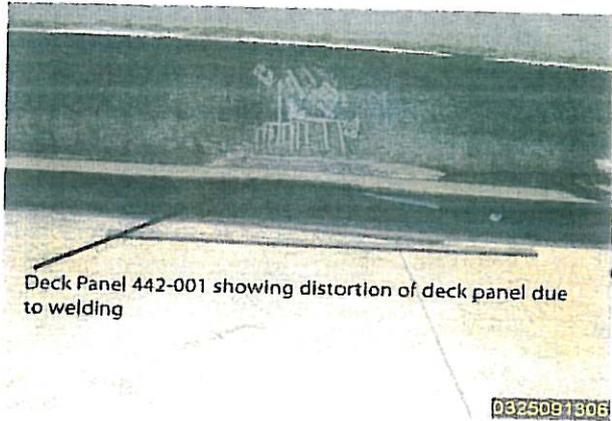
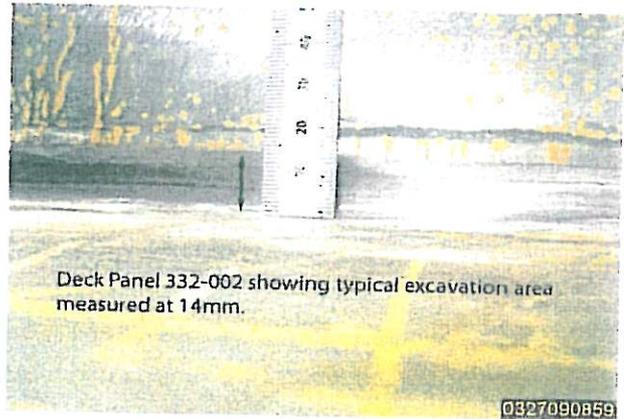
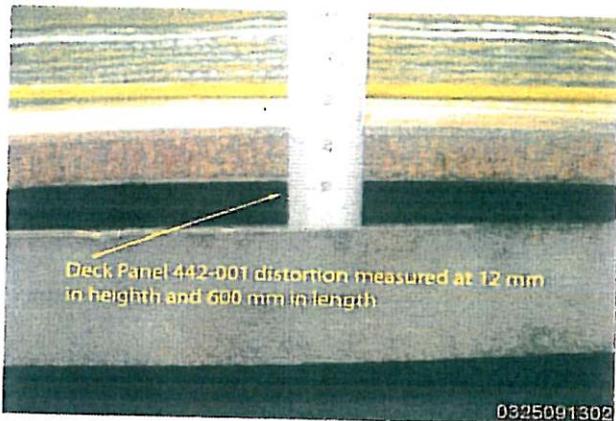
Caltrans Quality Assurance (QA) Inspector observed ZPMC welders performing base metal repairs on closed ribs of the deck panels. The repairs were located above the excavated cracks on the PJP weld joint for DP442-001, DP332-002, DP492-001, DP249-001, DP442-001, DP305-001, DP357-001, DP495-001, DP469-001, DP330-002, and DP415-001.

QA Inspector observed excessive welding on these repair area. Shortly after the welding, QA Inspector also noted the distortion of the deck panels. Also, QA Inspector confirmed with ZPMC QC Inspector Mr. Sun Bo that the repairs were done without an approved base metal repair procedure. These welding repairs were not performed according to the project requirements.
