Contract #: 04-0120F4Cty: SF/ALA Rte: 80 PM: 13.2/13.9File #: 69.25B**QUALITY ASSURANCE -- NON-CONFORMANCE REPORT****Location:** Changxing Island, Shanghai, PRC**Report No:** NCR-000273**Prime Contractor:** American Bridge/Fluor Enterprises, a JV**Date:** 20-May-2009**Submitting Contractor:** Zhenhua Port Machinery Company, Ltd (ZPMC), Changxing Island**NCR #:** ZPMC-0247**Type of problem:**

Reference Description: East Tower, Lift 1 unacceptable weld on backing plate at diaphragm corner piece**Description of Non-Conformance:**

Job Name: SAS Superstructure
Document No: 05.03.06-000238

Reference Description: Backing Plate Welds / East Shaft Lift 1 / Diaphragm Corner Plate

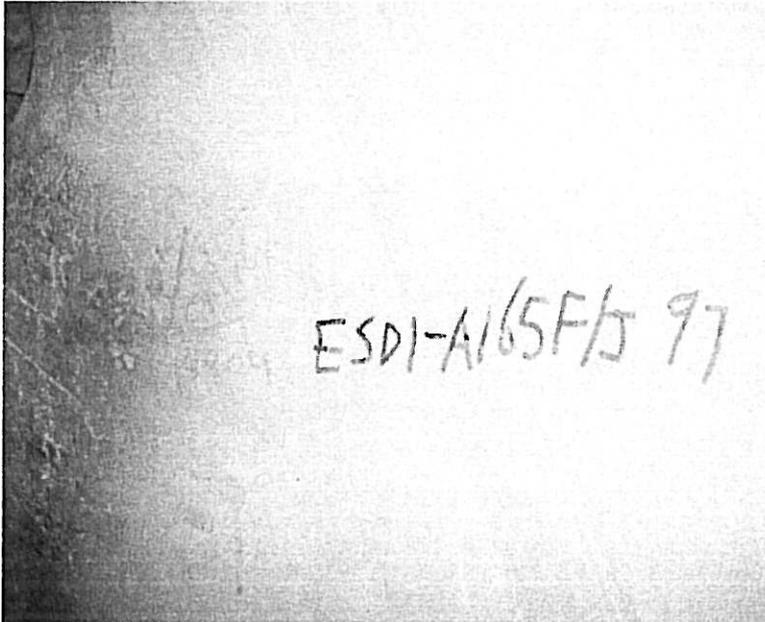
About this NCR we have removed all the tacks according AWS D1.5 Section 3.3.7.6 and did the repair work, after that we did the MT/UT/VT for this weld again to make sure no problem, ZPMC also submit the notification to CT guy (Baskar Govindarajan) to let him make sure no problem about this weld.
