Contract #: 04-0120F4Cty: SF/ALA Rte: 80 PM: 13.2/13.9File #: 69.25B**QUALITY ASSURANCE -- NON-CONFORMANCE REPORT****Location:** Changxing Island, Shanghai, PRC**Report No:** NCR-000278**Prime Contractor:** American Bridge/Fluor Enterprises, a JV**Date:** 26-May-2009**Submitting Contractor:** Zhenhua Port Machinery Company, Ltd (ZPMC), Changxing Island**NCR #:** ZPMC-0252**Type of problem:**

Reference Description: Missing backing bar at East Tower, Lift 1, 18m Diaphragm CJP weld**Description of Non-Conformance:**

Job Name: SAS Superstructure

Subject: NCR No. ZPMC-0252

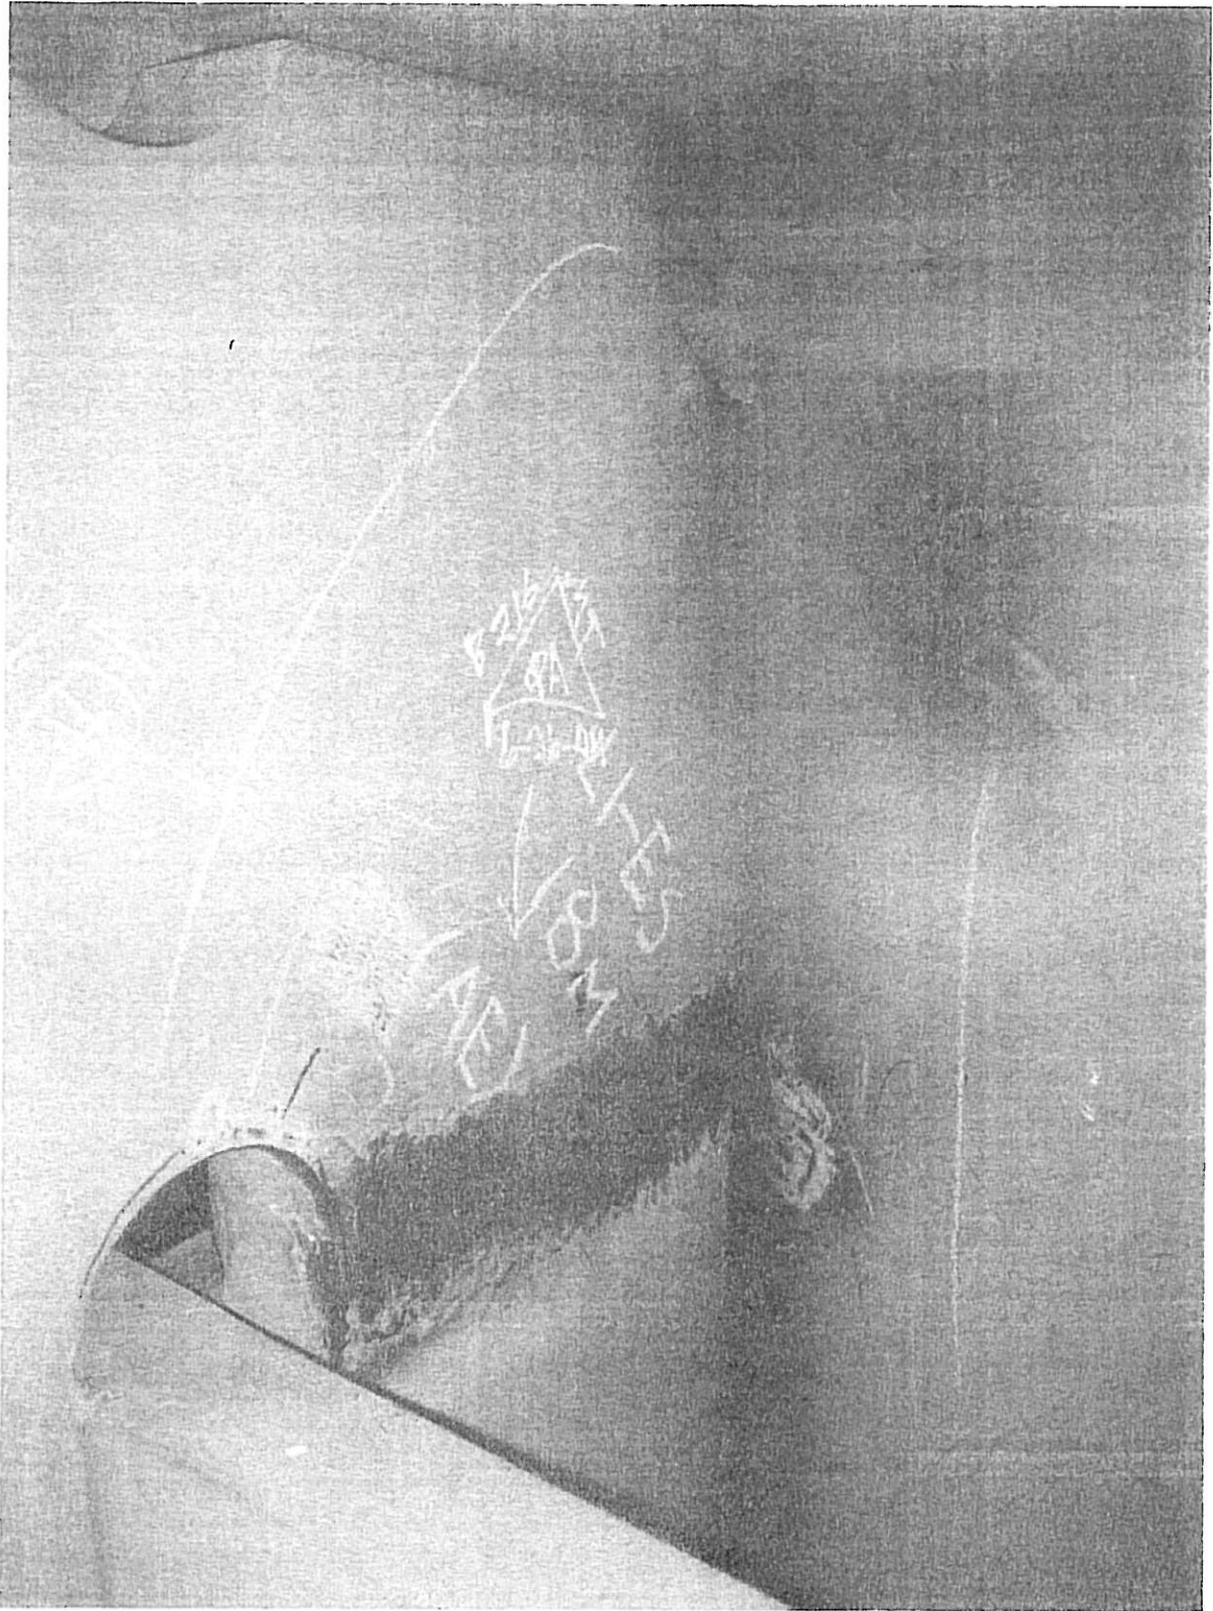
During random after-blast visual verification of East Tower, Lift 1, QA observed that there was no backing bar at 18m diaphragm weld joint ESD1-A167G/H-141.

About ESD1-A167G/H-141, ZPMC ground the weld back and repaired after VT. The MT, UT were performed to make sure no problem about this weld.
