Contract #: 04-0120F4Cty: SF/ALA Rte: 80 PM: 13.2/13.9File #: 69.25B**QUALITY ASSURANCE -- NON-CONFORMANCE REPORT****Location:** Changxing Island, Shanghai, P.R. China**Report No:** NCR-000341**Prime Contractor:** American Bridge/Fluor Enterprises, a JV**Date:** 24-Jun-2009**Submitting Contractor:** Zhenhua Port Machinery Company, Ltd (ZPMC), Changxing Island**NCR #:** ZPMC-0315**Type of problem:**

Reference Description: CJP welds replaced with fillet at repair locations prior to engineer's approval**Description of Non-Conformance:**

NON-CONFORMANCE REPORT TRANSMITTAL

Subject: NCR No. ZPMC-0315

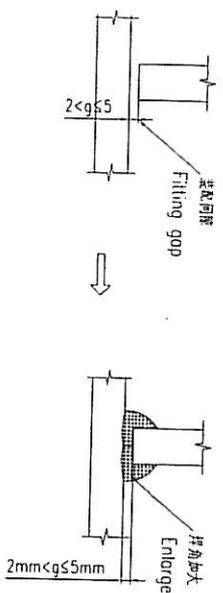
- 6. The out-of-tolerance of assembly gap of T-shoped joint and its repairing
- 6. T型接头角焊缝装配间隙修复方法(如: 角焊缝和盖与隔板装配间隙或隔板与横隔板装配间隙)
- 6.1 The gap is less than 5mm.
- 6.1 间隙T型装配间隙≤5mm 以内修复

$g > 5mm$

Repair method:

加大角焊缝焊脚尺寸, 但焊脚尺寸应符合规范而增加
