Contract #: 04-0120F4
 Cty: SF/ALA Rte: 80 PM: 13.2/13.9
 File #: 69.25B

QUALITY ASSURANCE -- NON-CONFORMANCE REPORT

Report No: NCR-000514

Reference Description: Heat Straightening not according to the Heat Straightening Procedure on Crossbeam
 8

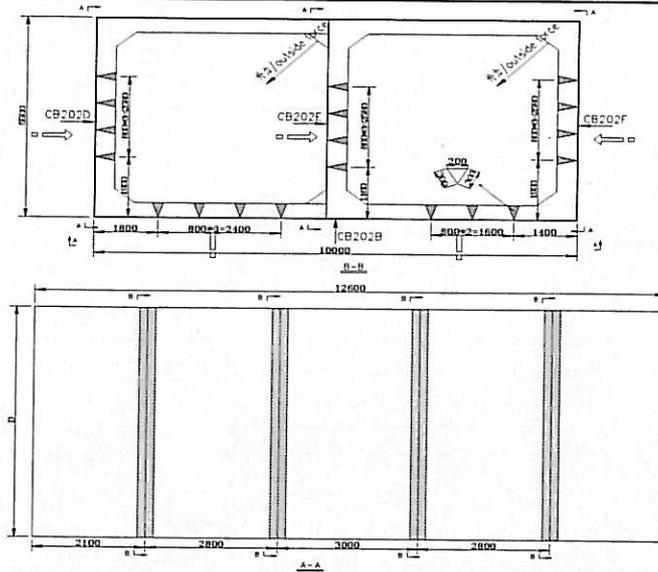
简图 Sketch

情况描述 Description of Condition

最高温度(Maximum temperature): <600°C

Cause原因 Welding distortion 焊接变形

Type of Defect缺陷类型 Welding distortion 焊接变形

缺陷去除方法(Defect Removal Method): Flame Straightening by oxygen acetylene 运用氧乙炔运行校火
