**DEPARTMENT OF TRANSPORTATION**

Contract #: 04-0120F4Cty: SF/ALA Rte: 80 PM: 13.2/13.9File #: 69.25B**QUALITY ASSURANCE -- NON-CONFORMANCE REPORT****Location:** Changxing Island, Shanghai, P.R. China**Report No:** NCR-000558**Prime Contractor:** American Bridge/Fluor Enterprises, a JV**Date:** 22-Dec-2009**Submitting Contractor:** Zhenhua Port Machinery Company, Ltd (ZPMC), Changxing Island**NCR #:** ZPMC-0531**Type of problem:**

**Reference Description:** Side Panel Flatness, L5E**Description of Non-Conformance:**

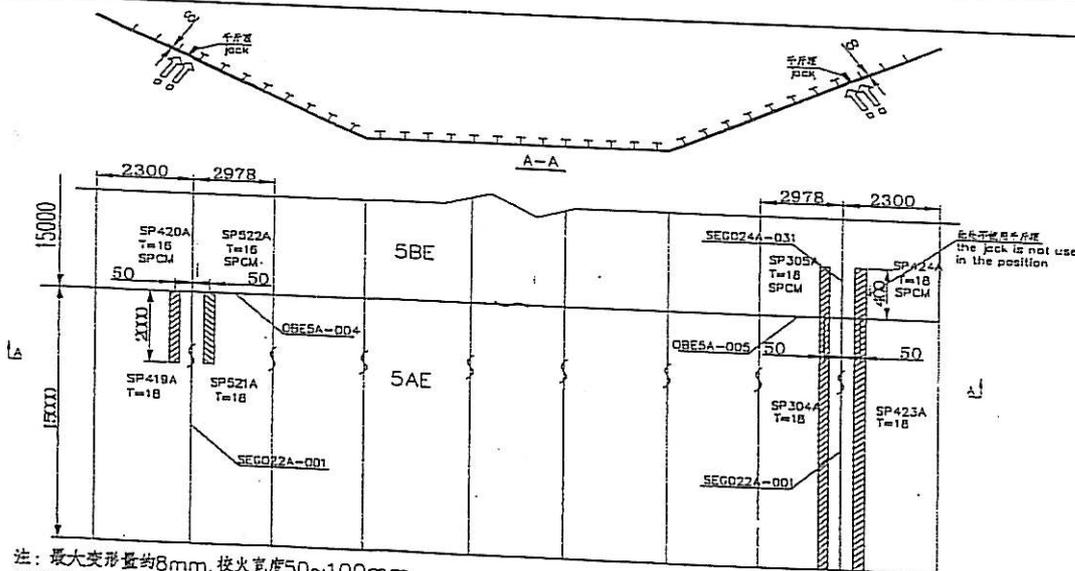
### 简图 Sketch

Cause原因 Welding distortion 焊接变形

Type of Defect缺陷类型 Welding distortion 焊接变形

最高温度 (Maximum temperature): &lt;650°C
