Contract #: 04-0120F4  
 Cty: SF/ALA Rte: 80 PM: 13.2/13.9  
 File #: 69.25B

## QUALITY ASSURANCE -- NON-CONFORMANCE REPORT

**Report No:** NCR-000576

**Reference Description:** Weld Repair without Engineer's Approval (CWR) and without WPS, Weld OBE5-004, Segments 5AE/5BE

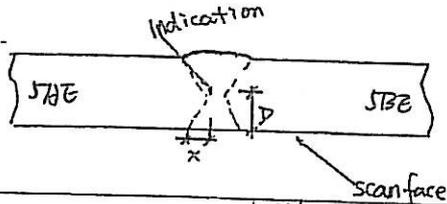
Report Number: UT-5E-006 (1/2)

Weld No.	Indication No.	Scan Face	Dimensions (mm)				Indication Rating "J"	Evaluation	Inspector	Inspection Date
			"Y" from O Axis	"X"	Length "L"	Depth "D"				
OBES-002 (A10)		outside	/	/	/	/	ACC.	S016, S014	09.12.9	
OBES-003 (A1)			/	/	/	/	↓	S013, S002		
OBES-004 (A2)	1	↓	710	10	30	16.8	+6	LLI, REJ.	S002	
	2	↓	820	10	30	16.1	+8	↓	↓

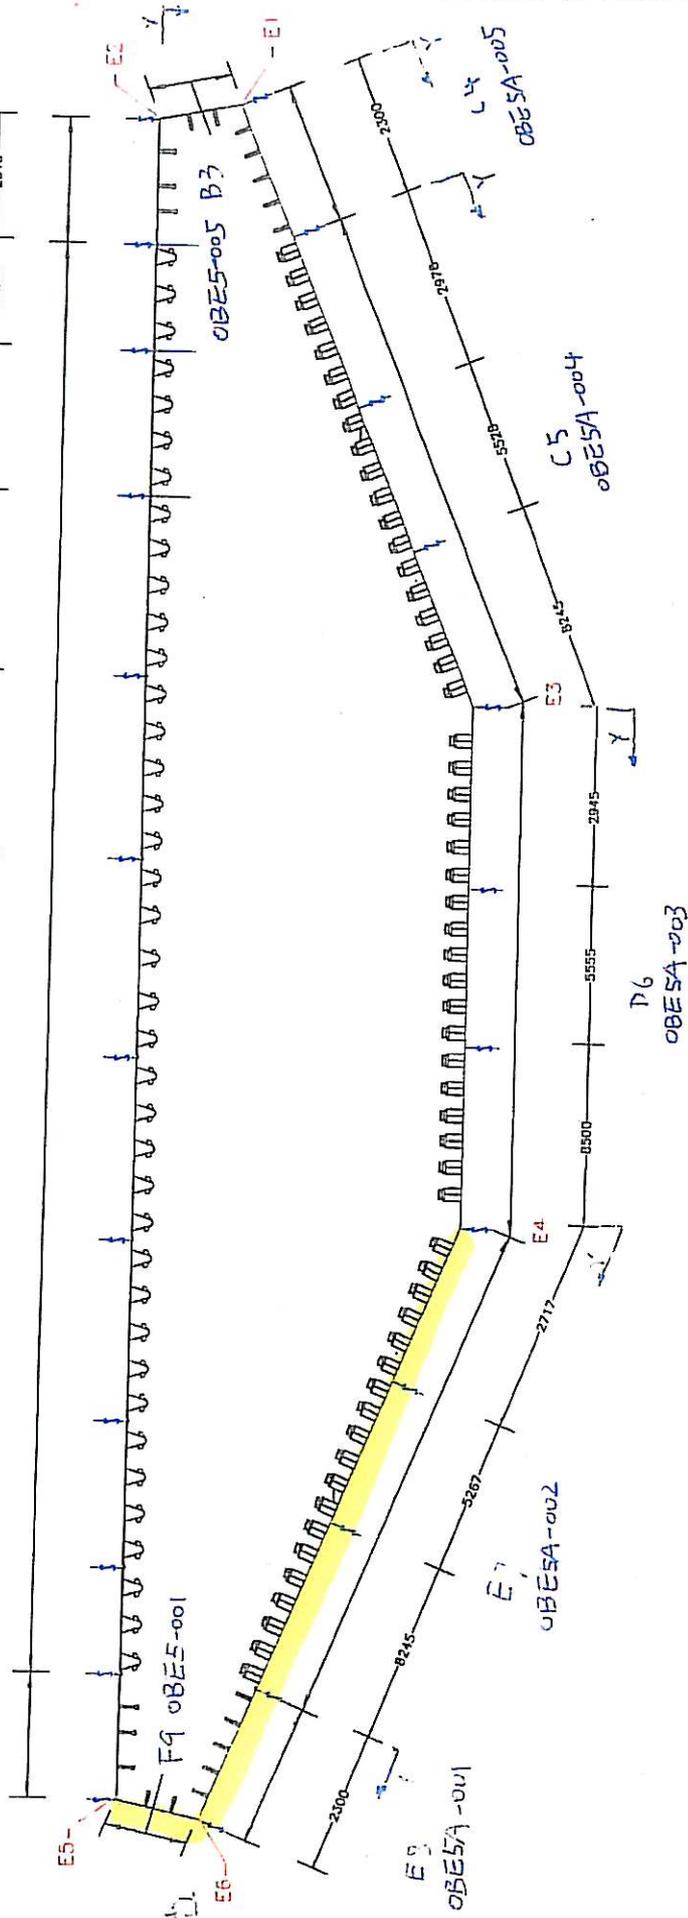
OBES-004

- Weld repair was performed without the Engineer's approval.
- No approved welding procedure specification (WPS) was onsite during the welding repair process.
- This weld is identified as: OBE5-004
- Y location is 710mm measured from the Counter Weight side on the interior of the Deck Plate at Panel Point (PP32).
- This is a second time weld repair performed on a Transverse Indication.
- ZPMC discovered this indication utilizing the Magnetic Particle (MT) method.
- Lift 5 East is located in the OGB Trial Assembly Area.

Contractor submitted CWR after repair work was completed and NDT inspections have verified the weld in question is in conformance with Contract specifications. ZPMC has reiterated the Contract requirements regarding having an approved WPS on site during welding to the QC in charge of the area during the time of the incident.
