**DEPARTMENT OF TRANSPORTATION**

Contract #: 04-0120F4Cty: SF/ALA Rte: 80 PM: 13.2/13.9File #: 69.25B**QUALITY ASSURANCE -- NON-CONFORMANCE REPORT****Location:** Changxing Island, Shanghai, P.R. China**Report No:** NCR-000602**Prime Contractor:** American Bridge/Fluor Enterprises, a JV**Date:** 05-Jan-2010**Submitting Contractor:** Zhenhua Port Machinery Company, Ltd (ZPMC), Changxing Island**NCR #:** ZPMC-0575**Type of problem:**

**Reference Description:** Missed MT Indication by QC on 7DW on FB to BP joint**Description of Non-Conformance:**

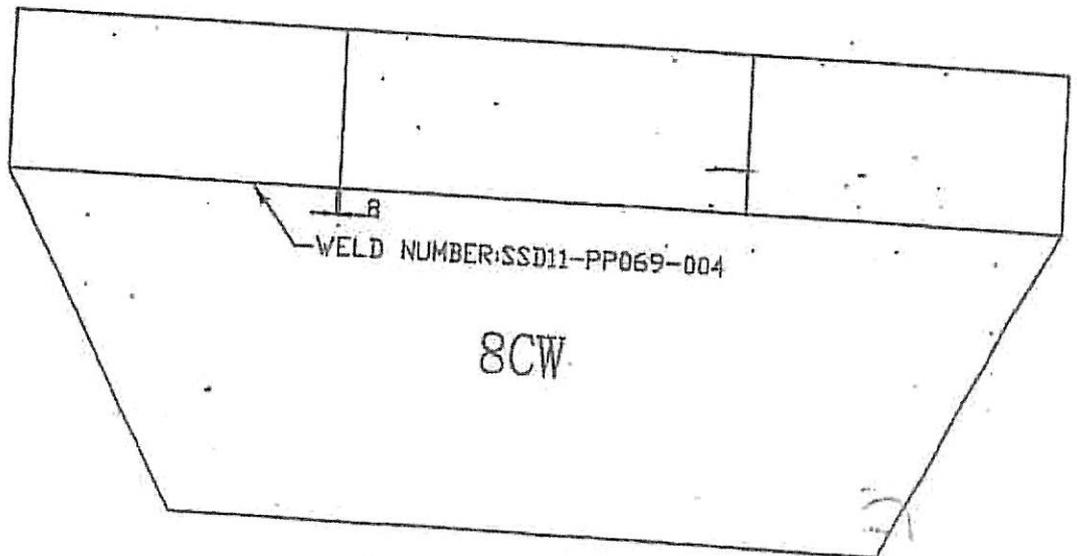
Draft of Welding Discontinuity:

Cause:

1. Moisture wasn't completely removed during drying operation (preheating) or the area wasn't preheated sufficiently.

1. QC and a Lead CWI shall be present, direct and supervise all grinding and welding operations during this repair to ensure the repair is per the disposition requirements

2. QC and a Lead CWI shall have an approved copy of the CWR in hand prior to the repair.
3. Remove paint  $\geq 25$ mm in all direction of HAZ prior to MT.

4. Clean the excavation area of all loose debris including MT powder. Preheat to 85° C before removing cracks by grinding, repair area shall extend a minimum of 50mm beyond each end of single crack repairs.

5. If base metal is damaged by grinding, the damaged area shall be ground clean prior to performing weld repair. If gap  $> 5$ mm is found during or after grinding, comply with the notification on changing fillet weld to CJP which is submitted for Engineer's review and approval form.

6. Prepare excavation in accordance with the New Repair Procedure prior to welding.
7. Before this repair, Verify with VT and MT repair areas are defects free, and also MT shall be performed on the base metal laying abroad cracks to ensure that no cracks were propagated to the base metal. Separate CWR approval is needed if cracks are found in the base metal, and only after this new CWR's approval can continue the repair.

8. Clean excavation area of all loose debris including MT powder after excavation. Preheat and weld according to repair WPS, the preheat shall between 160° C-230° C.

9. Perform post weld heating according to repair WPS, the postheat shall between 230° C-315° C and for one hour minimum.
10. Allow the weld to cool to ambient temperature gradually. Control cooling rate after PWHT to no more than 50° C per hour.

11. Grind the repaired area flush with base metal or the adjacent weld after post weld heating.
12. Wait 48 hours at least after the repair area has cooled to ambient temperature before performing NDT.

13. Perform MT inspection to all repair area according to Contract Drawings along with all additional NDT required by the applicable notes Special Provision Section 10-1.59 'Steel Structure', subsection 'Inspection testing'. NDT include VT, MT and UT if it is a CJP weld.
