Contract #: 04-0120F4Cty: SF/ALA Rte: 80 PM: 13.2/13.9File #: 69.25B**QUALITY ASSURANCE -- NON-CONFORMANCE REPORT****Location:** Changxing Island, Shanghai, P.R. China**Report No:** NCR-000610**Prime Contractor:** American Bridge/Fluor Enterprises, a JV**Date:** 07-Jan-2010**Submitting Contractor:** Zhenhua Port Machinery Company, Ltd (ZPMC), Changxing Island**NCR #:** ZPMC-0583**Type of problem:**

Reference Description: ZPMC performed Base Metal Repairs without the prior approval of the Engineer in Segment 6BE/6CE

Job Name: SAS Superstructure

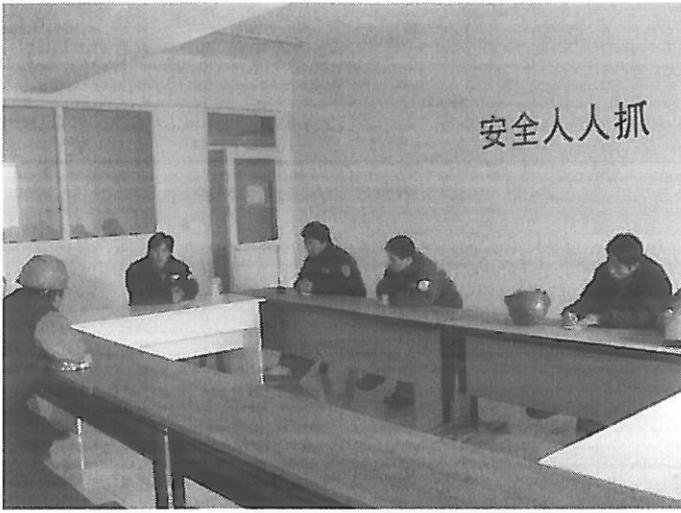
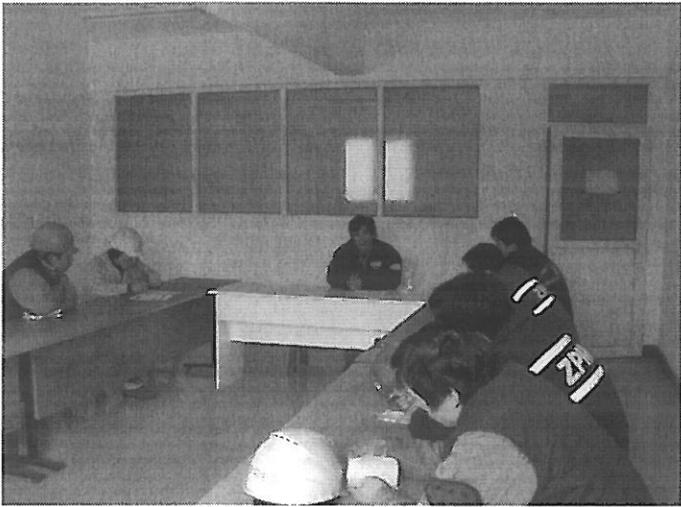
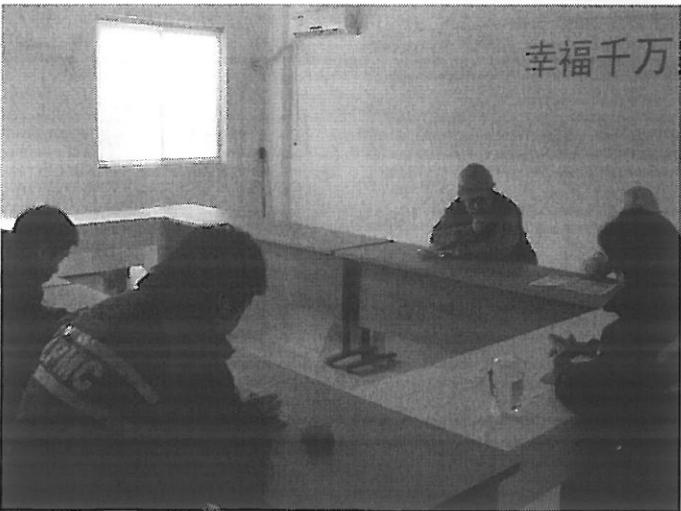
During the Quality Assurance (QA) random in-process visual inspection of the OBG segments in the Trial Assembly area, this QA inspector discovered the following issues:

- Base metal repairs (BMR) were being performed without prior approval of the Engineer at locations of removed temporary attachments.
- These BMR's were located along the 6BE/6CE Bottom Plate Complete Joint Penetration (CJP) Splice.
- The Bottom Plates on 6BE are identified as: BP168A, BP60A, BP114A
- The Bottom Plates on 6CE are identified as: BP169A, BP61A, BP115A
- The CJP splice weld # is designated OBE6C-004.
- The approximate lengths of the BMR's range from 10mm to 150mm.
- A total of seventeen (17) repairs were in-process on 6BE and twenty-two (22) repairs on 6CE throughout the length of the Bottom Plate splice.
- The material is A709M Grade 345 Non-SPCM.

Reference Resolution: ZPMC has held internal training with the CWIs and production regaining base metal repairs without Engineer approval. NDT of base metal repaired areas will be provided when available.
