**DEPARTMENT OF TRANSPORTATION**

Contract #: 04-0120F4Cty: SF/ALA Rte: 80 PM: 13.2/13.9File #: 69.25B**QUALITY ASSURANCE -- NON-CONFORMANCE REPORT****Location:** Changxing Island, Shanghai, P.R. China**Report No:** NCR-000646**Prime Contractor:** American Bridge/Fluor Enterprises, a JV**Date:** 23-Jan-2010**Submitting Contractor:** Zhenhua Port Machinery Company, Ltd (ZPMC), Changxing Island**NCR #:** ZPMC-0617**Type of problem:**

| <b>Procedural</b> | <b>Procedural</b> | <b>Description:</b> Unapproved Buttering of Side Panel Splice Welds | |

**Reference Description:** ZPMC performed unapproved buttering to correct root opening size on side panels for OBG Segment 12CE

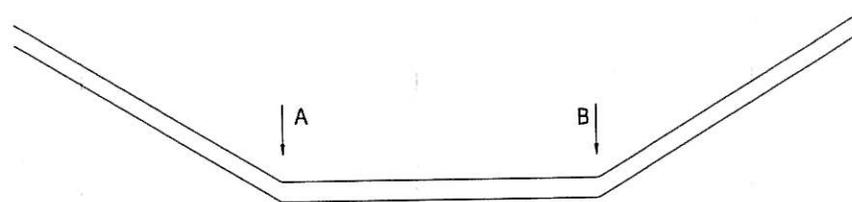
VIEW A

- Deposition of weld metal (buttering/build up) of up to 21mm measured horizontally from the groove face to correct excessive root opening by Flux Cored Arc Welding (FCAW) without the prior approval of the engineer.
- Buttering was performed on Side Panel SP3012A (38mm x L=1500mm) and SP3021A (30mm x L=2000mm)
- ZPMC onsite Quality Control Inspector (QC), Mr. Guo Xing Hui, produced Welding Repair Report (WRR)-B-WR-10076 Dated January 9th, 2010 for the work being performed.
- The material being welded is Non SPCM.
- The Side Panel components are located in Bay 14.

1. Grind the edge of the repair area cleanly;
2. Prepare an right joint according to the approved WPS;
3. Perform VT to the repair area to ensure no impurity exist;
4. Add steel backing according to the attached drawing 1;
5. Preheat and weld according to the relevant repaired WPS;
6. Remove the steel backing and grind the weld flush with around metal;
7. Perform post NDT (VT MT UT) of repaired area to insure sound weld metal has been de posited.
8. Prepare excavation again according to the shop drawings
