**DEPARTMENT OF TRANSPORTATION**

Contract #: 04-0120F4Cty: SF/ALA Rte: 80 PM: 13.2/13.9File #: 69.25B**QUALITY ASSURANCE -- NON-CONFORMANCE REPORT****Location:** Changxing Island, Shanghai, P.R. China**Report No:** NCR-000651**Prime Contractor:** American Bridge/Fluor Enterprises, a JV**Date:** 24-Jan-2010**Submitting Contractor:** Zhenhua Port Machinery Company, Ltd (ZPMC), Changxing Island**NCR #:** ZPMC-0622**Type of problem:**

**Reference Description:** Missed MT Indication by QC for a weld joint on the Lift 12 Longitudinal Shear Plate**Description of Non-Conformance:**

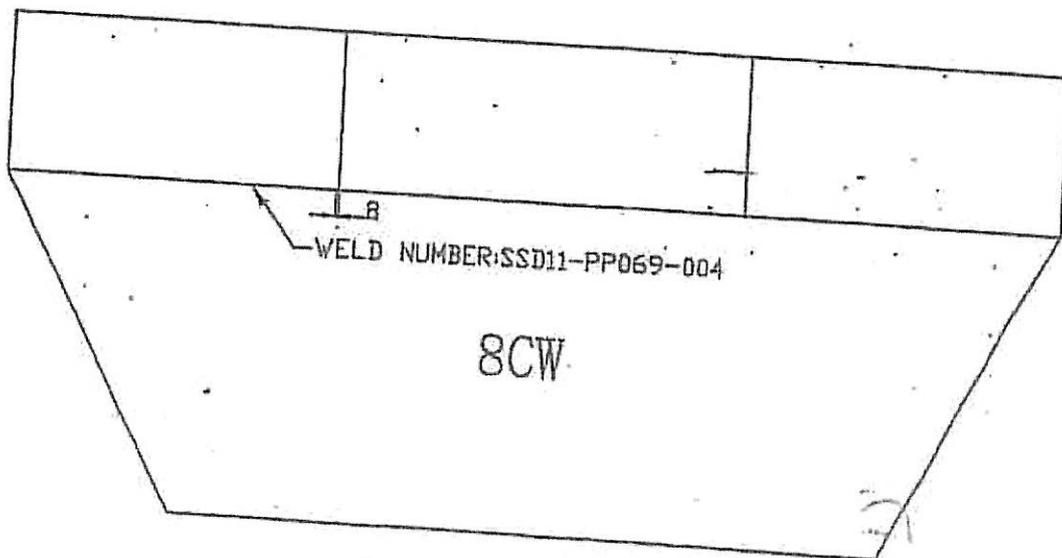
Draft of Welding Discontinuity:

1. Moisture wasn't completely removed during drying operation (preheating) or the area wasn't preheated sufficiently.

1. QC and a Lead CWI shall be present, direct and supervise all grinding and welding operations during this repair to ensure the repair is per the disposition requirements

2. QC and a Lead CWI shall have an approved copy of the CWR in hand prior to the repair.
3. Remove paint  $\geq 25$ mm in all direction of HAZ prior to MT.

4. Clean the excavation area of all loose debris including MT powder. Preheat to 85° C before removing cracks by grinding, repair area shall extend a minimum of 50mm beyond each end of single crack repairs.

5. If base metal is damaged by grinding, the damaged area shall be ground clean prior to performing weld repair. If gap  $> 5$ mm is found during or after grinding, comply with the notification on changing fillet weld to CJP which is submitted for Engineer's review and approval form.

6. Prepare excavation in accordance with the New Repair Procedure prior to welding.
7. Before this repair, Verify with VT and MT repair areas are defects free, and also MT shall be performed on the base metal laying abroad cracks to ensure that no cracks were propagated to the base metal. Separate CWR approval is needed if cracks are found in the base metal, and only after this new CWR's approval can continue the repair.

8. Clean excavation area of all loose debris including MT powder after excavation. Preheat and weld according to repair WPS, the preheat shall between 160° C-230° C.

9. Perform post weld heating according to repair WPS, the postheat shall between 230° C-315° C and for one hour minimum.
10. Allow the weld to cool to ambient temperature gradually. Control cooling rate after PWHT to no more than 50° C per hour.

11. Grind the repaired area flush with base metal or the adjacent weld after post weld heating.
12. Wait 48 hours at least after the repair area has cooled to ambient temperature before performing NDT.

13. Perform MT inspection to all repair area according to Contract Drawings along with all additional NDT required by the applicable notes Special Provision Section 10-1.59 'Steel Structure', subsection 'Inspection testing'. NDT include VT, MT and UT if it is a CJP weld.
