Contract #: 04-0120F4  
 Cty: SF/ALA Rte: 80 PM: 13.2/13.9  
 File #: 69.25B

## QUALITY ASSURANCE -- NON-CONFORMANCE REPORT

**Report No:** NCR-000658

**Reference Description:** Welder was not qualified to weld in 4F position for 6CW counterweight connection plate

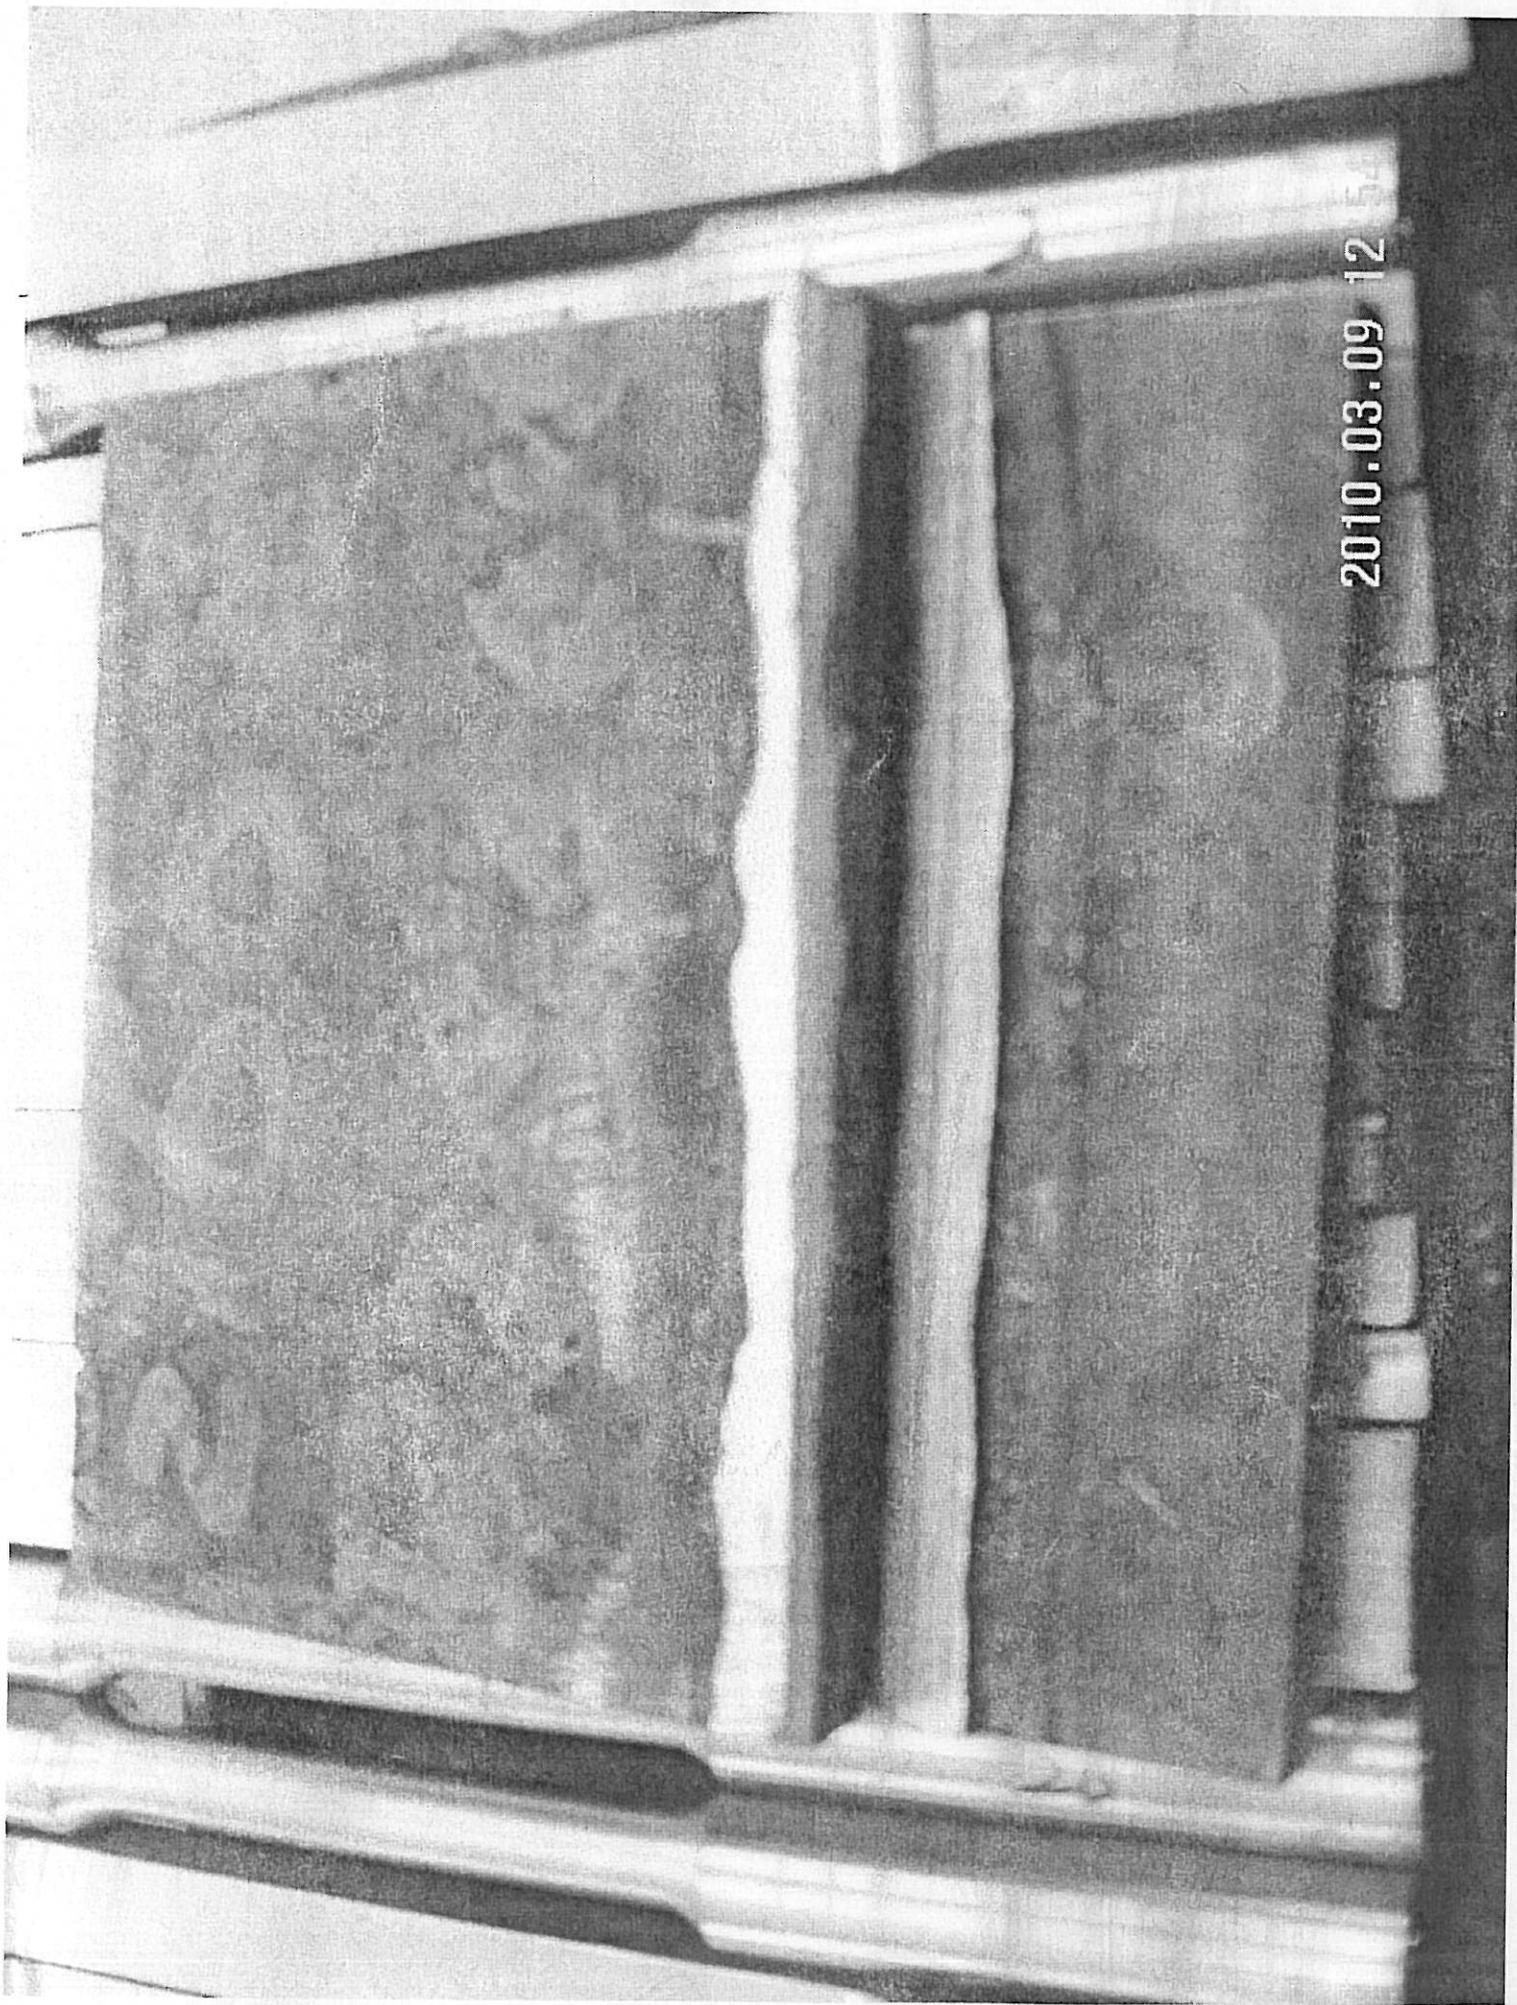
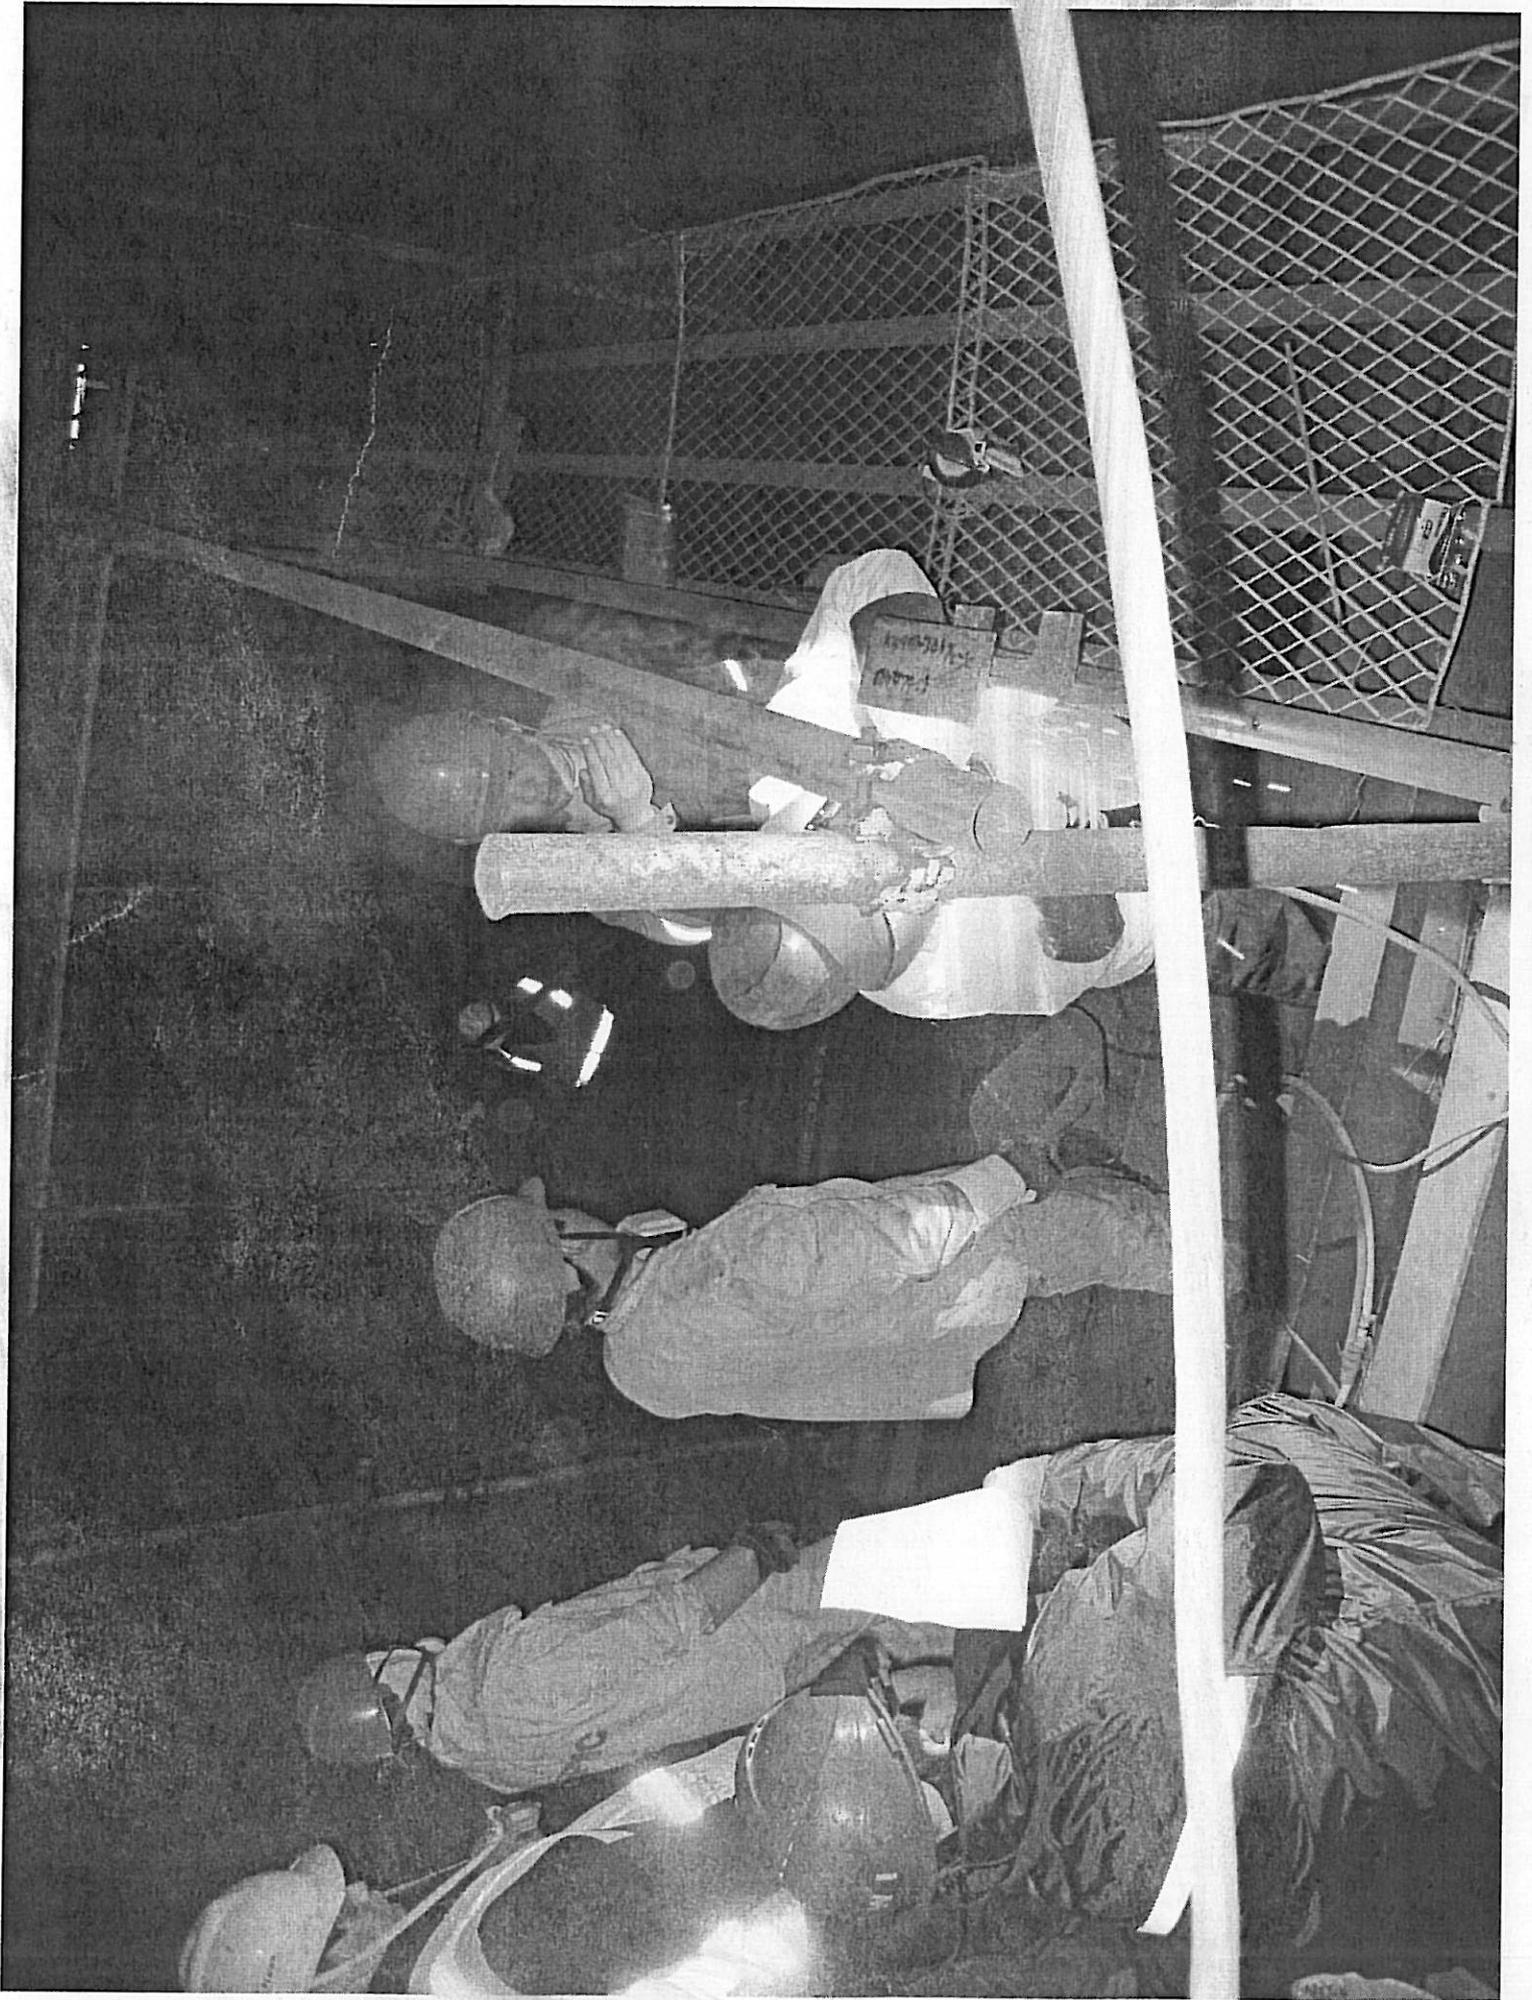
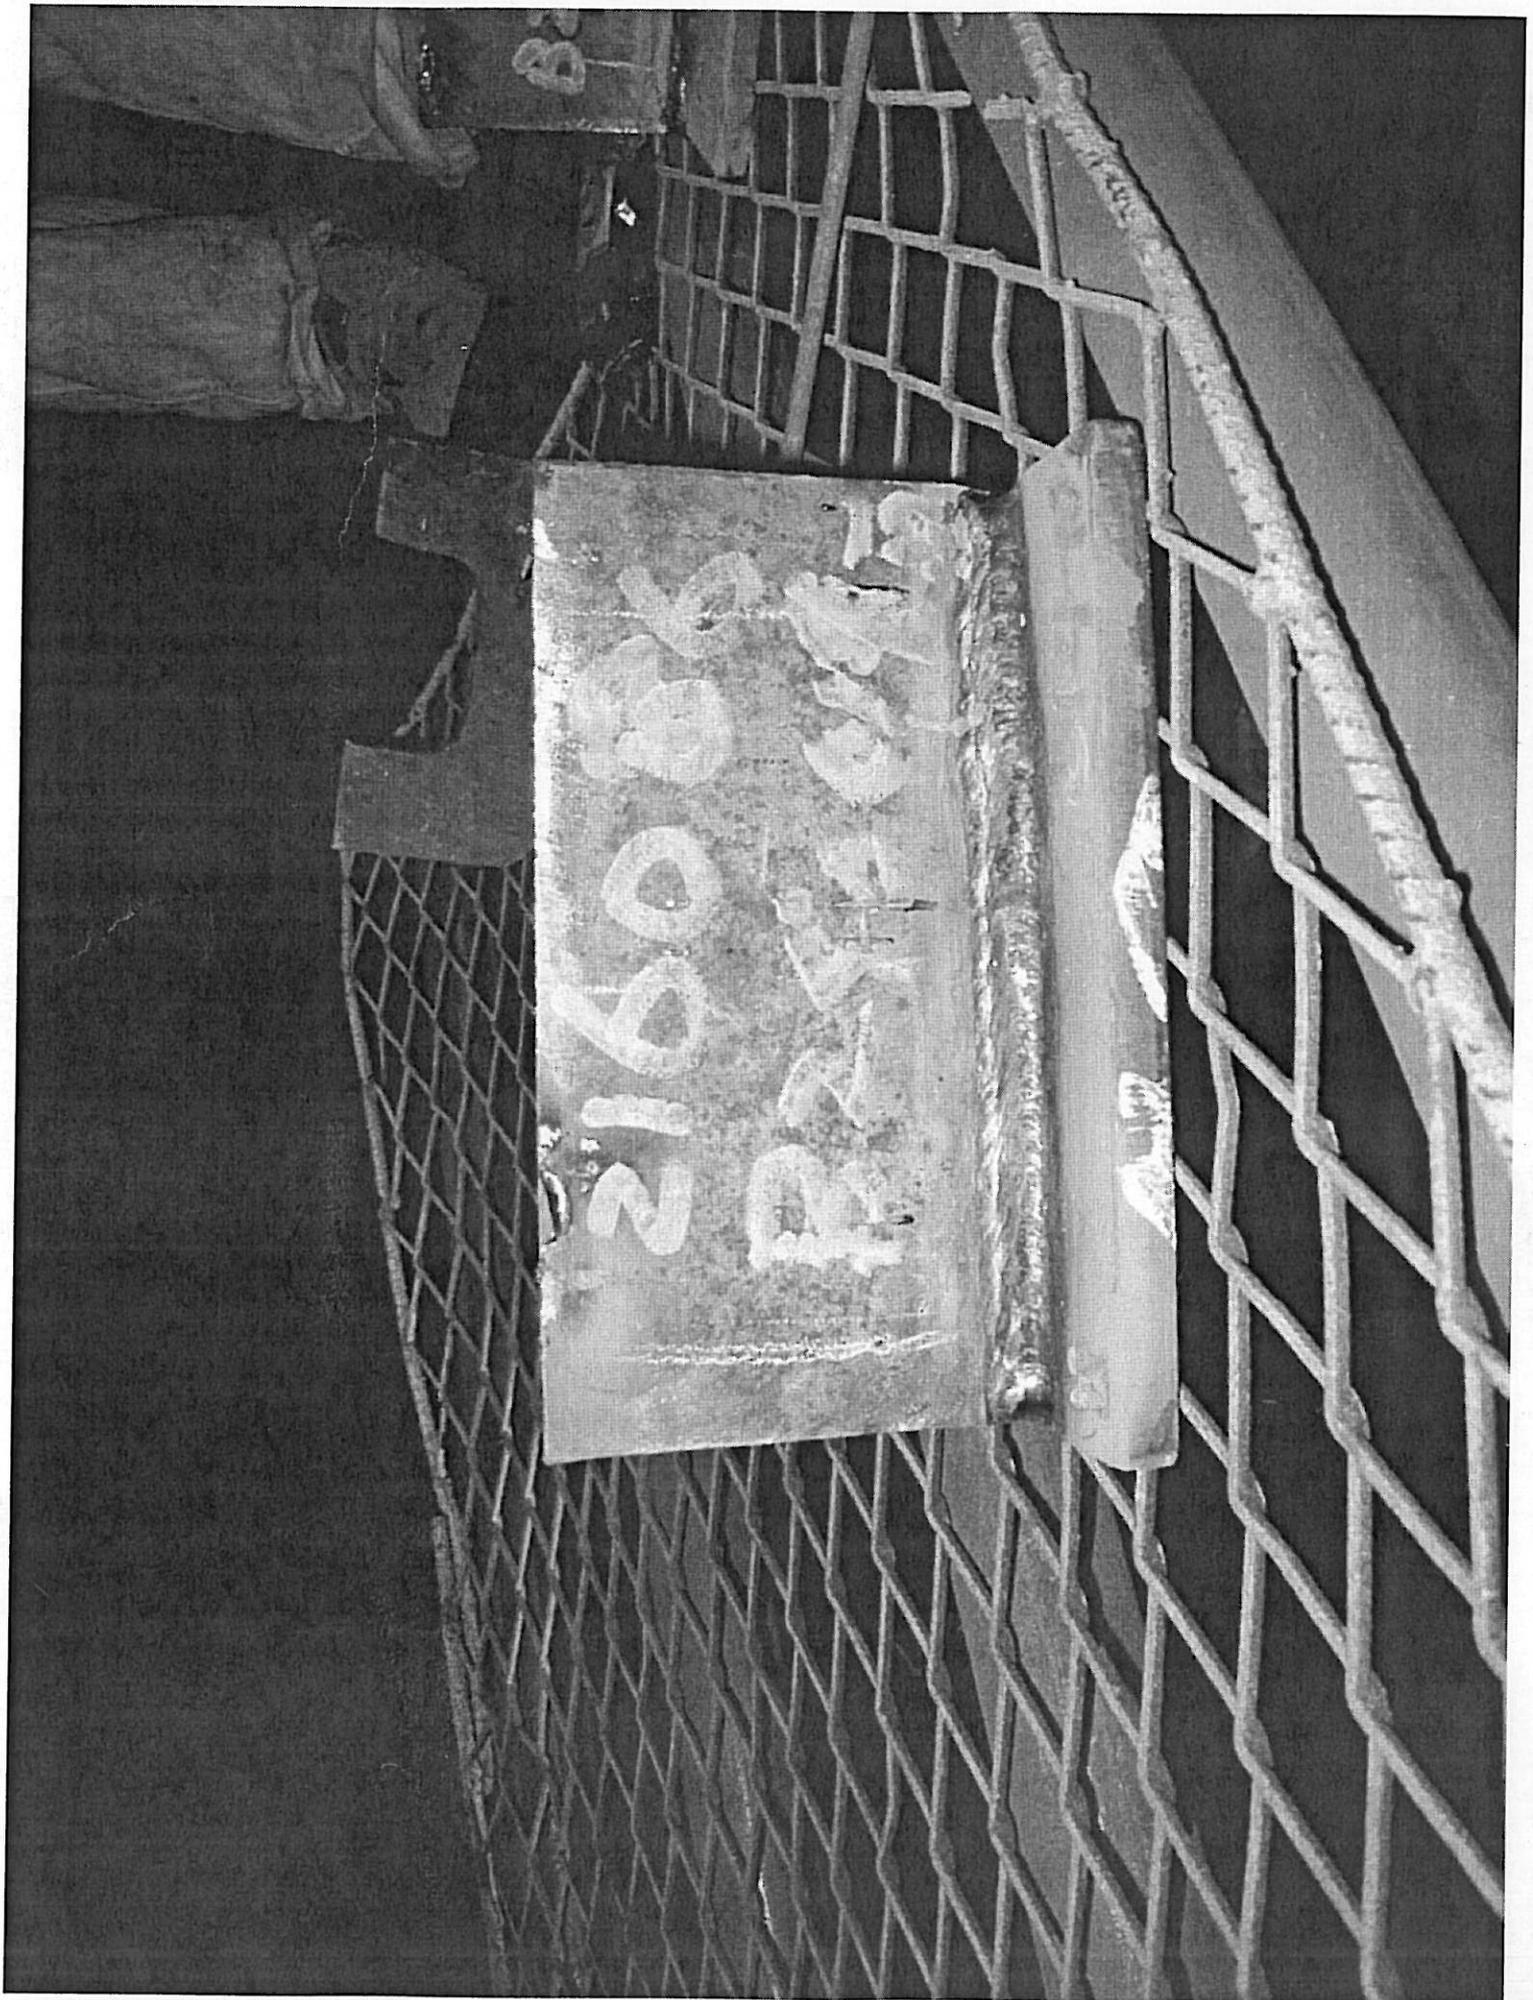
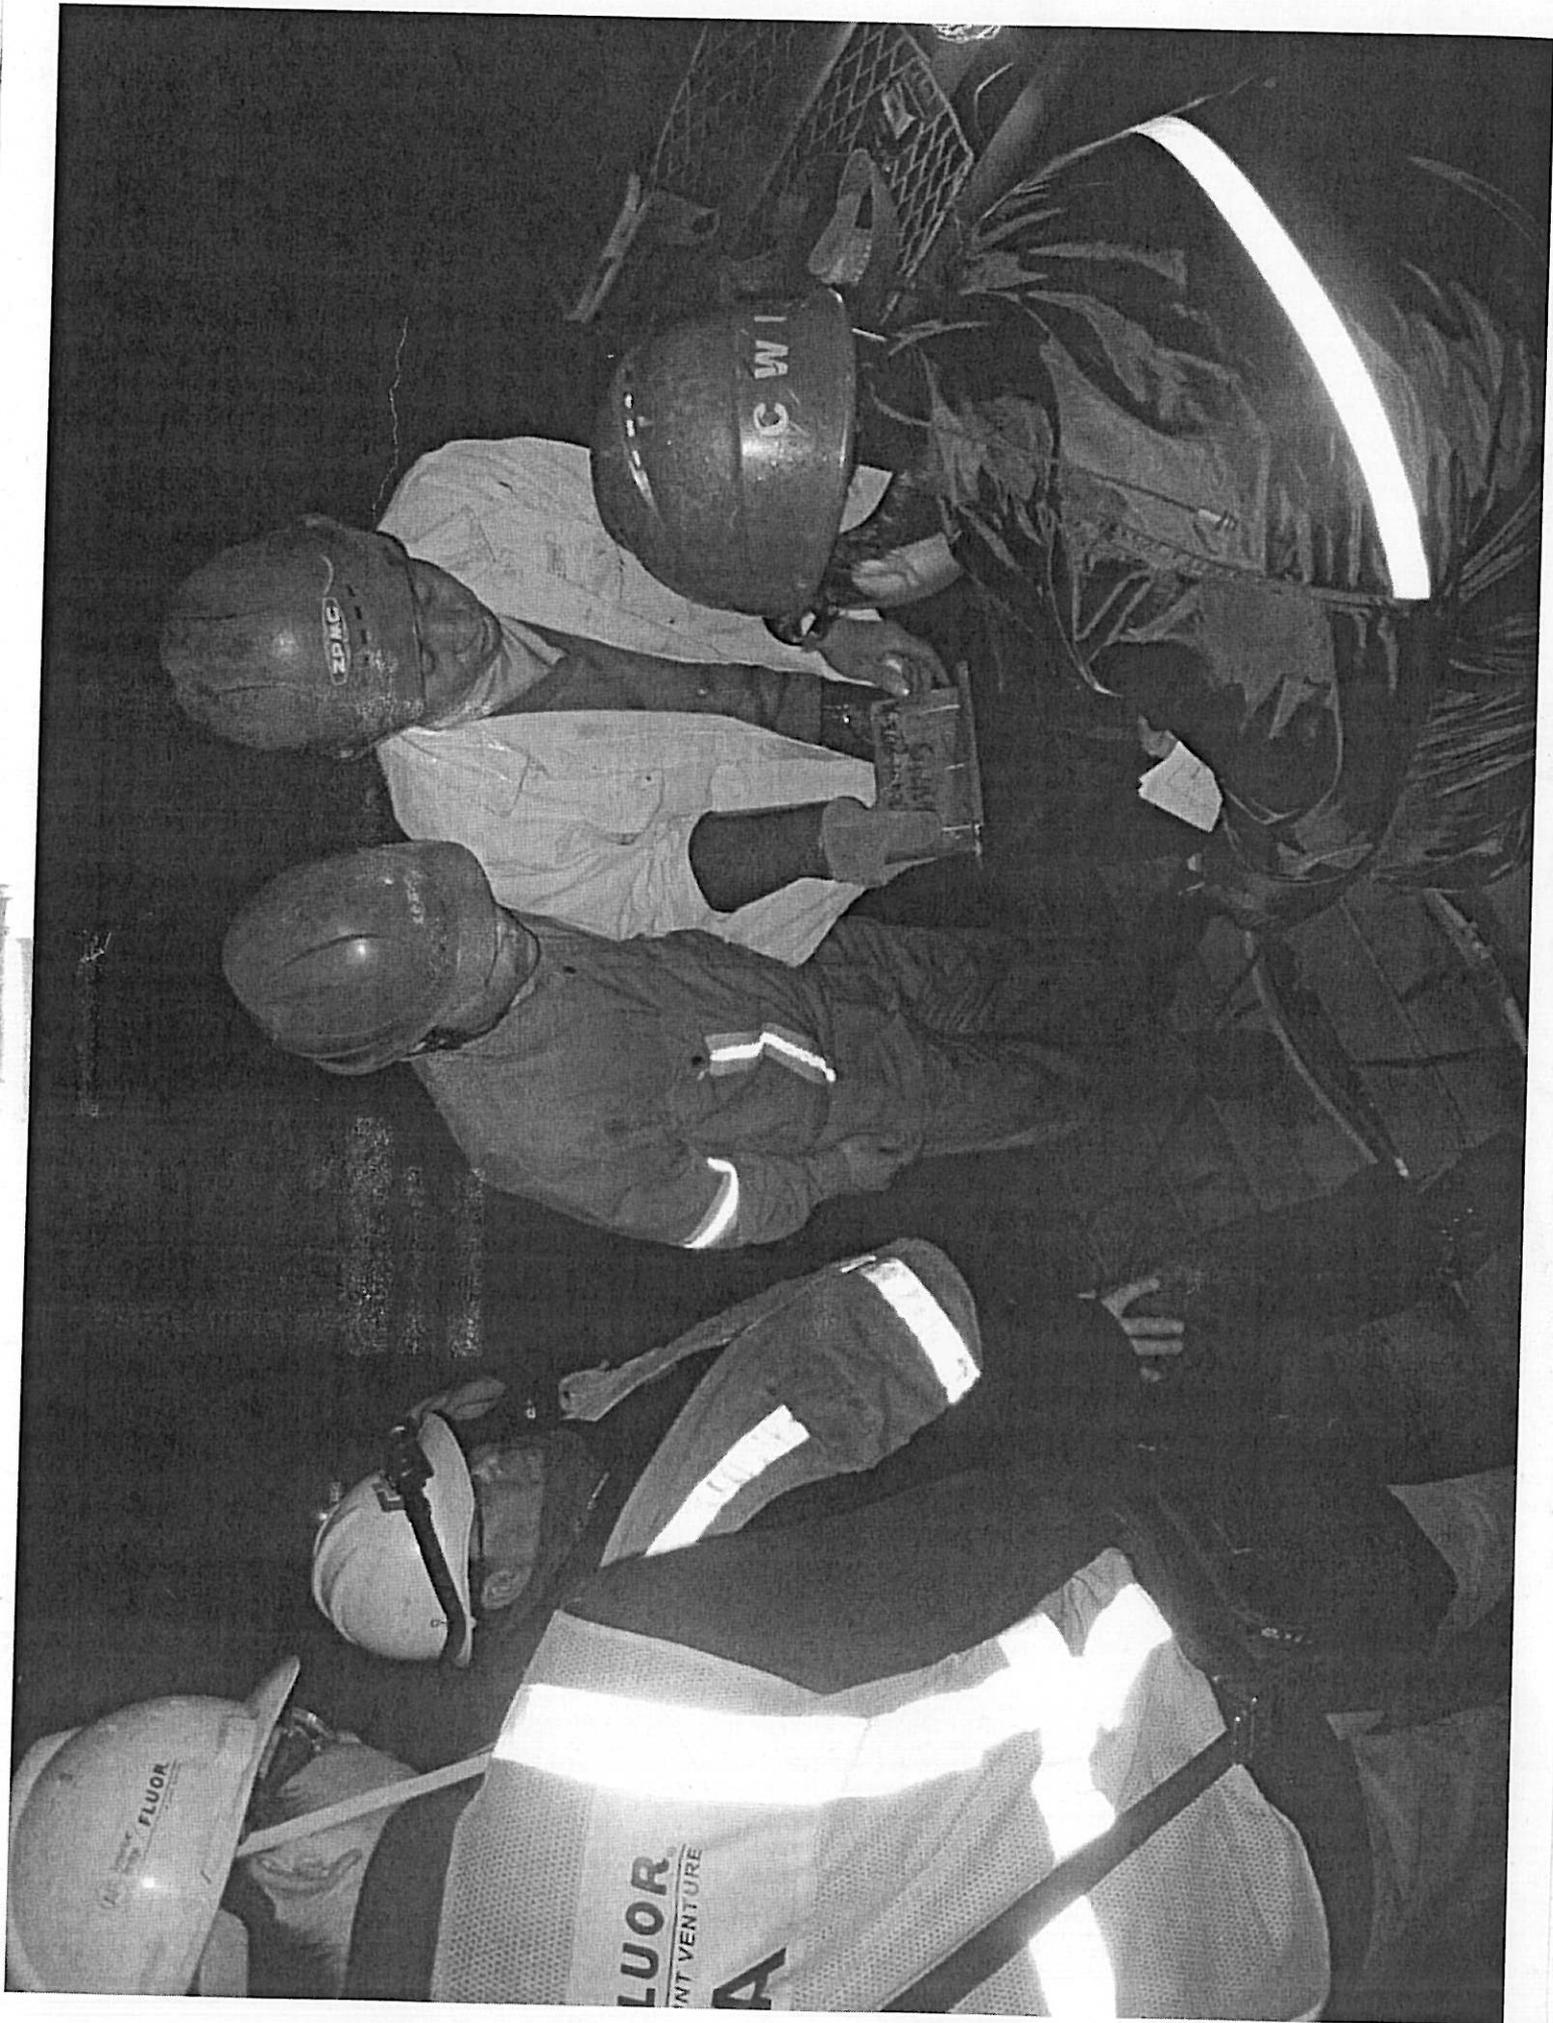
- ZPMC welder Xiao Di # 066401 was observed welding in the 4F overhead welding position, which he is only qualified in 3F vertical position.
- Welding was performed on the Connection Plate to Deck Plate.
- The Deck Plate is identified as CA29A.
- The weld is identified as OBW6F-009.
- This weld is a Complete Joint Penetration (CJP).
- A total of eight (8) repairs were performed on the bottom side of weld joint OBW6F-009.
- These repairs are located on the Counter Weight side of segment 6CW at the W3 line.
- Lift 6W is located in the OGB Trial Assembly Area.
