DEPARTMENT OF TRANSPORTATION
 DIVISION OF ENGINEERING SERVICES
 Office of Structural Materials
 Quality Assurance and Source Inspection

Contract #: 04-0120F4
 Cty: SF/ALA Rte: 80 PM: 13.2/13.9
 File #: 69.25B

QUALITY ASSURANCE -- NON-CONFORMANCE REPORT

Report No: NCR-000695

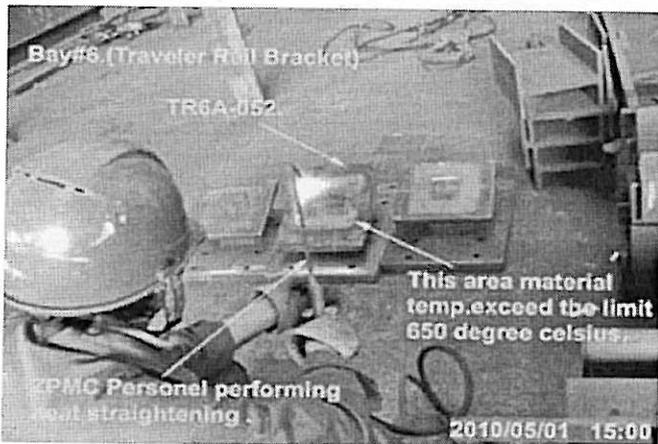
During the Quality Assurance (QA) random in-process observations of the fabrication of OBG Traveler Rail (TR) brackets, this Caltrans QA Inspector observed the following:
