Contract #: 04-0120F4Cty: SF/ALA Rte: 80 PM: 13.2/13.9File #: 69.25B**QUALITY ASSURANCE -- NON-CONFORMANCE REPORT****Location:** Changxing Island, Shanghai, P.R. China**Report No:** NCR-000713**Prime Contractor:** American Bridge/Fluor Enterprises, a JV**Date:** 21-Apr-2010**Submitting Contractor:** Zhenhua Port Machinery Company, Ltd (ZPMC), Changxing Island**NCR #:** ZPMC-0680**Type of problem:**

Reference Description: Heat straightening utilizing excessive heat and performing the work with no written procedure to show QA and QC on Floorbeam FB3014-001

Job Name: SAS Superstructure

Subject: NCR No. ZPMC-0680

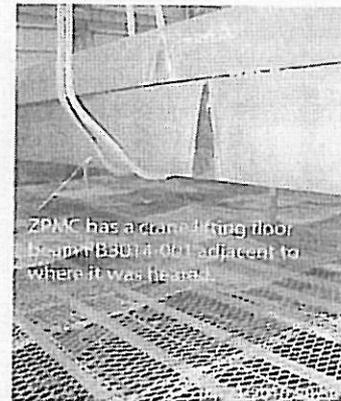
During random in process observations of OBG segment 12CE in Bay 14, this Caltrans Quality Assurance (QA) Inspector observed the following issues:

- Heat straightening was performed on Floorbeam FB3014-001 without an approved heat straightening document.
- ZPMC had a crane lifting upward with an unknown amount of uplifting force on the Floorbeam while heat straightening the Floorbeam base metal to a bright cherry-red color.

- Floorbeam FB3014-001 is welded in place at OBG segment 12CE near panel point PP115.5.

AWS D1.5 2002, Section 3.7.3 – “Members distorted by welding shall be straightened by mechanical means or by carefully supervised application of a limited amount of localized heat as approved by the Engineer.” The temperature of the heated areas as measured by approved methods shall not exceed 600°C [1100°F] for quenched and tempered steel nor 650°C [1200°F] (a dull, red color) for other steels. The part to be heated for straightening shall be substantially free of stress and from external forces, except those stresses resulting from the mechanical straightening.”

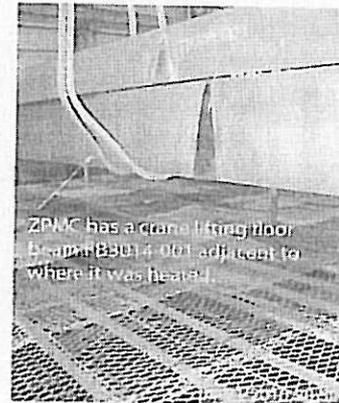
During random in process observations of OBG segment 12CE in Bay 14, this Caltrans Quality Assurance (QA) Inspector observed the following issues:

AWS D1.5 2002, Section 3.7.3 – “Members distorted by welding shall be straightened by mechanical means or by carefully supervised application of a limited amount of localized heat as approved by the Engineer.” The temperature of the heated areas as measured by approved methods shall not exceed 600°C [1100°F] for quenched and tempered steel nor 650°C [1200°F] (a dull, red color) for other steels. The part to be heated for straightening shall be substantially free of stress and from external forces, except those stresses resulting from the mechanical straightening.”

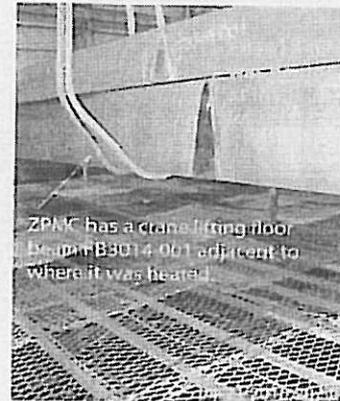
AWS D1.5 2002, Section 3.7.3 – “Members distorted by welding shall be straightened by mechanical means or by carefully supervised application of a limited amount of localized heat as approved by the Engineer.” The temperature of the heated areas as measured by approved methods shall not exceed 600°C [1100°F] for quenched and tempered steel nor 650°C [1200°F] (a dull, red color) for other steels. The part to be heated for straightening shall be substantially free of stress and from external forces, except those stresses resulting from the mechanical straightening.”

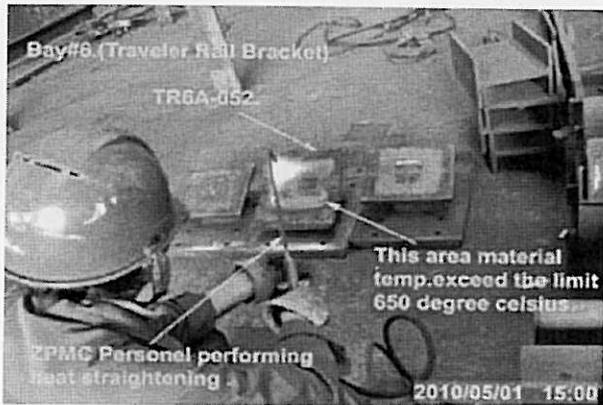
AWS 1.5 2002 section 3.7.3 "Members distorted by welding shall be straightened by mechanical means or by carefully supervised application of a limited amount of localized heat as approved by the Engineer. The temperature of the heated areas as measured by approved methods shall not exceed 600°C [1100°F] for quenched and tempered steel nor 650°C [1200°F] (a dull, red color) for other steels. The part to be heated for straightening shall be substantially free of stress and from external forces, except those stresses resulting from the mechanical straightening method used in conjunction with the application of heat."
