Contract #: 04-0120F4Cty: SF/ALA Rte: 80 PM: 13.2/13.9File #: 69.25B**QUALITY ASSURANCE -- NON-CONFORMANCE REPORT****Location:** Changxing Island, Shanghai, P.R. China**Report No:** NCR-000726**Prime Contractor:** American Bridge/Fluor Enterprises, a JV**Date:** 01-May-2010**Submitting Contractor:** Zhenhua Port Machinery Company, Ltd (ZPMC), Changxing Island**NCR #:** ZPMC-0689**Type of problem:**

Reference Description: Excessive heat was utilized during heat straightening of the traveler rail bracket TR6A-052; QC allowed heat straightening to be performed without a temperature measuring device

Job Name: SAS Superstructure

Subject: NCR No. ZPMC-0689

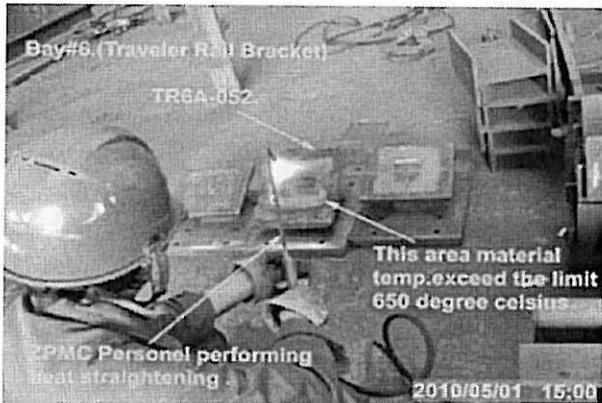
- ZPMC personnel perform heat straightening of traveler rail bracket base plate. The material was heated to a bright red color.
- Per ZPMC Heat Straightening Report identified as HSR1 (B)-8405, the maximum temperature is 650 °C.
- AWS D1.5 2002 defines the color of material heated to 650 °C as a "dull red color".
- A temperature indicating crayon, digital temperature measurement gauge, or other similar means of monitoring the temperature was not utilized by ZPMC QC and the actual maximum attained temperature was not measured.
- ZPMC QC personnel Shen Jian Gao was aware of the on-going heat straightening work performed without any temperature measuring device.
- The Traveler Rail Bracket is identified as TR6A-052.
- The base material thickness measured 30mm.
