Contract #: 04-0120F4Cty: SF/ALA Rte: 80 PM: 13.2/13.9File #: 69.25B**QUALITY ASSURANCE -- NON-CONFORMANCE REPORT****Location:** Changxing Island, Shanghai, P.R. China**Report No:** NCR-000746**Prime Contractor:** American Bridge/Fluor Enterprises, a JV**Date:** 27-May-2010**Submitting Contractor:** Zhenhua Port Machinery Company, Ltd (ZPMC), Changxing Island**NCR #:** ZPMC-0709**Type of problem:**

Reference Description: Missed UT indication by QC on OBG Segment 10CE Upper Floorbeam Flange (PP94)

Subject: NCR No. ZPMC-0709

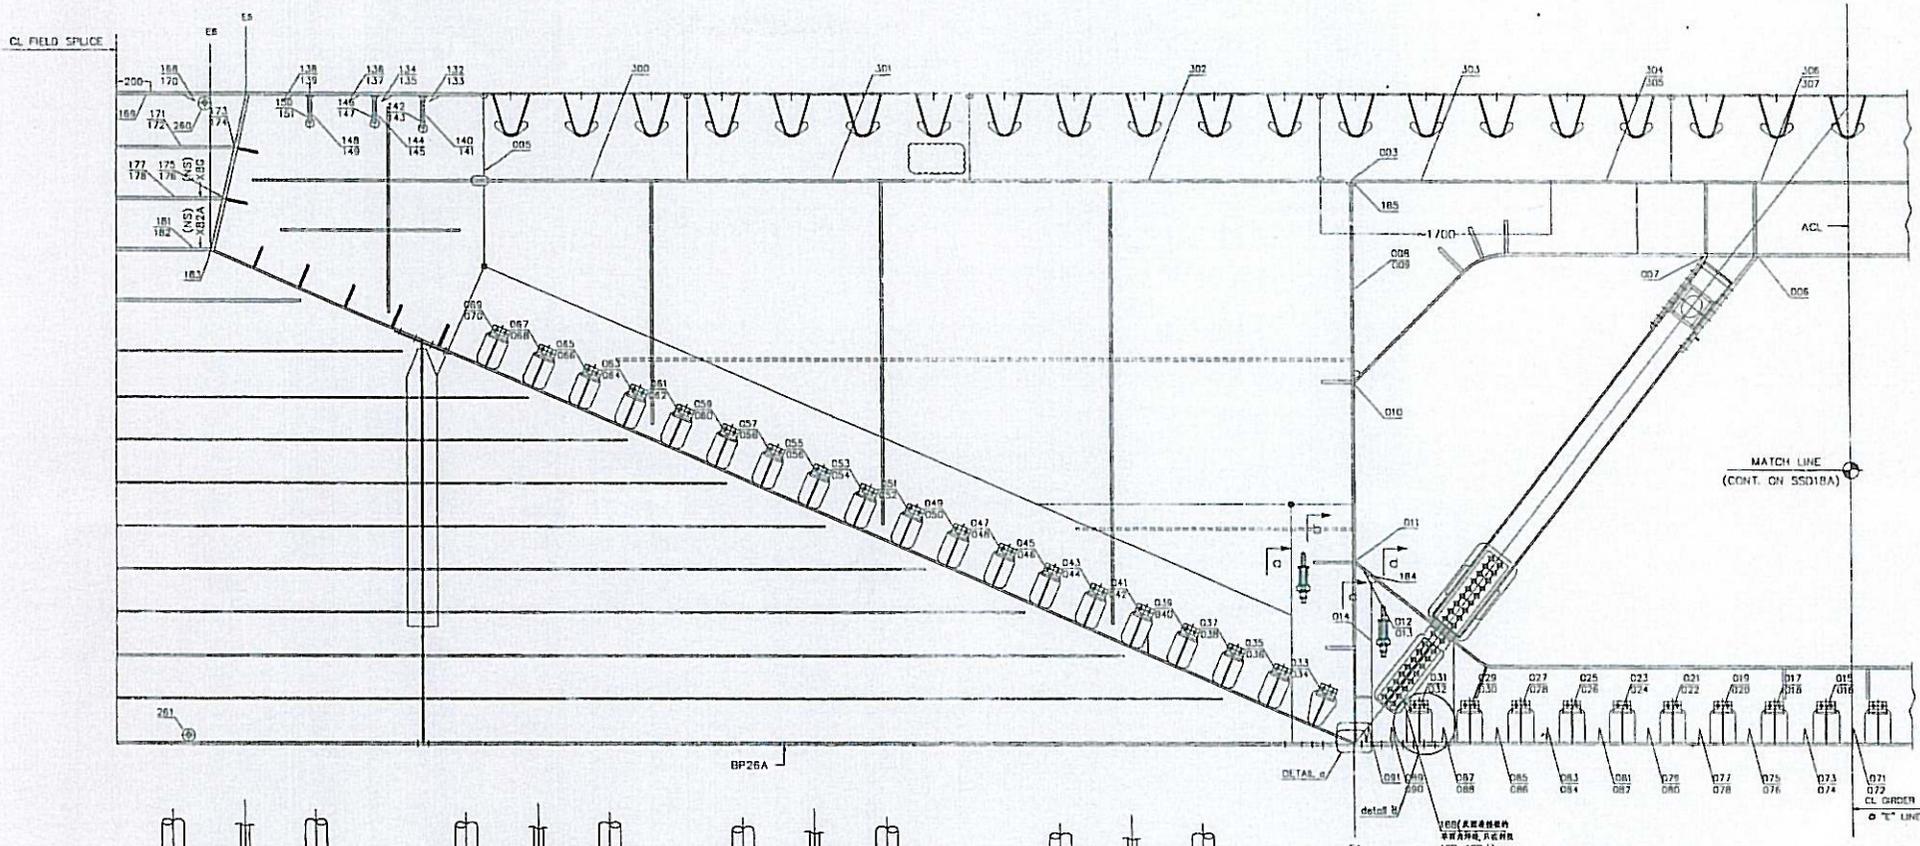
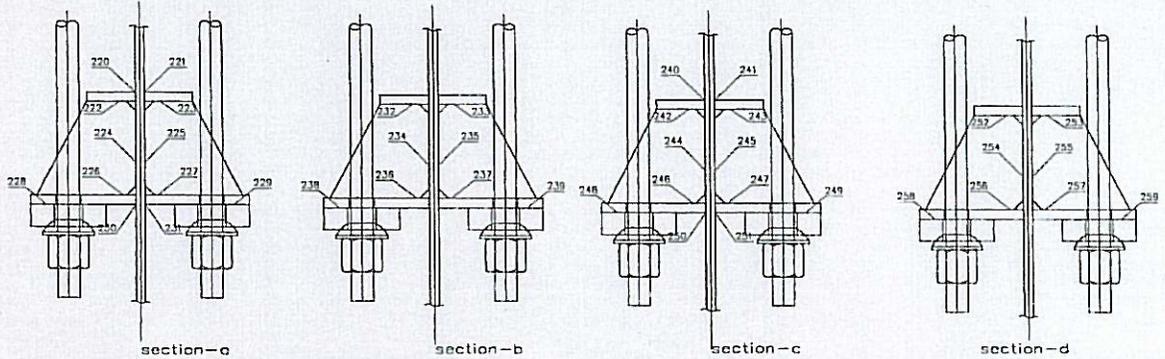
SECTION 18A-18A
SECTION 18B-18B
SECTION 18C-18C
SECTION 18E-18E
SECTION 18F-18F
SECTION 18G-18G
SECTION 18H-18H
SECTION 18J-18J

- One (1) longitudinal linear indication measuring approximately 80mm in length.
 - The indication dB rating is a +4.
 - Material thickness is 14mm.
 - The depth of the indication is approximately 10mm.

- The weld is identified as SSD-PP94-001/002 at Crossbeam side, Panel Point (PP) 94.
 - According to the approved shop drawing and due to excessive root gap ZPMC has changed the joint to a Complete Joint Penetration (CJP) "T" joint.

1. Gouge or grind from nearer side from metal edge ($D \leq 0.65T$, "D" is depth of defects, "T" is thickness of metal) to remove all defects;

2. Follow repair WPS for joint preparation, preheat, and weld deposit;

3. Verify with VT no defects remain in the weld joint prior to welding;

4. Grind the repaired area flush with base metal or the adjacent weld;

Repair said indication and perform NDT required to verify weld quality.
