Contract #: 04-0120F4Cty: SF/ALA Rte: 80 PM: 13.2/13.9File #: 69.25B**QUALITY ASSURANCE -- NON-CONFORMANCE REPORT****Location:** Changxing Island, Shanghai, P.R. China**Report No:** NCR-000750**Prime Contractor:** American Bridge/Fluor Enterprises, a JV**Date:** 28-May-2010**Submitting Contractor:** Zhenhua Port Machinery Company, Ltd (ZPMC), Changxing Island**NCR #:** ZPMC-0713**Type of problem:**

**Reference Description:** Excessive heat was utilized during heat straightening of the traveler rail 20TR2-013**Description of Non-Conformance:**

# QUALITY ASSURANCE -- NON-CONFORMANCE REPORT

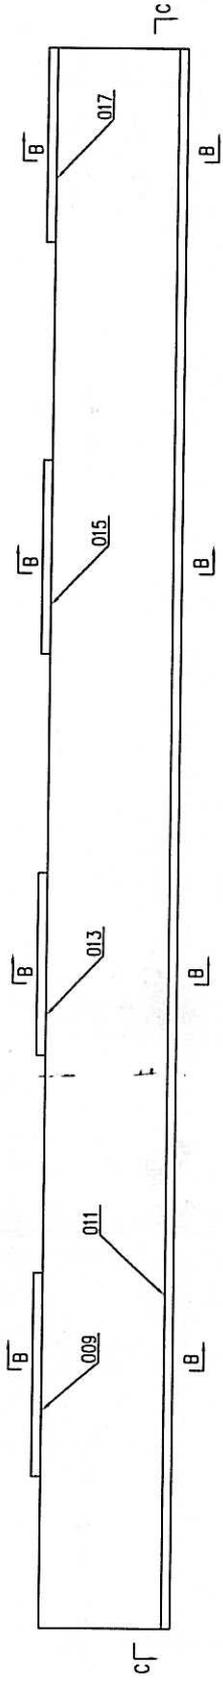
20TR2

-ZPMC personnel performed heat straightening of the traveler rail flange base plate. The material was heated to a bright red condition and the temperature is above 650°C.

-This QA Inspector observed the 760°C Tempilstik was melted when struck against the red base metal.

-Additionally, this QA Inspector observed ZPMC apply a 13 Tons load on the Traveler rail.

Contractor will provide the weld maps revision for the repairs made. Contractor will submit NDT results to prove the welds are acceptable.
