QUALITY ASSURANCE -- NON-CONFORMANCE REPORT

Report No: NCR-000847

NCR #: ZPMC-0809

Reference Description: QA found a missed MT transverse crack after ZPMC had tested and accepted the weld in the Bikepath

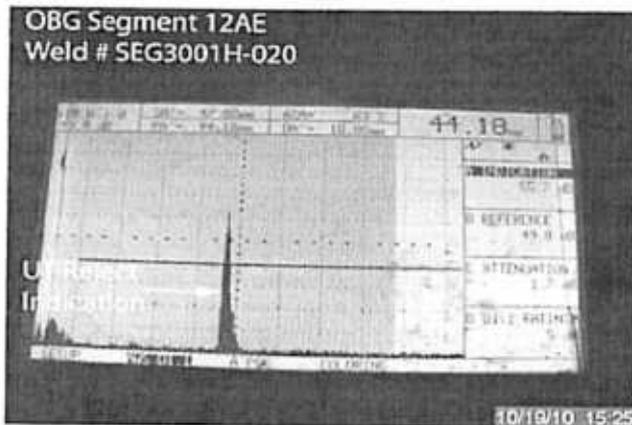
-AWS D1.5-2002, Section 6, Table 6.3; "Specifies a class A indication as having a dBs rating of +8 and lower for weld thicknesses 21mm through 38mm."
