Contract #: 04-0120F4
 Cty: SF/ALA Rte: 80 PM: 13.2/13.9
 File #: 69.25B

QUALITY ASSURANCE -- NON-CONFORMANCE REPORT

Report No: NCR-000861

Reference Description: Lift 5 West Shaft: Missed MT Crack at Skin D and Transverse Plate

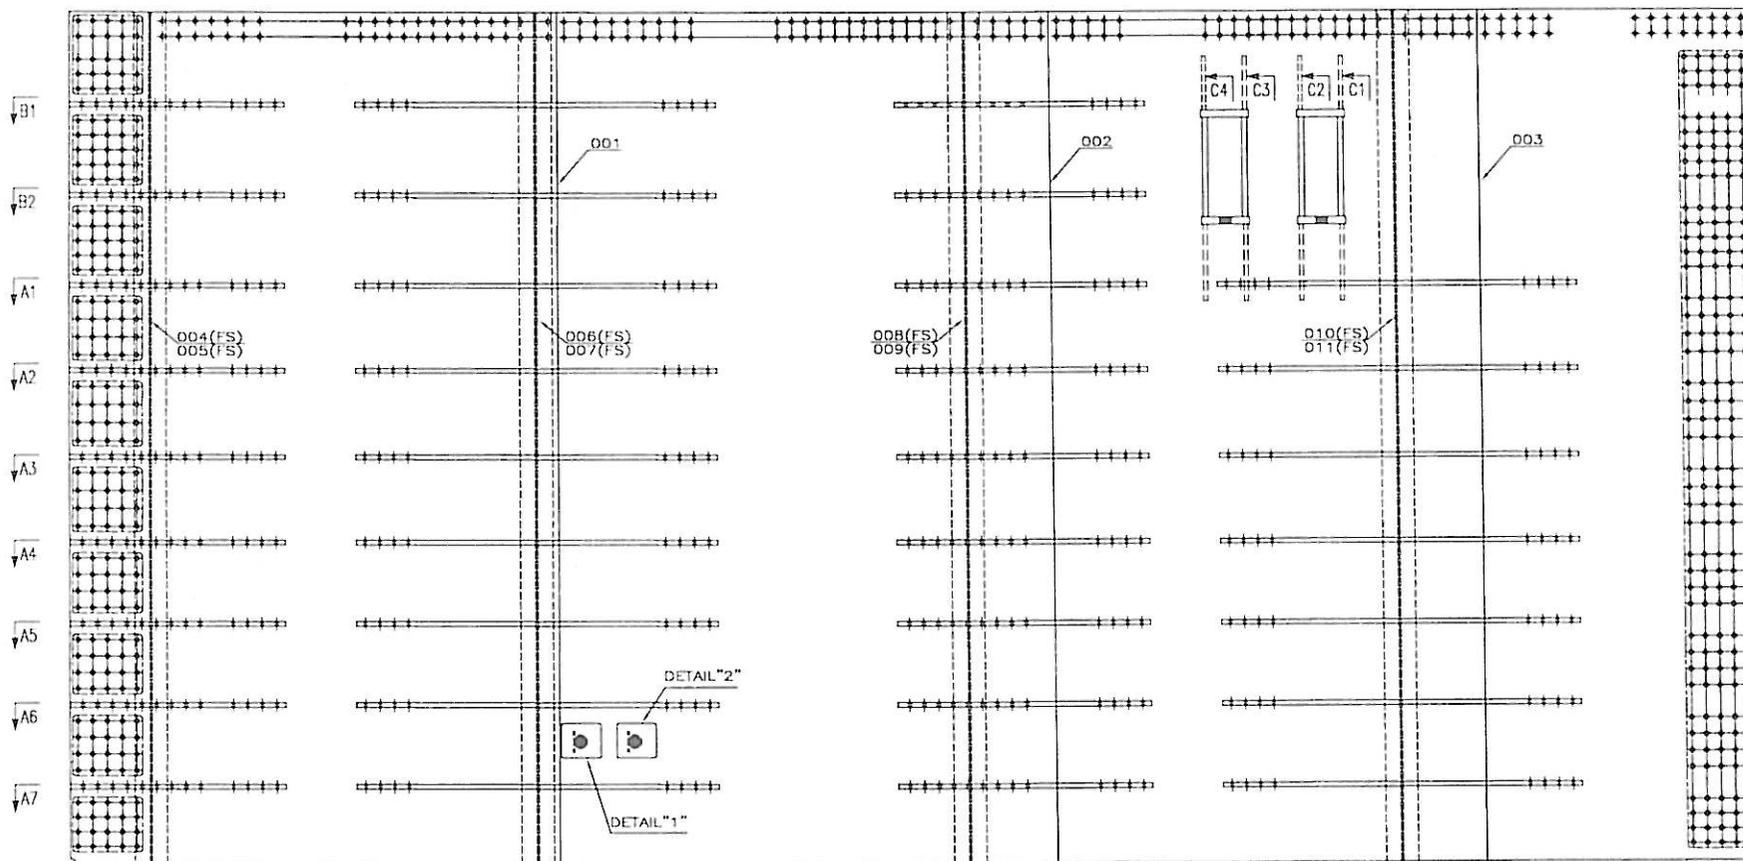
DRAWN: [Signature]
CHECKED: [Signature]
SHOP DRAWING NO: LD3028
PAGINATION: 1/3

Reference Description: QA found UT indications on Segment 13 LD after ZPMC had tested and accepted the welds

LONGITUDINAL DIAPHRAGM SUB-ASSY ~ MARK LD3028A
(TYPE 2) (E3, LOOKING NORTH - DEVELOPED)
