QUALITY ASSURANCE -- NON-CONFORMANCE REPORT

Location: Changxing Island, Shanghai, P.R. China**Report No:** NCR-000866**Prime Contractor:** American Bridge/Fluor Enterprises, a JV**Date:** 17-Oct-2010**Submitting Contractor:** Zhenhua Port Machinery Company, Ltd (ZPMC), Changxing Island**NCR #:** ZPMC-0828**Type of problem:**

Reference Description: QA found a missed UT indication after ZPMC had tested and accepted these weld in Segment 12AE Deck Panel Diaphragm

| Subject: | NCR No. ZPMC-0828 | Document No: | 05.03.06-000823 |

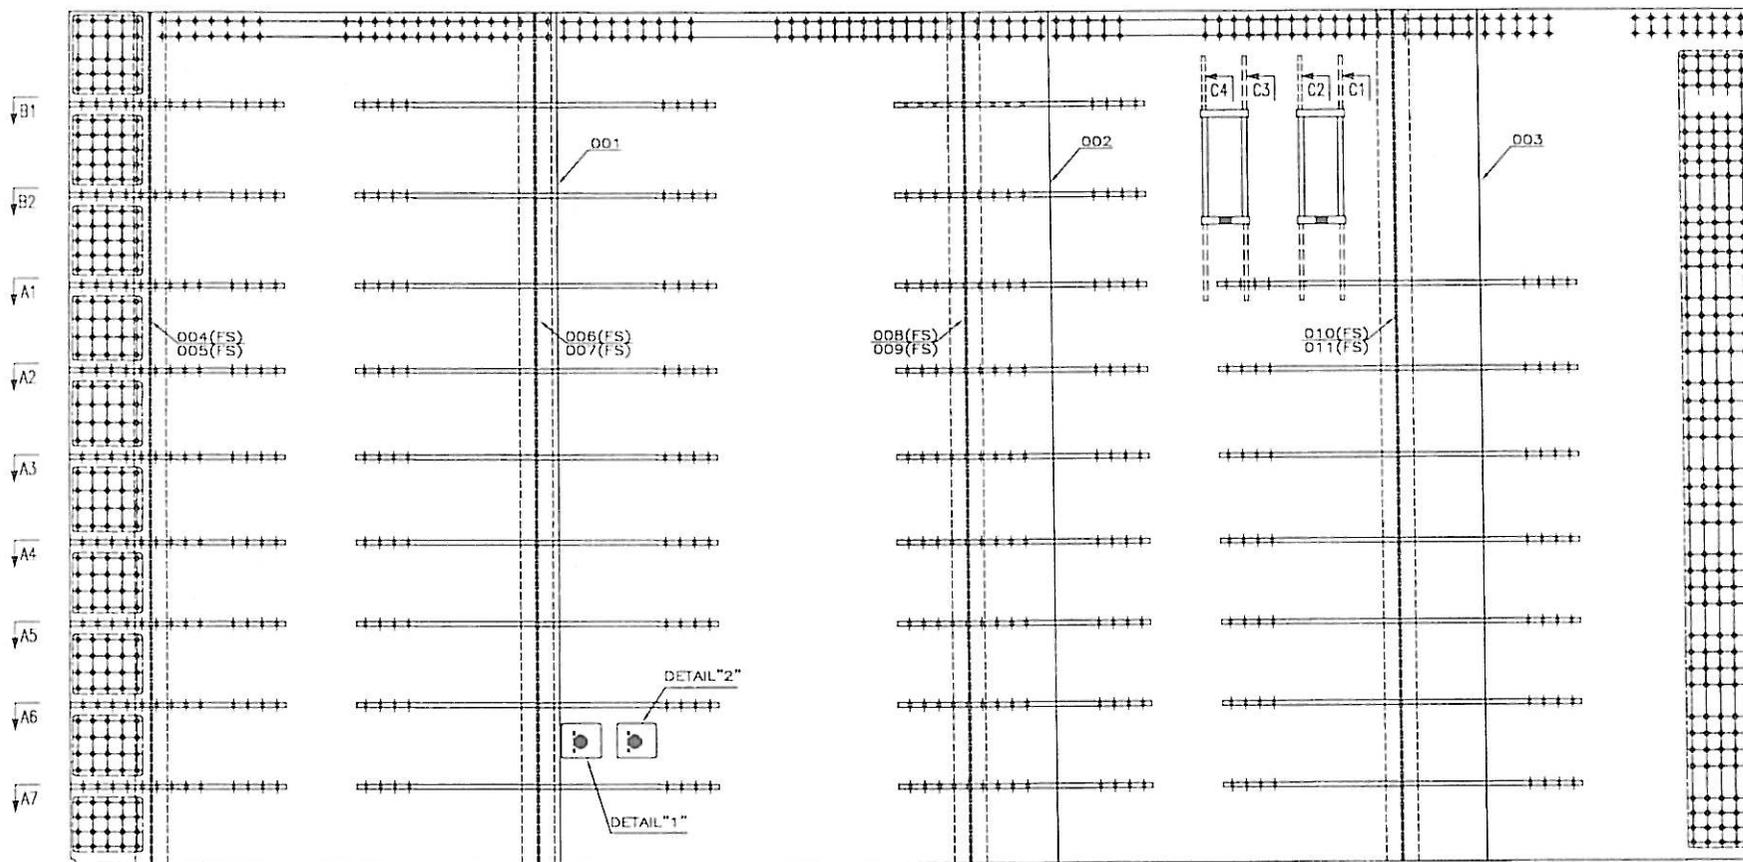
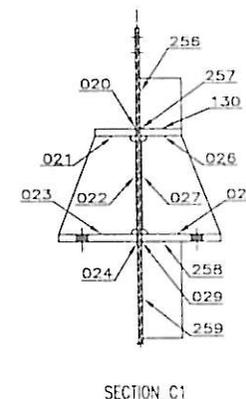
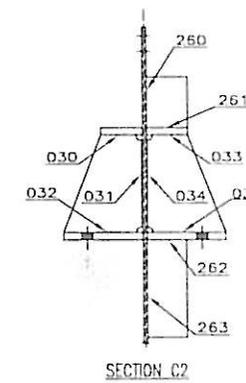
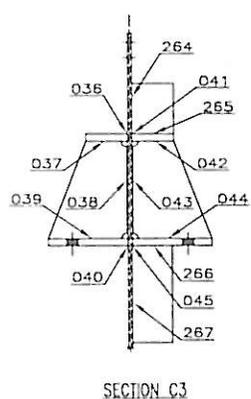
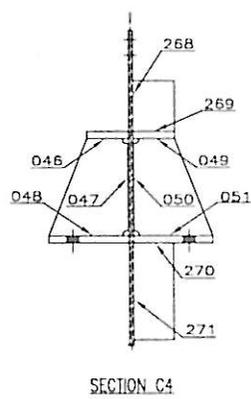
LONGITUDINAL DIAPHRAGM SUB-ASSY ~ MARK LD3028A
(TYPE 2) (E3, LOOKING NORTH - DEVELOPED)

Reference Description: QA found UT indications on Segment 13 LD after ZPMC had tested and accepted the welds
