Contract #: 04-0120F4Cty: SF/ALA Rte: 80 PM: 13.2/13.9File #: 69.25B**QUALITY ASSURANCE -- NON-CONFORMANCE REPORT****Location:** Changxing Island, Shanghai, PRC**Report No:** NCR-000207**Prime Contractor:** American Bridge/Fluor Enterprises, a JV**Date:** 21-Oct-2008**Submitting Contractor:** Zhenhua Port Machinery Company, Ltd (ZPMC), Changxing Island**NCR #:** ZPMC-0184**Type of problem:**

**Job Name:** SAS Superstructure

**Subject:** NCR No. ZPMC-0184

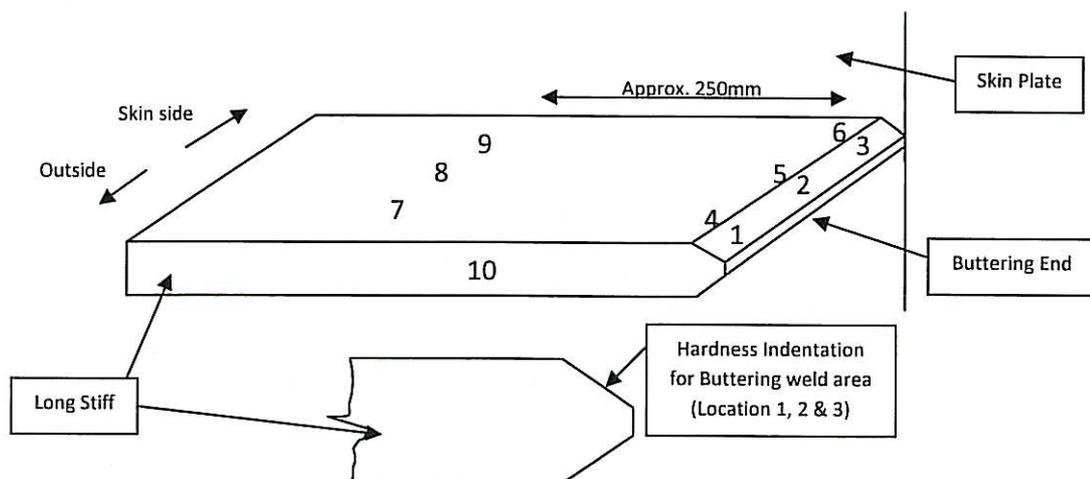
### Location of Hardness Indentation Points

- 5 Readings are taken in each tested point in general, highest and lowest values are deleted and not used.
