Contract #: 04-0120F4Cty: SF/ALA Rte: 80 PM: 13.2/13.9File #: 69.25B**QUALITY ASSURANCE -- NON-CONFORMANCE REPORT****Location:** Changxing Island, Shanghai, P.R. China**Report No:** NCR-000672**Prime Contractor:** American Bridge/Fluor Enterprises, a JV**Date:** 03-Feb-2010**Submitting Contractor:** Zhenhua Port Machinery Company, Ltd (ZPMC), Changxing Island**NCR #:** ZPMC-0640**Type of problem:**

Reference Description: Missed MT and UT indications by QC on welded members in Segment 9AE**Description of Non-Conformance:**

Dear: Mr. Charles Kanapicki
Attention: Mr. Thomas Nilsson Project/Fabrication Manager
Subject: NCR No. ZPMC-0640

Job Name: SAS Superstructure
Document No: 05.03.06-000631

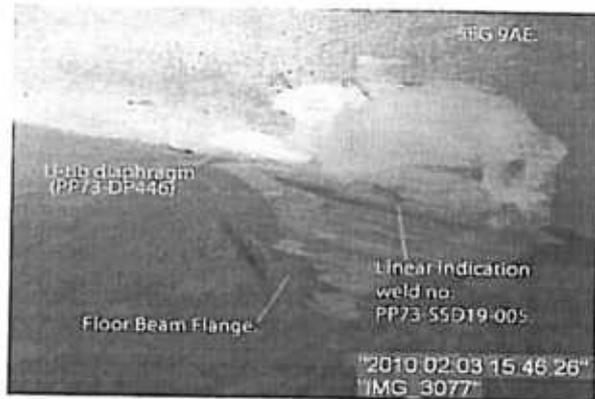
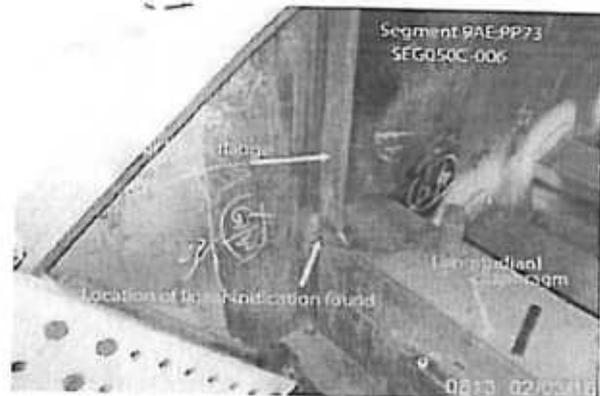
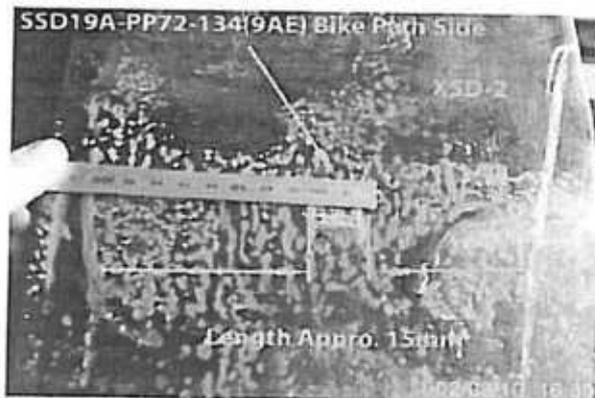
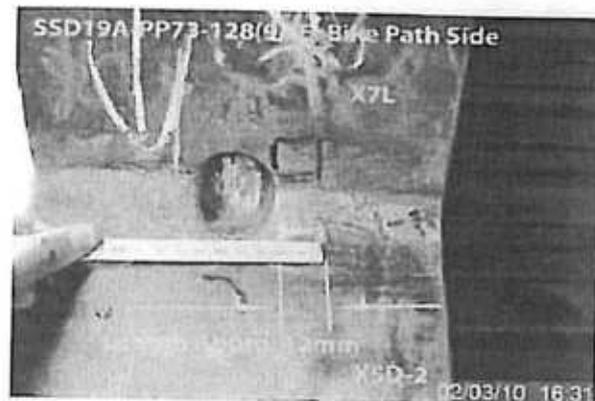
- One (1) longitudinal linear crack that measured approximately 10mm in length.
 - The weld is identified as SEG050C-006 at panel point (PP) 73.
 - This weld is a partial joint penetration (PJP) weld joining the Floor Beam (FB10A) to the vertical Flange (X7J) that attaches to the Longitudinal Diaphragm (LD2A).

- These indications are located within the area that has been previously tested and accepted by ZPMC Quality Control (QC) personnel. ZPMC's QC personnel are required to perform 100% MT inspection of this weld.
