QUALITY ASSURANCE -- NON-CONFORMANCE REPORT

Location: Changxing Island, Shanghai, China**Report No:** NCR-000868**Prime Contractor:** American Bridge/Fluor Enterprises, a JV**Date:** 18-Oct-2010**Submitting Contractor:** Zhenhua Port Machinery Company, Ltd (ZPMC), Changxing Island**NCR #:** ZPMC-0830**Type of problem:**

Reference Description: Missed UT Indication Discovered by Quality Assurance**Description of Non-Conformance:**

Subject: NCR No. ZPMC-0830

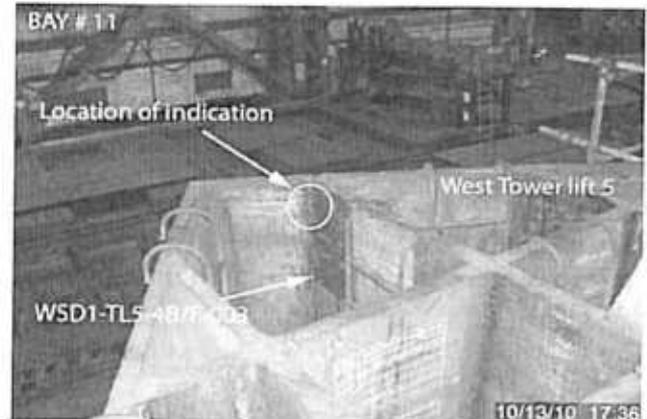
-One longitudinal toe crack measuring approximately 40mm in length.

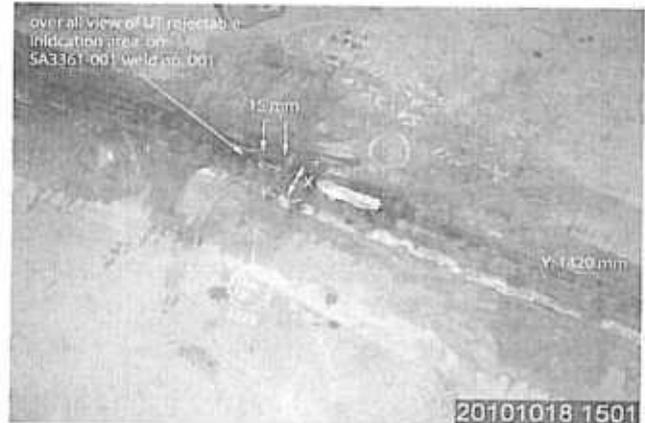
Reference Description: QA found a missed UT indication after ZPMC had tested and accepted these weld in Segment 12AE Deck Panel Diaphragm
