QUALITY ASSURANCE -- NON-CONFORMANCE REPORT

Location: Changxing Island, Shanghai, P.R. China **Report No:** NCR-000889
Prime Contractor: American Bridge/Fluor Enterprises, a JV **Date:** 09-Nov-2010
Submitting Contractor: Zhenhua Port Machinery Company, Ltd (ZPMC), Changxing Island **NCR #:** ZPMC-0851

Reference Description: QA found non-approved drilled holes on the service platform electrical panel support SP6.

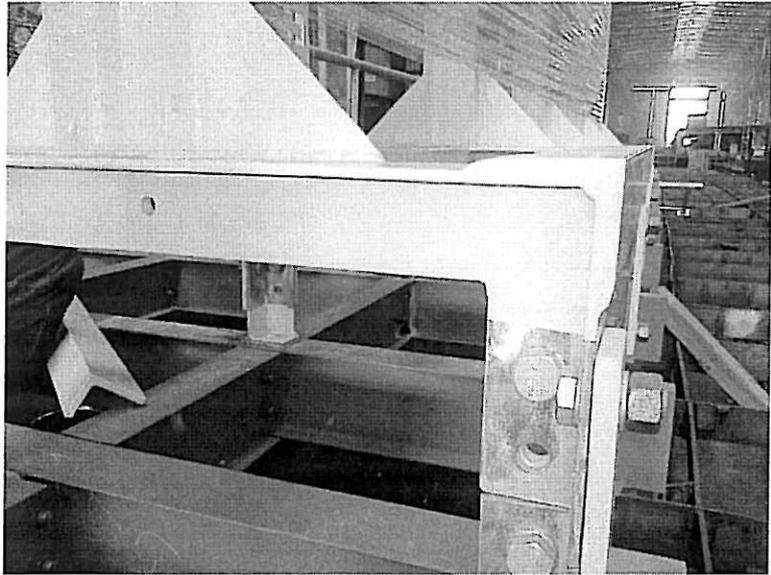
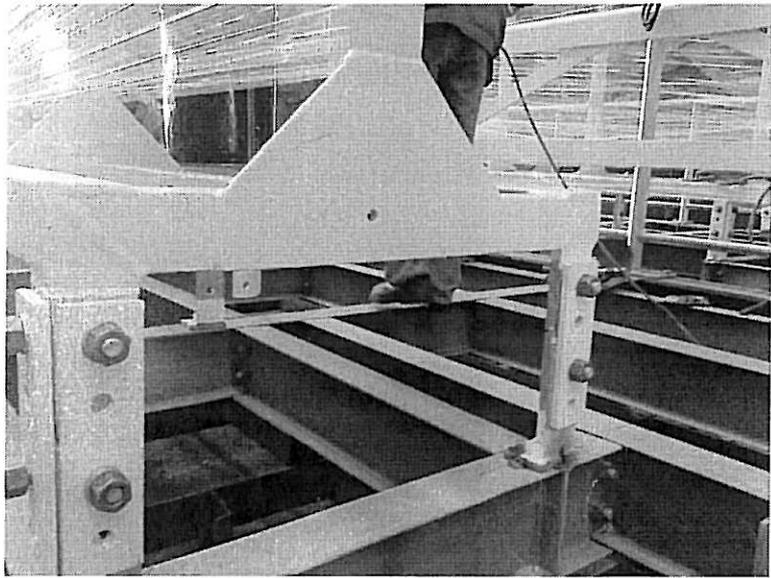
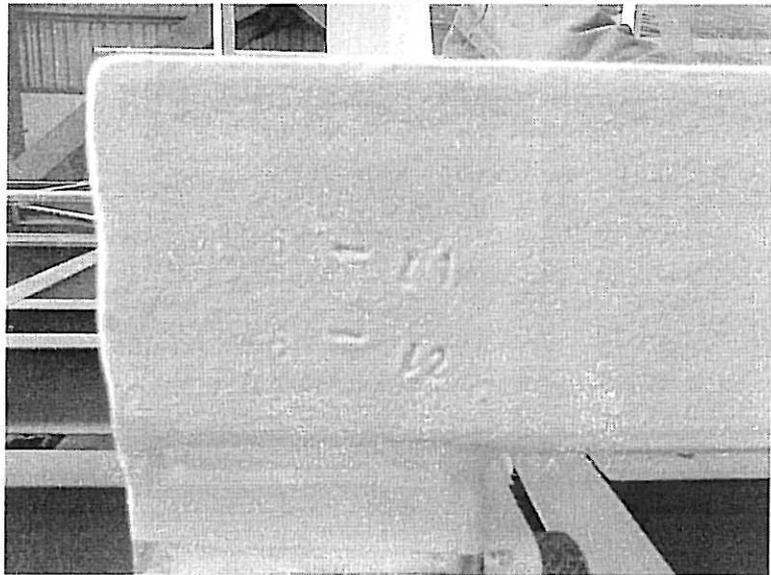
After inspection, we found they have added extra holes to the Service Platform cable supports on the welding area. The total number is 8.

Worker operator error caused base metal gouged.

1. Grind the repair area to a smooth finish according to the approved repair WPS.
2. Prepare the joint according to the approved WPS.
3. Perform 100%MT and 100%VT of the repair area.
4. Remove all defects by grinding to ensure all defects are completely removed if defects still exist, and repeat "step 4" to assure complete removal of all defects if necessary.
5. Clean the repair area of all loose debris including MT powder.
6. Preheat and weld according to the approved WPS.
7. Grind the weld flush after welding.
8. Perform NDT of the repair area.

ZPMC to repair the mis-drilled holes which overlap the existing welds. Perform the NDT to prove the weld is acceptable.

The mis-drilled holes have been repaired. NDT report submitted showed that the repair is acceptable.
