**DEPARTMENT OF TRANSPORTATION**

Contract #: 04-0120F4Cty: SF/ALA Rte: 80 PM: 13.2/13.9File #: 69.28**WELDING INSPECTION REPORT****Resident Engineer:** Pursell, Gary**Address:** 333 Burma Road**City:** Oakland, CA 94607**Report No:** WIR-001627**Date Inspected:** 19-Feb-2008**Project Name:** SAS Superstructure**OSM Arrival Time:** 600**Prime Contractor:** American Bridge/Fluor Enterprises, a JV**OSM Departure Time:** 1530**Contractor:** Zhenhua Port Machinery Company, Ltd (ZPMC), Changxing Island **Location:** Shanghai China**CWI Name:** Zhin Zhong Hai**CWI Present:** Yes No**Inspected CWI report:** Yes No N/A**Rod Oven in Use:** Yes No N/A**Electrode to specification:** Yes No N/A**Weld Procedures Followed:** Yes No N/A**Qualified Welders:** Yes No N/A**Verified Joint Fit-up:** Yes No N/A**Approved Drawings:** Yes No N/A**Approved WPS:** Yes No N/A**Delayed / Cancelled:** Yes No N/A**Bridge No:** 34-0006**Component:** Tower Mock-ups**Summary of Items Observed:****89m Mock up**

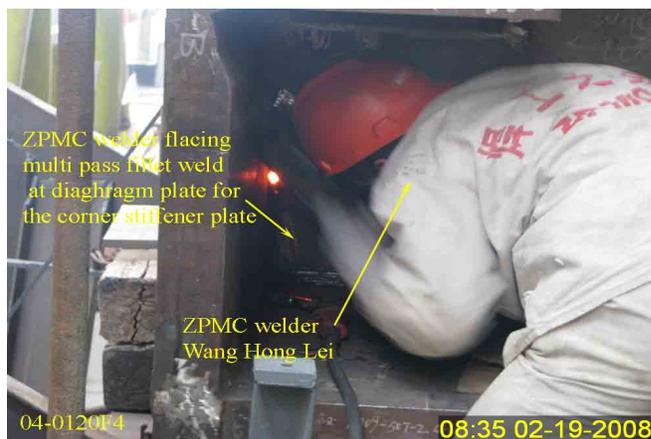
This Quality Assurance (QA) inspector arrived at ZPMC for observation at the tower shop for the 89m mock-up and witnessed ZPMC personnel performing Critical Weld Repairs (CWR) On CWR numbers 44(see photo #3 below) and 45(see digital photo #1 below). The CWR's were for cracks in the welds discovered by grinding after the welds were completed by ZPMC. The weld number for each CWR's are CWR-44; MUSA-SA105A/B-36 and CWR-45; MUSA-SA104A/B-22. This QA Inspector witnessed ZPMC preheat the areas prior to excavation to 65°C

as required by the CWR documentation and then proceeded with the complete removal both depth and length for the repairs with air carbon arc gouging. Once removed ZPMC proceeded to grind the areas smooth and perform a Magnetic particle inspection of the areas to ensure complete removal of the cracks as performed MT technician Zhou Dong Yun and witnessed by this QA inspector. ZPMC QC/CWI Inspector relayed to this QA Inspector that both areas were acceptable and ready for welding. ZPMC then applied preheat with thermal electric couplers to achieve a minimum temperature of 200°c as verified by this QA inspector. ZPMC welding personnel Yang Lei performed the repair welding under WPS numbers; WPS-345-SMAW-2G (2F)-FCM-Repair 5 mm electrode and WPS-345-SMAW-3G (3F)-FCM-Repair 4mm electrode and the parameters were verified by this QA Inspector as follows; 2G position-200amps , 26.7 volts and a travel speed of 121mm/min. the 3G position 187 amps,24.3 volts and a travel speed of 104mm/min. which were within the required tolerances of both WPS's. The welder was observed using the proper interpass cleaning using a wire brush and chipping hammer. ZPMC QC Chen Tan relayed that the final MT inspection would be performed until after ZPMC has completed the final pick-up had been completed on skin C so all locations needing MT would be performed together. The above work appeared to be within the general requirements of the contract documents.
