DEPARTMENT OF TRANSPORTATION

Contract #: 04-0120F4Cty: SF/ALA Rte: 80 PM: 13.2/13.9File #: 69.28**WELDING INSPECTION REPORT****Resident Engineer:** Pursell, Gary**Address:** 333 Burma Road**City:** Oakland, CA 94607**Report No:** WIR-004170**Date Inspected:** 13-Sep-2008**Project Name:** SAS Superstructure**OSM Arrival Time:** 700**Prime Contractor:** American Bridge/Fluor Enterprises, a JV**OSM Departure Time:** 1700**Contractor:** Zhenhua Port Machinery Company, Ltd (ZPMC), Changxing Island **Location:** Shanghai, China**CWI Name:** Sun Wei**CWI Present:** Yes No**Inspected CWI report:** Yes No N/A**Rod Oven in Use:** Yes No N/A**Electrode to specification:** Yes No N/A**Weld Procedures Followed:** Yes No N/A**Qualified Welders:** Yes No N/A**Verified Joint Fit-up:** Yes No N/A**Approved Drawings:** Yes No N/A**Approved WPS:** Yes No N/A**Delayed / Cancelled:** Yes No N/A**Bridge No:** 34-0006**Component:** OBG**Summary of Items Observed:**

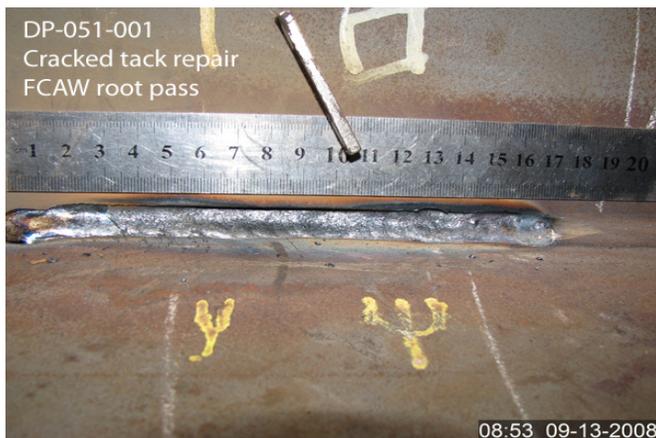
After the first repair flux cored arc welding pass, no crack like indications were observed by ZPMC or the Quality Assurance Inspector. Numerous indications were located by ZPMC and the Quality Assurance Inspector after the initial excavation as illustrated in the digital photograph below. The "Y" axis locations were recorded in an onsite

ZPMC started repairing the cracked tack welds on deck panels DP-051-001 and DP-050-001 today. The procedure is as follows.

1. Excavate the crack using 100 and or 75 millimeter grinders.
2. Assure 80 percent depth of excavation was achieved by measuring with a sheet metal template. Below is a digital photograph illustrating the template.
3. Perform magnetic particle testing to the excavation. Numerous indications were present at this point.
4. Preheat to a minimum of 110 degrees Celsius.
5. Weld the root pass utilizing the flux cored arc welding process.
6. Grind the root pass and blend with adjacent welds.
7. Perform magnetic particle testing again.
8. Weld the rest of the excavation utilizing the flux cored arc welding process. It was observed this typically takes three to four weld passes.
