**DEPARTMENT OF TRANSPORTATION**

Contract #: 04-0120F4Cty: SF/ALA Rte: 80 PM: 13.2/13.9File #: 1.28**WELDING INSPECTION REPORT****Resident Engineer:** Pursell, Gary**Address:** 333 Burma Road**City:** Oakland, CA 94607**Report No:** WIR-012375**Date Inspected:** 03-Mar-2010**Project Name:** SAS Superstructure**OSM Arrival Time:** 700**Prime Contractor:** American Bridge/Fluor Enterprises, a JV**OSM Departure Time:** 1500**Contractor:** American Bridge/Fluor Enterprises, a JV**Location:** Job Site**CWI Name:** Bill Norris/Steve McConnell**CWI Present:** Yes No**Inspected CWI report:** Yes No N/A**Rod Oven in Use:** Yes No N/A**Electrode to specification:** Yes No N/A**Weld Procedures Followed:** Yes No N/A**Qualified Welders:** Yes No N/A**Verified Joint Fit-up:** Yes No N/A**Approved Drawings:** Yes No N/A**Approved WPS:** Yes No N/A**Delayed / Cancelled:** Yes No N/A**Bridge No:** 34-0006**Component:** Orthotropic Box Girders (OBG)**Summary of Items Observed:**

# WELDING INSPECTION REPORT

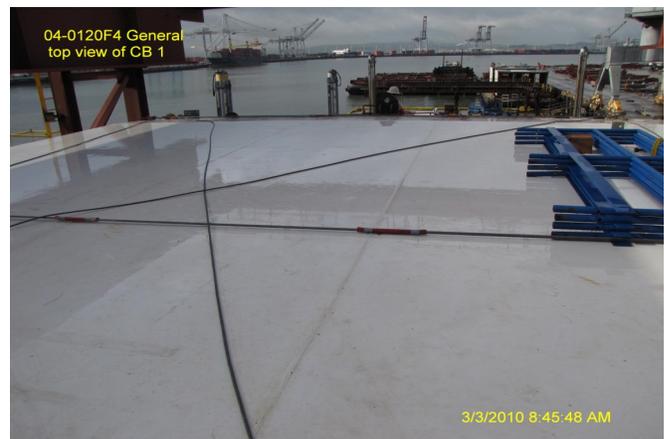
The QA inspector periodically observed a crew of ABF personnel performing grinding/cleaning/buffing the coating from the bevel edges and hold back areas for the transverse weld splice at approximately PP13. In addition to this a crew of personnel are in the process of placing the components for scaffolding, welding, lighting, walkways, temporary bolts and other miscellaneous items in preparation of mobilizing lift 2 West to the erection site. This work continued throughout the balance of the shift, was not completed and appeared to be progressing in general conformance with the contract documents.
