DEPARTMENT OF TRANSPORTATION

Contract #: 04-0120F4Cty: SF/ALA Rte: 80 PM: 13.2/13.9File #: 69.28**WELDING INSPECTION REPORT****Resident Engineer:** Pursell, Gary**Address:** 333 Burma Road**City:** Oakland, CA 94607**Report No:** WIR-013658**Date Inspected:** 07-Feb-2010**Project Name:** SAS Superstructure**OSM Arrival Time:** 700**Prime Contractor:** American Bridge/Fluor Enterprises, a JV**OSM Departure Time:** 1900**Contractor:** Zhenhua Port Machinery Company, Ltd (ZPMC), Changxing Island **Location:** Shanghai, China**CWI Name:** ZPMC and ABF**CWI Present:** Yes No**Inspected CWI report:** Yes No N/A**Rod Oven in Use:** Yes No N/A**Electrode to specification:** Yes No N/A**Weld Procedures Followed:** Yes No N/A**Qualified Welders:** Yes No N/A**Verified Joint Fit-up:** Yes No N/A**Approved Drawings:** Yes No N/A**Approved WPS:** Yes No N/A**Delayed / Cancelled:** Yes No N/A**Bridge No:** 34-0006**Component:** Tower**Summary of Items Observed:**

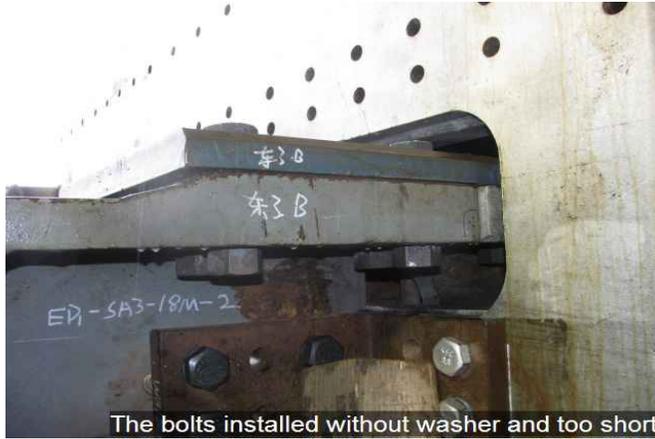
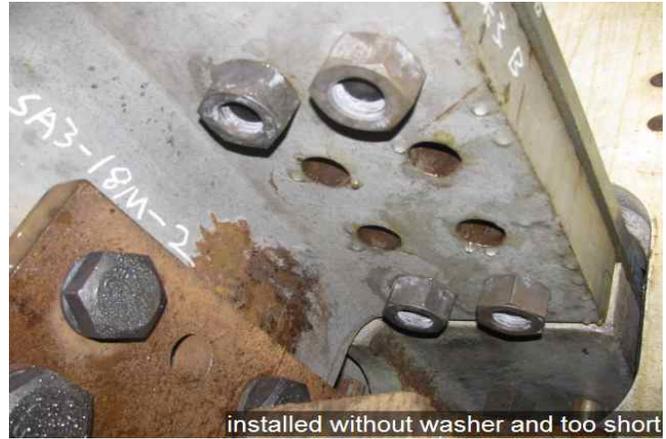
The following is the bolts issues:

1. ZPMC installed only 50% bolts instead of 100% bolts on each strut which connected at elevation 47.6m and 18m.
2. A lot of short bolts have been installed into struts; some of bolt appeared not long enough drove all the way into the nut end.
3. Some of bolt appeared one rotates thread is over the nut end after drove through the nut.
4. Some of bolt has over size length.
5. Some of bolts installed without washer.
6. A lot of strut secured by various type bolts on one area, the ID such as SFC88, NL109, and S601 etc.
7. Some of high strength bolts is used bolts.
8. Some of high strength bolt visually can't be identifying.
