DEPARTMENT OF TRANSPORTATION

Quality Assurance and Source Inspection

Contract #: 04-0120F4Cty: SF/ALA Rte: 80 PM: 13.2/13.9File #: 69.28**WELDING INSPECTION REPORT****Resident Engineer:** Siegenthaler, Peter**Address:** 333 Burma Road**City:** Oakland, CA 94607**Report No:** WIR-016937**Date Inspected:** 14-Sep-2010**Project Name:** SAS Superstructure**OSM Arrival Time:** 700**Prime Contractor:** American Bridge/Fluor Enterprises, a JV**OSM Departure Time:** 1900**Contractor:** Zhenhua Port Machinery Company, Ltd (ZPMC), Changxing Island **Location:** Shanghai, China**CWI Name:** Mr. Zhao Chen Sun**CWI Present:** Yes No**Inspected CWI report:** Yes No N/A**Rod Oven in Use:** Yes No N/A**Electrode to specification:** Yes No N/A**Weld Procedures Followed:** Yes No N/A**Qualified Welders:** Yes No N/A**Verified Joint Fit-up:** Yes No N/A**Approved Drawings:** Yes No N/A**Approved WPS:** Yes No N/A**Delayed / Cancelled:** Yes No N/A**Bridge No:** 34-0006**Component:** Tower**Summary of Items Observed:**

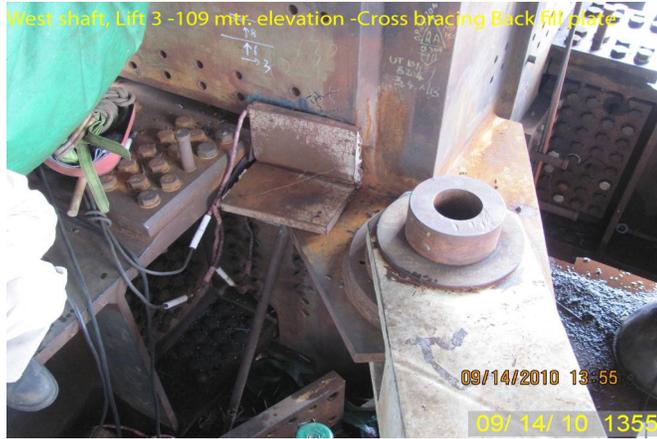
2. This QA inspector, Baskar Govindarajan, observed, ZPMC qualified welding personnel identified as 040614 perform SMAW welding in; Cross Bracing Gusset and Back fill plate on Skin A of West shaft, Lift 3, in 109 mtr. elevation and the weld joint is identified as WSD1-FASA3-2 B/E-21, 28. ZPMC CWI Identified as Mr. Zhao Chen Sun. The welding parameters as measured using QC's calibrated instruments appeared to be in general compliance with WPS-B-T-3212-B-U2a-2. (Photo of Preheating is attached)
