DEPARTMENT OF TRANSPORTATION

Contract #: 04-0120F4Cty: SF/ALA Rte: 80 PM: 13.2/13.9File #: 1.28**WELDING INSPECTION REPORT****Resident Engineer:** Siegenthaler, Peter**Address:** 333 Burma Road**City:** Oakland, CA 94607**Report No:** WIR-017362**Date Inspected:** 07-Oct-2010**Project Name:** SAS Superstructure**OSM Arrival Time:** 1000**Prime Contractor:** American Bridge/Fluor Enterprises, a JV**OSM Departure Time:** 1830**Contractor:** American Bridge/Fluor Enterprises, a JV**Location:** Job Site

CWI Name:	Bonifacio Daquinag and Jesse Cayabyab			CWI Present:	Yes	No	
Inspected CWI report:	Yes	No	N/A	Rod Oven in Use:	Yes	No	N/A
Electrode to specification:	Yes	No	N/A	Weld Procedures Followed:	Yes	No	N/A
Qualified Welders:	Yes	No	N/A	Verified Joint Fit-up:	Yes	No	N/A
Approved Drawings:	Yes	No	N/A	Approved WPS:	Yes	No	N/A
				Delayed / Cancelled:	Yes	No	N/A
Bridge No:	34-0006			Component:	Orthotropic Box Girder

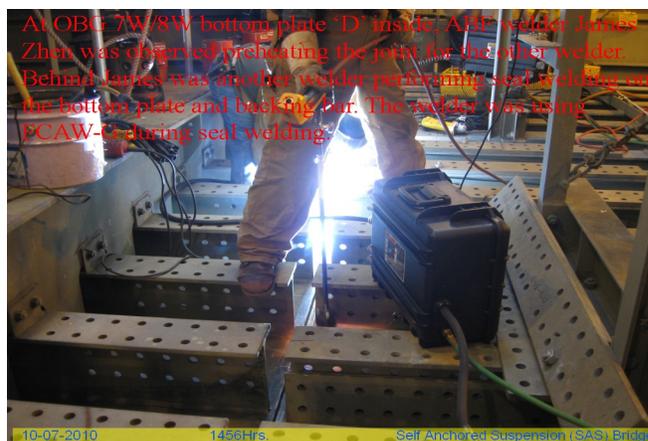
At OBG 7W/8W bottom plate 'D' inside, ABF QC William Sherwood was observed measuring the fit up alignment of the splice butt joint after installing the backing bar from the outside.
