DEPARTMENT OF TRANSPORTATION

Contract #: 04-0120F4Cty: SF/ALA Rte: 80 PM: 13.2/13.9File #: 99.28**WELDING INSPECTION REPORT****Resident Engineer:** Siegenthaler, Peter**Address:** 333 Burma Road**City:** Oakland, CA 94607**Report No:** WIR-018580**Date Inspected:** 14-Dec-2010**Project Name:** SAS Superstructure**OSM Arrival Time:** 700**Prime Contractor:** American Bridge/Fluor Enterprises, a JV**OSM Departure Time:** 1900**Contractor:** Zhenhua Port Machinery Company, Ltd (ZPMC)**Location:** Shanghai, China**CWI Name:** Li Yang and Zhu Zhong Hai**CWI Present:** Yes No**Inspected CWI report:** Yes No N/A**Rod Oven in Use:** Yes No N/A**Electrode to specification:** Yes No N/A**Weld Procedures Followed:** Yes No N/A**Qualified Welders:** Yes No N/A**Verified Joint Fit-up:** Yes No N/A**Approved Drawings:** Yes No N/A**Approved WPS:** Yes No N/A**Delayed / Cancelled:** Yes No N/A**Bridge No:** 34-0006**Component:** OBG Trial Assembly**Summary of Items Observed:**

WELDING INSPECTION REPORT

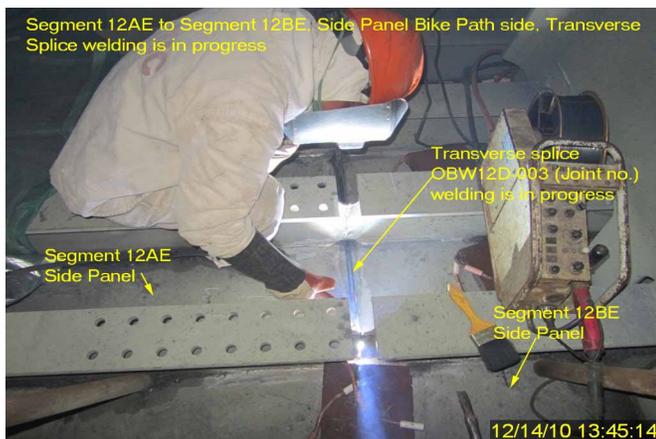
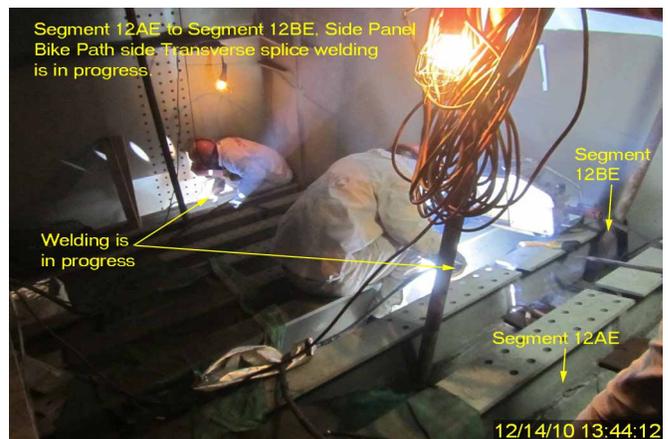
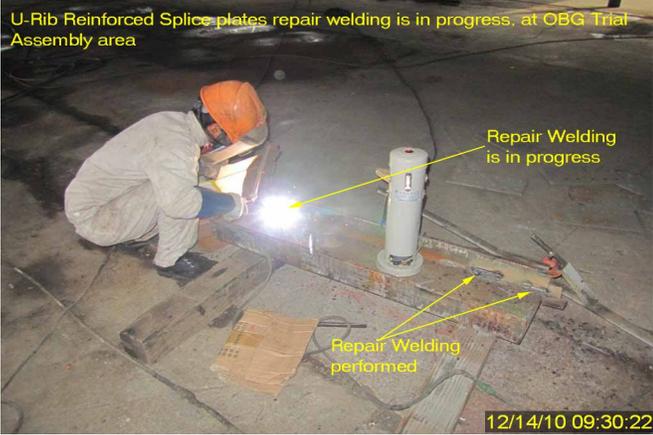
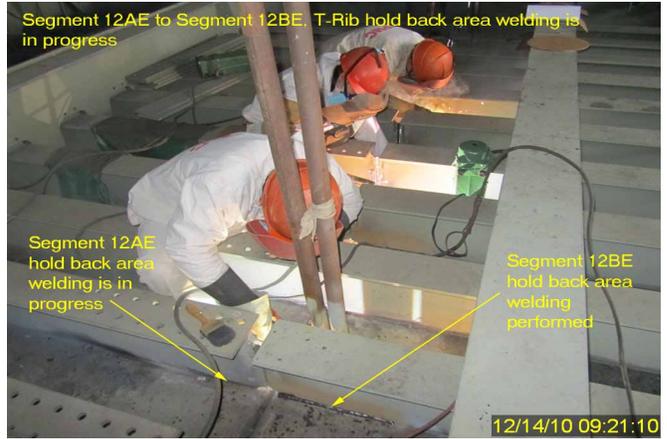
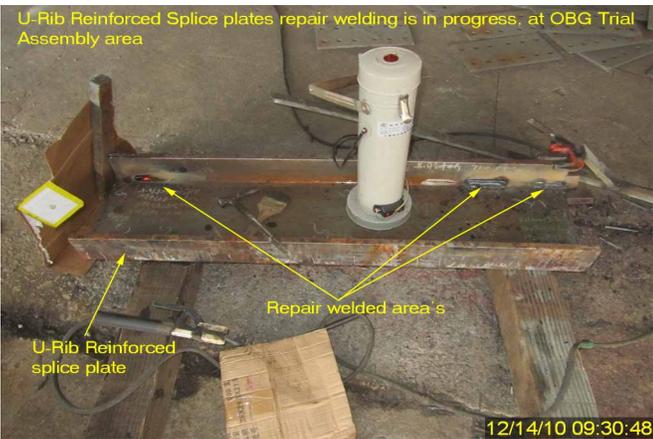
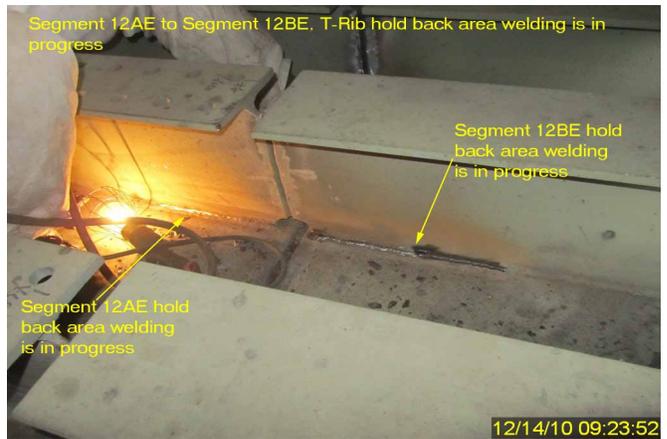
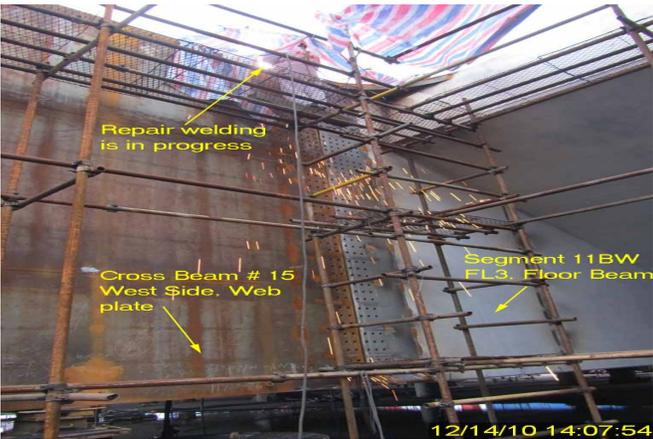
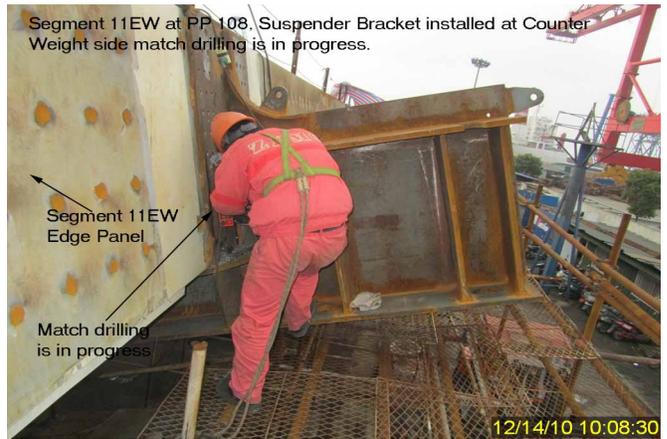
This QA Inspector observed the in-process welding by Flux Cored Arc Welding (FCAW) process on a Complete Joint Penetration (CJP) groove weld. The Weld joint was designated as OBW12D-001. The welder identification was 040458 and observed welding in the 3G (Vertical) position using approved Welding Procedure Specification WPS-B-T-2233T-ESAB. The piece mark was identified as the Side Panel Corner Assembly, transverse splice Cross Beam side.

This QA Inspector observed the in-process welding by Flux Cored Arc Welding (FCAW) process on a Complete Joint Penetration (CJP) groove weld. The Weld joint was designated as OBW12D-003. The welder identification was 052763, 040367 and 047353 and observed welding in the 3G (Vertical) position using approved Welding Procedure Specification WPS-B-T-2233T-ESAB. The piece mark was identified as the Side Panel, transverse splice Bike Path side.

This QA Inspector observed the in-process welding by Flux Cored Arc Welding (FCAW) process on a Complete Joint Penetration (CJP) groove weld. The Weld joint was designated as OBW12D-008. The welder identification was 040458 and observed welding in the 3G (Vertical) position using approved Welding Procedure Specification WPS-B-T-2233T-ESAB. The piece mark was identified as the Side Panel Corner Assembly, transverse splice Bike Path side.

This QA Inspector observed the in process fillet welding operation by the Shielded Metal Arc Welding (SMAW) process. The Weld joint was designated as BP3001-001-055/056. The welder identification was 044515 and was observed welding in the 2F (Horizontal) position using approved Welding Procedure Specification WPS-B-P-2112-FCM-1. The piece mark was identified as the Bottom Panel, T-Ribs hold back weld.

This QA Inspector observed the in process fillet welding operation by the Shielded Metal Arc Welding (SMAW) process. The Weld joint was designated as BP3005-001-013/014. The welder identification was 040320 and was observed welding in the 2F (Horizontal) position using approved Welding Procedure Specification WPS-B-P-2112-FCM-1. The piece mark was identified as the Bottom Panel, T-Ribs hold back weld.

This QA Inspector observed the repair welding by Shielded Metal Arc Welding (SMAW) process on a Complete Joint Penetration (CJP) groove weld. The Weld joint was designated as CB202A-015-001. The welder identification was 050289 and was observed welding in the 2G (Horizontal) position using approved Welding Procedure Specification WPS-345-SMAW-2G(2F)-FCM-Repair-1. The piece mark was identified as the Cross Beam #15, East side Web plate to Deck Plate at PP 100. ZPMC personnel performing repair welding in accordance with Welding Repair Report B-WR18800.

This QA Inspector observed match drilling is in progress for the Suspender Bracket plate to the Edge panel installed at PP 108, Counter Weight side for Segment 11EE.

Cross Beam # 15. West side plate to Deck Plate connecting weld Repair welding is in progress at PP 100
