**DEPARTMENT OF TRANSPORTATION**

Contract #: 04-0120F4Cty: SF/ALA Rte: 80 PM: 13.2/13.9File #: 1.28**WELDING INSPECTION REPORT****Resident Engineer:** Siegenthaler, Peter**Address:** 333 Burma Road**City:** Oakland, CA 94607**Report No:** WIR-019343**Date Inspected:** 14-Jan-2011**Project Name:** SAS Superstructure**OSM Arrival Time:** 900**Prime Contractor:** American Bridge/Fluor Enterprises, a JV**OSM Departure Time:** 1730**Contractor:** American Bridge/Fluor Enterprises, a JV**Location:** Job Site**CWI Name:** Gary Ershan and Pat Swain**CWI Present:** Yes No**Inspected CWI report:** Yes No N/A**Rod Oven in Use:** Yes No N/A**Electrode to specification:** Yes No N/A**Weld Procedures Followed:** Yes No N/A**Qualified Welders:** Yes No N/A**Verified Joint Fit-up:** Yes No N/A**Approved Drawings:** Yes No N/A**Approved WPS:** Yes No N/A**Delayed / Cancelled:** Yes No N/A**Bridge No:** 34-0006**Component:** Orthotropic Box Girder**Summary of Items Observed:**

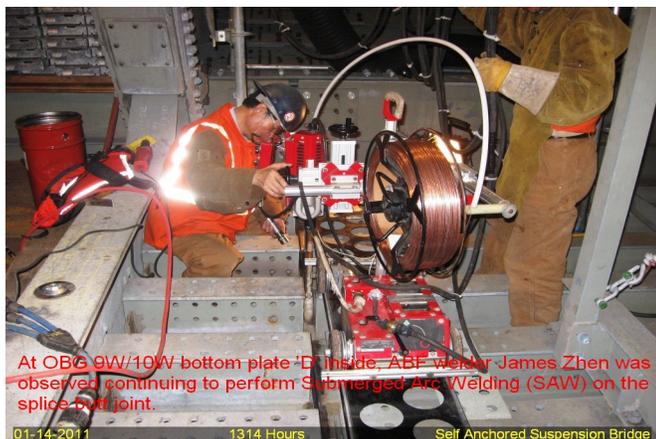
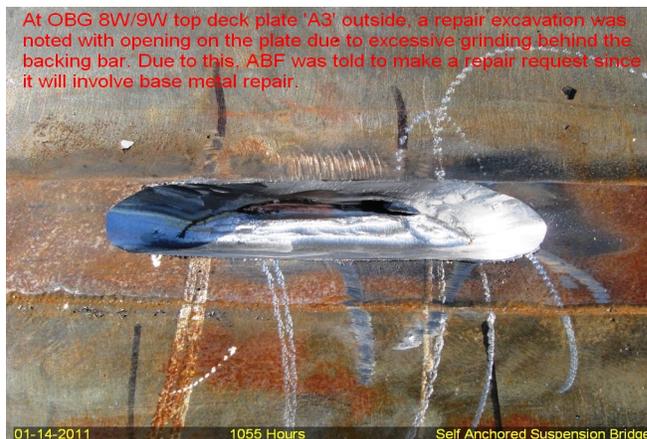
At OBG 8W/9W top deck plate 'A3' outside, ABF welder Wai Kitlai still welded the repair excavation that has the hole/opening on the plate without ABF obtaining repair request.

Prior to the repair welding at this location 8W/9W top deck plate 'A3', QA consulted with Lead QA Rick Bettencourt about the procedure for welding repair with burn through or excessive grinding since this particular weld repair has a hole due to excessive grinding behind the backing bar. ABF needs to make a repair request with Engineer's approval since this repair does not only involve the weld defect but also includes a base metal repair. QC Inspector Pat Swain informed QA this has happened before on similar joints which the Engineer had approved. Per Pat Swain, he will not stop the welder to perform the repair and the repair request will be followed at a later time. The welder performed the repair and was completed. QA issued an incident report for the repair being made without engineer approval.
