Contract #: 04-0120F4Cty: SF/ALA Rte: 80 PM: 13.2/13.9File #: 1.28**WELDING INSPECTION REPORT**

Report No: WIR-027350
Date Inspected: 23-Mar-2012

Project Name: SAS Superstructure
Prime Contractor: American Bridge/Fluor Enterprises, a JV
Contractor: American Bridge/Fluor Enterprises, a JV

CWI Name:	As noted below	CWI Present:	Yes	No	
Inspected CWI report:	Yes No N/A	Rod Oven in Use:	Yes	No	N/A
Electrode to specification:	Yes No N/A	Weld Procedures Followed:	Yes	No	N/A
Qualified Welders:	Yes No N/A	Verified Joint Fit-up:	Yes	No	N/A
Approved Drawings:	Yes No N/A	Approved WPS:	Yes	No	N/A
		Delayed / Cancelled:	Yes	No	N/A
Bridge No:	34-0006	Component:	SAS OBG

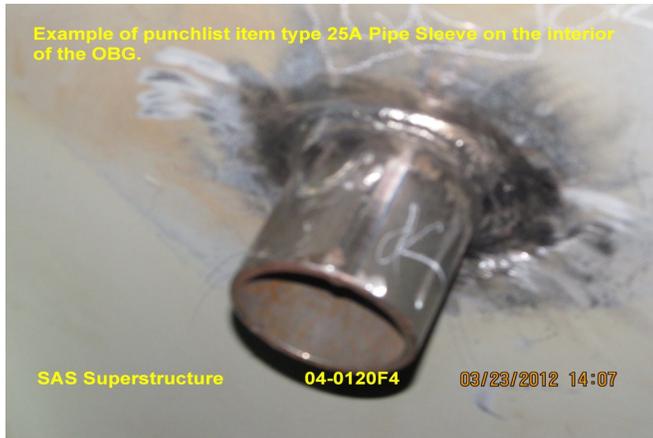
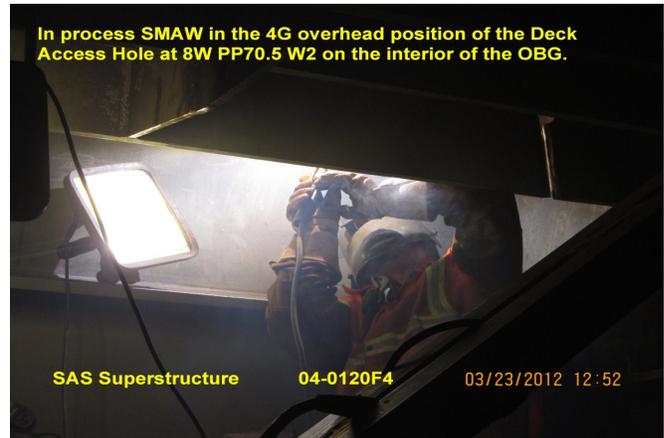
This QA Inspector at random intervals, observed ABF welder Salvador Sandoval (ID 2202) perform the Shielded Metal Arc Welding (SMAW) process in the 4G overhead position on face "B" of the Deck Access Hole (DAH) located at 9E PP84.5 E5 on the interior of the OBG. The welder was observed utilizing 3.2mm E7018-H4R electrodes obtained from a baking oven and drawing amperage of 123. QC Inspector Steve McConnell was on hand to monitor the welding, parameters and measure the inter-pass temperatures as they apply to ABF-WPS-D1. 5-1010-1. On subsequent observations the welder was observed cleaning the work between passes by employing a small disc grinder, brushes and compressed air. This QA Inspector noted that Mr. Sandoval completed the welding on the interior side of the DAH and was relocated to the DAH located at 12E PP109.5 E5. ABF welder Todd Jackson (ID 4639) was tasked to continue the work on the Longitudinal Stiffeners at this location and on subsequent observations by this QA Inspector it was noted that no welding had commenced by the end of the shift.

This QA Inspector made random observations of SMAW on the DAH located at 8W PP70.5 W2 on the interior of the OBG. ABF welder Eric Sparks (ID 3040) was observed welding in the 4G overhead position

utilizing 3.2mm E7018-H4R electrodes that were obtained from a remote baking oven verified by this QA Inspector. QC Inspector Steve Jensen was present to monitor the welding and the parameters to ensure compliance with ABF-WPS-D1.5-1010-Revision 1. The welder was observed cleaning the work between passes and employed a small disc grinder to blend the start/stop edges for a smooth transition, as the QC Inspector measured the inter-pass temperatures. This QA Inspector made subsequent observations throughout the shift to monitor quality and noted that the work at this location is in progress and appeared to be in general conformance with the contract specifications.
