DEPARTMENT OF TRANSPORTATION

Contract #: 04-0120F4Cty: SF/ALA Rte: 80 PM: 13.2/13.9File #: 1.28**WELDING INSPECTION REPORT****Resident Engineer:** Casey, William**Address:** 333 Burma Road**City:** Oakland, CA 94607**Report No:** WIR-028792**Date Inspected:** 28-Nov-2012**Project Name:** SAS Superstructure**OSM Arrival Time:** 700**Prime Contractor:** American Bridge/Fluor Enterprises, a JV**OSM Departure Time:** 1730**Contractor:** American Bridge/Fluor Enterprises, a JV**Location:** Job Site**CWI Name:** See below.**CWI Present:** Yes No**Inspected CWI report:** Yes No N/A**Rod Oven in Use:** Yes No N/A**Electrode to specification:** Yes No N/A**Weld Procedures Followed:** Yes No N/A**Qualified Welders:** Yes No N/A**Verified Joint Fit-up:** Yes No N/A**Approved Drawings:** Yes No N/A**Approved WPS:** Yes No N/A**Delayed / Cancelled:** Yes No N/A**Bridge No:** 34-0006**Component:** OBG**Summary of Items Observed:**

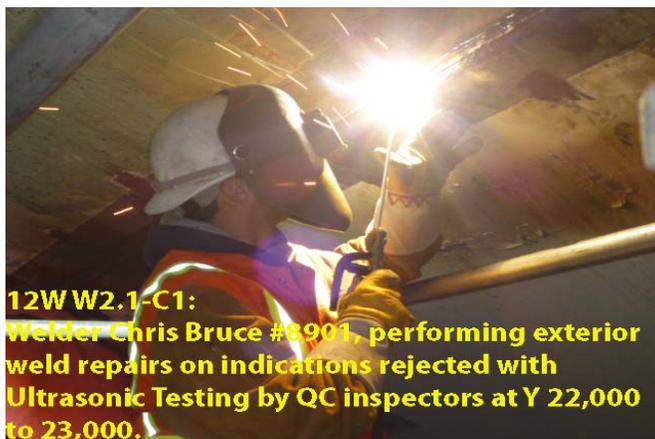
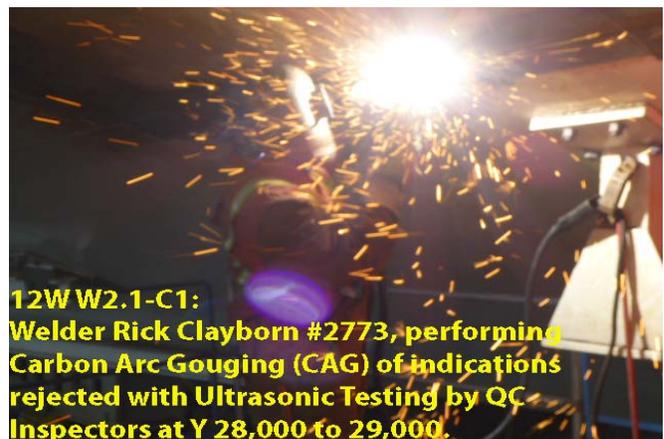
Welder was observed performing R1 exterior weld repairs on weld 12W W2.1-C1 indications rejected with Ultrasonic Testing (UTSW) by QC Inspectors between Y 25,800 and 26,800. Welder was observed utilizing Welding Procedure Specification (WPS) ABF-WPS-D15-1000 Repair for Shielded Metal Arc Welding (SMAW). Welder was observed preheating the weld prior to welding. Welding parameters as verified by QC Inspector William Sherwood appear to be in compliance with the WPS noted above. Weld sections at Y 18,600 to 31,000 is non SPCM, a "Request for Weld Repair" or (RWR) is not required for R1 repairs.

12W W2.1-C1:
Welder Wai Kit Lai #2953, performing weld repairs on indications rejected with Ultrasonic Testing by QC Inspectors at Y 25,800 to 26,800.
