File: 04- SOL-84 PM 12.1
04-0G660
Efis 0400000343
DPGR

Subject: **DISTRICT PRELIMINARY GEOTECHNICAL REPORT FOR MINER SLOUGH BRIDGE**

This memorandum is in response to your request for technical studies developing the EIR/Categorical Exclusion for the Miner Slough Bridge (Br. #23-0035) Replacement Project, State Route (SR) 84, Post Mile (PM) 11.8 - 12.5 (Figure 1). The scope of work is to construct a new bridge with control house, for the draw bridges operation, to be built on the levee, after which the existing bridge will be demolished. It is our conclusion that there are no significant geotechnical conditions and the project can be constructed as proposed. However, there are some significant geologic constraints that may require special considerations, specifically ground shaking.

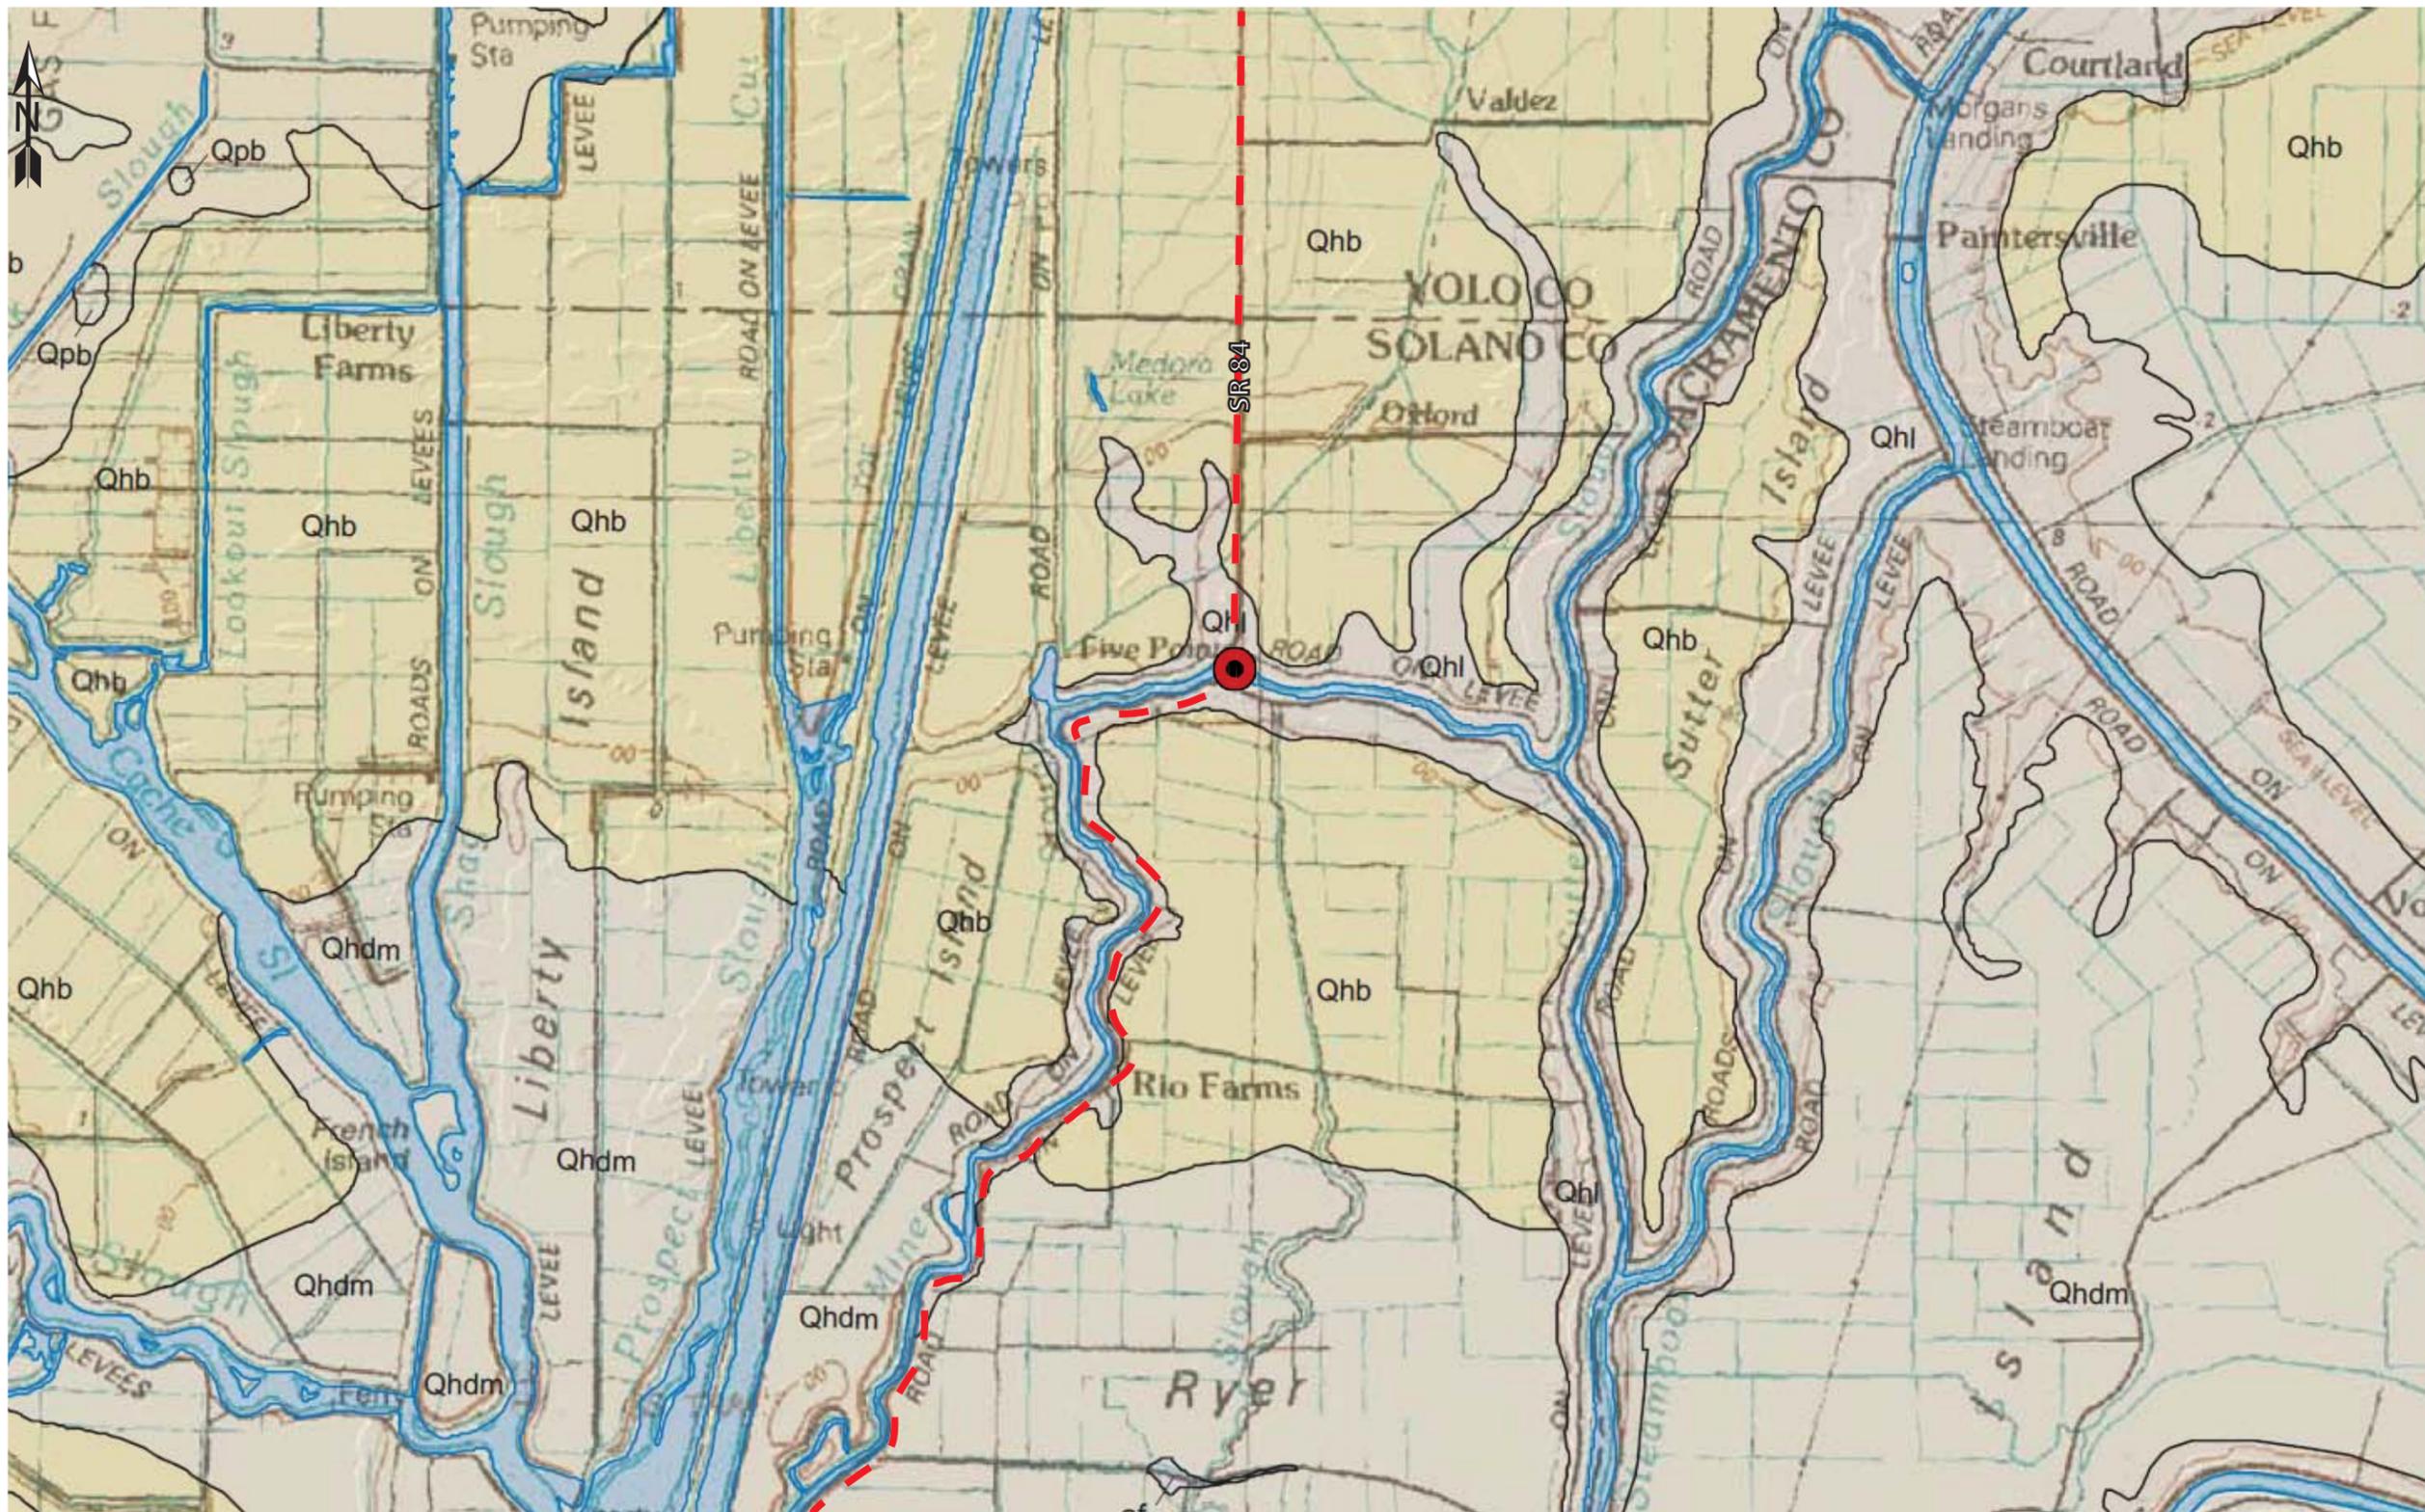
FIGURE 2

Explanation

- Qhl** Holocene fan levee deposits
- Qhdm** Holocene Delta mud
- Qhb** Holocene basin deposits
- Qpb** Latest Pleistocene basin deposits

GEOLOGY	
04-SOL-84	0400000343
PM. 12.1	March 2015

The project site is entirely covered by Holocene alluvial fan levee deposits (see the Geology Map Figure 2).

“The alluvial fan levee deposits are natural levee deposits of alluvial fans and formed by streams that overtop their banks and deposit sediment adjacent to the channel. They contain coarser material than the adjoining interlevee areas, especially adjacent to creek banks where the coarsest material is deposited during floods. Levee deposits are loose, moderately to poorly grained sand, silt and clay.”⁶

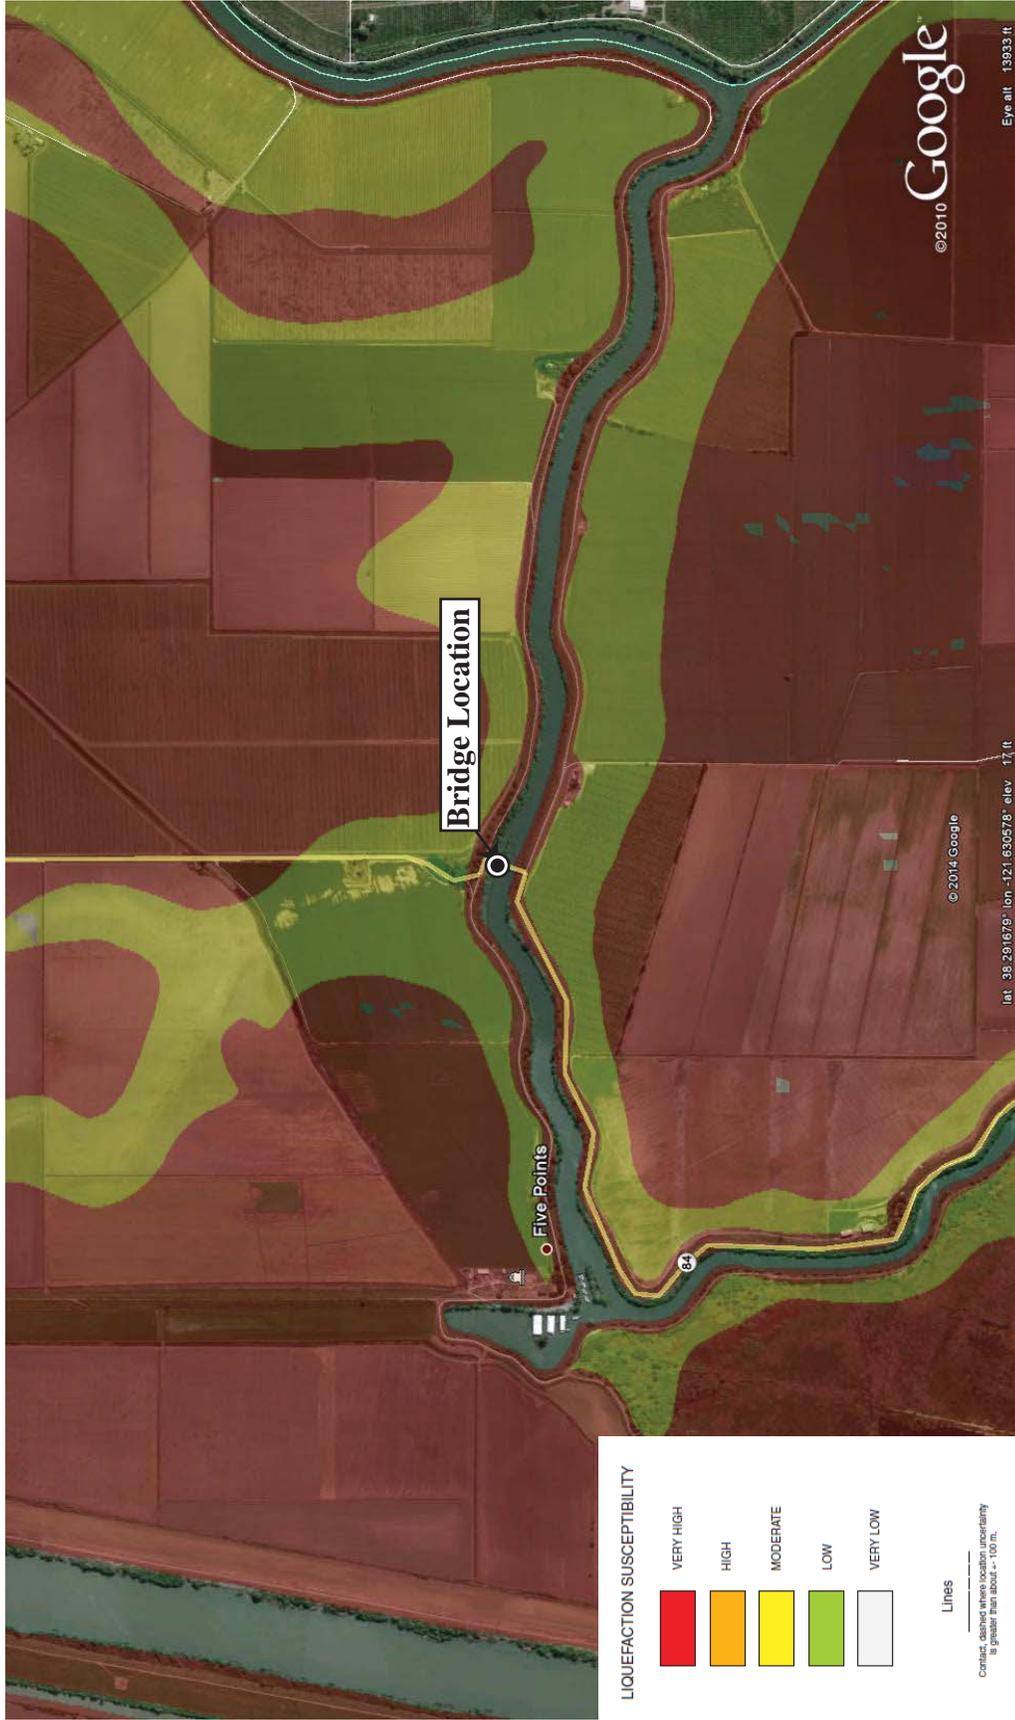
FIGURE 4

<http://earthquake.usgs.gov/regional/nca/bayarea/liquefaction.php>

Liquefaction Susceptibility is very high at the stream banks and moderate approximately 100 feet inland.⁹ (Figure 4)
