SUPPLEMENTAL INVESTIGATION REPORT

YERBA BUENA ISLAND DUCT BANK
SAN FRANCISCO COUNTY, CALIFORNIA

CALTRANS CONTRACT 04A1862
TASK ORDER NO. 68
EA No. 04-0120P1

MARCH 2007

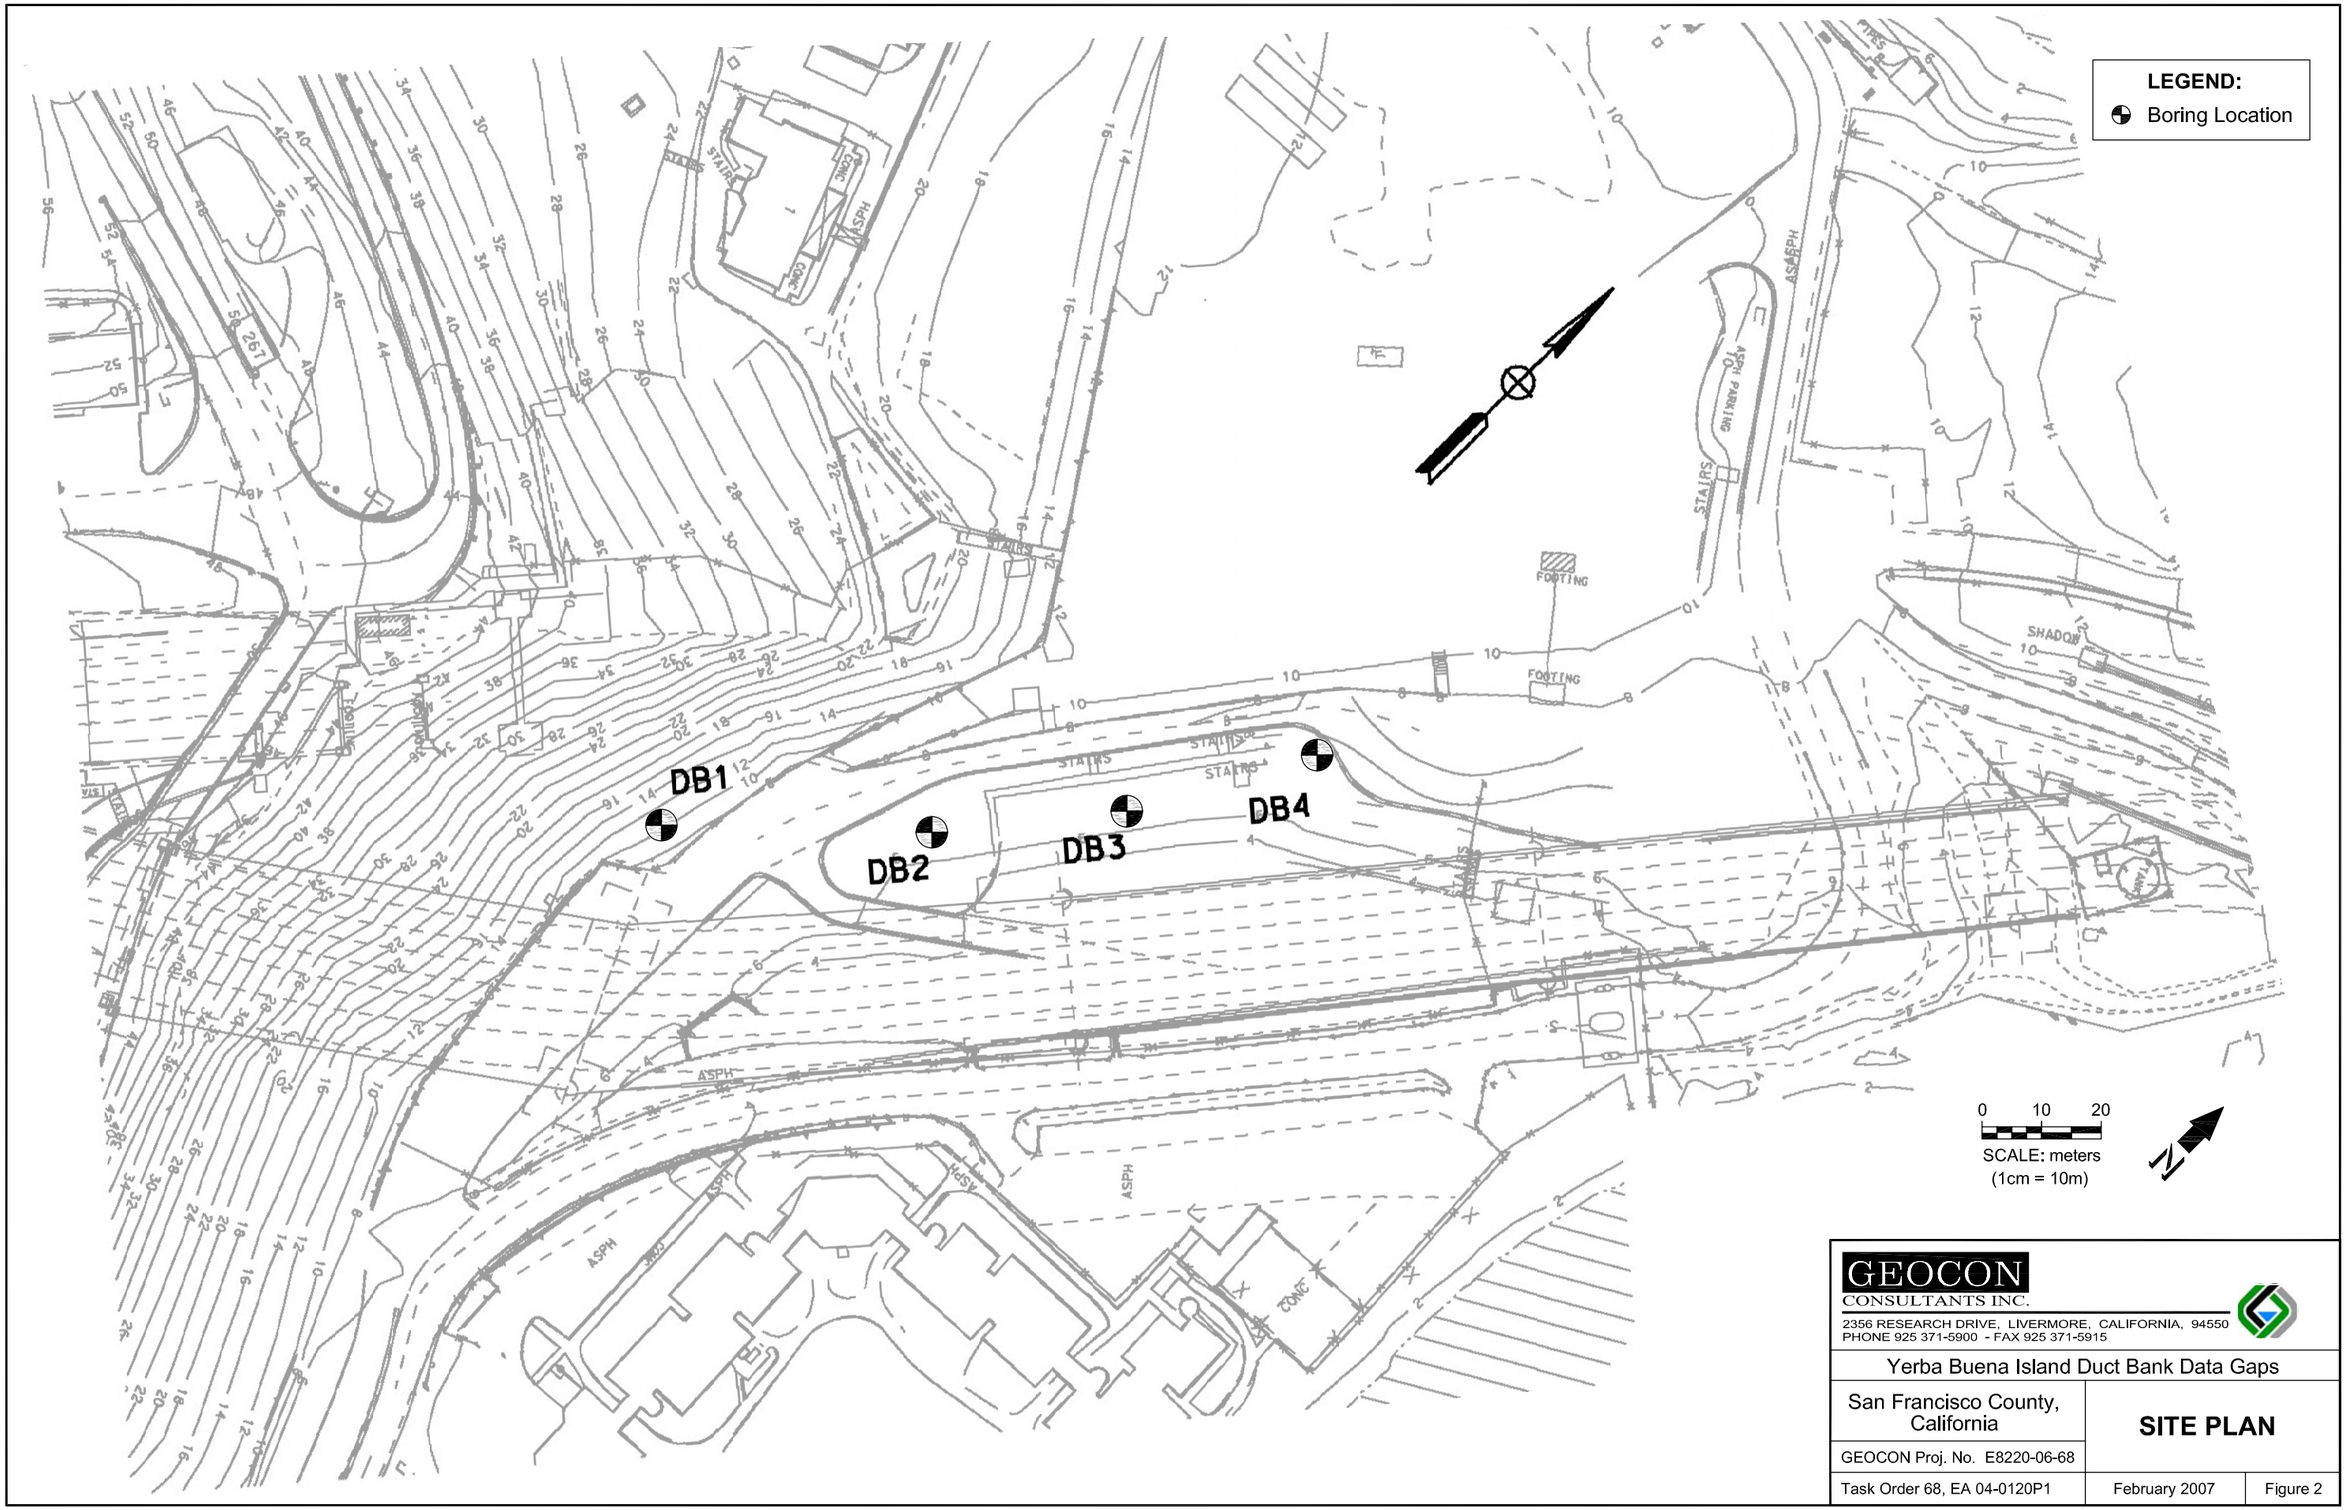
SITE PLAN

The boreholes were advanced using hand auger equipment. Field personnel collected soil samples using 2-inch by 6-inch stainless steel liners driven with a slide hammer sampler. After collection, sample liners selected for laboratory analysis had their ends covered with Teflon tape and secured with plastic end caps, were labeled, and placed in a cooler with ice. The boring locations, as selected by Caltrans, are shown on the Site Plan, Figure 2. Boring coordinates are summarized in Table 1.

Soil encountered during hand augering was generally gravelly silty sand, or fine silty sand. In the areas of borings DB2 through DB4, the upper 2.5 to 3 feet of material contained concrete debris ranging from sand to cobble size.
