PROFILOGRAPH STUDY - TOPEKA TEST ROAD

July 16, 1956

Using Manual Profilograph

Analysis and Report by. . . . . Bailey Tremper
and
D. L. Spellman

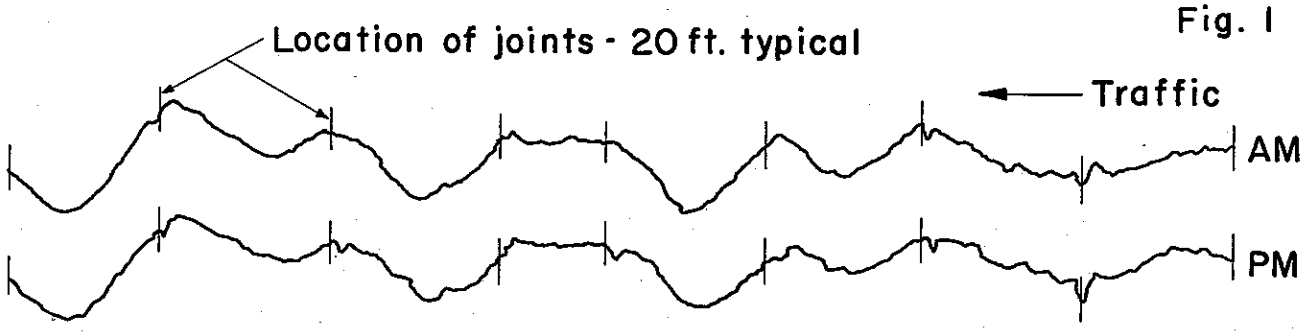
of traces are fairly representative of those sections of average roughness for each of the three cements. The fourth pair of curves is an example of extreme roughness and the lower pair, of exceptional smoothness.

Section 19 Cement 2 1"Aggt. 1924 Curing 124" per mile

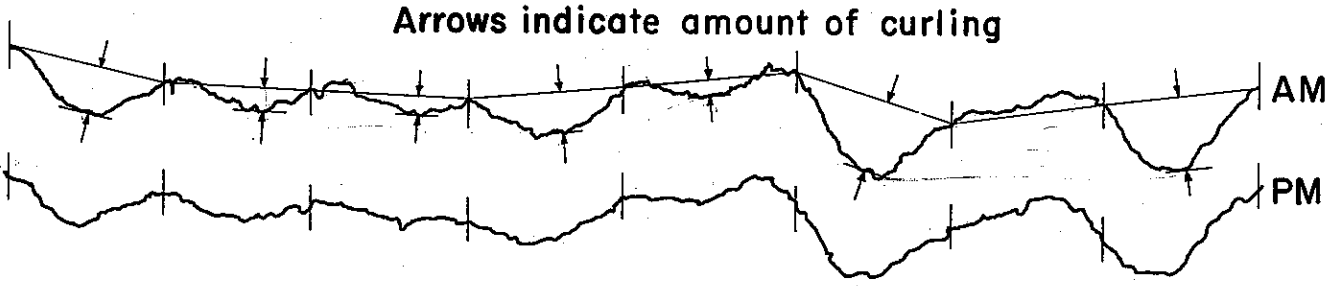
Section 22 Cement 3 1"Aggt. 1924 Curing 108" per mile

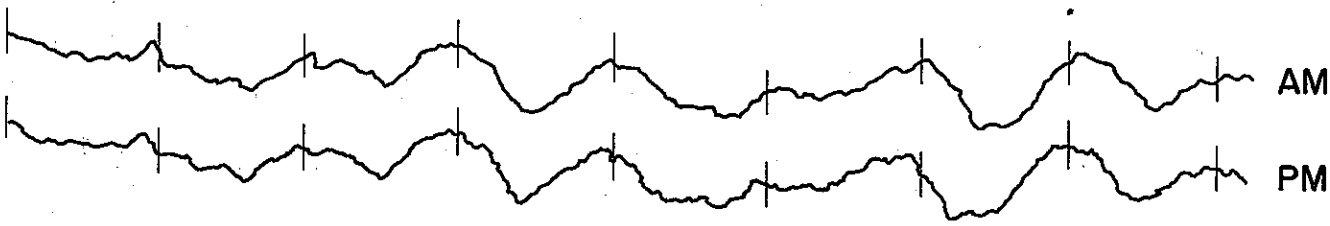
Section 1 Cement 1 1"Aggt. 1949 Curing 106" per mile

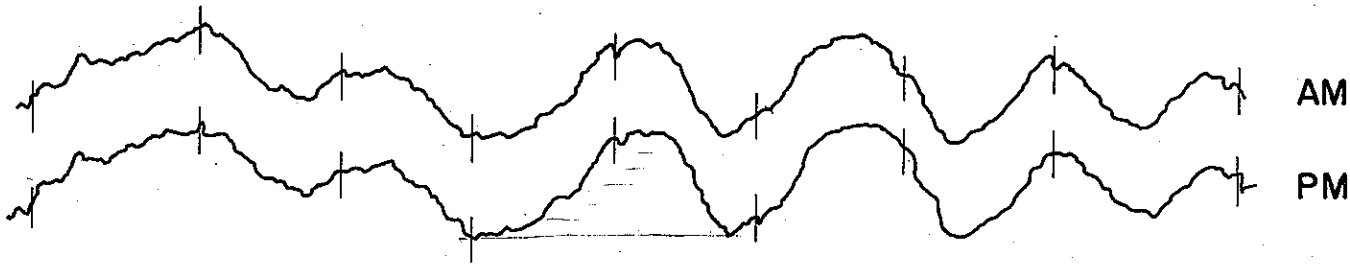
the profilograph exceeds that of the roughometer by more than 20 inches per mile. The roughometer shows section 34 to be the smoothest but the profilograph shows it to be of average roughness. Section 33 which is shown to be the roughest by roughometer is also of average roughness by profilograph estimate.

Section 33 Cement 2 1"Aggt. 1924 Curing 158" per mile

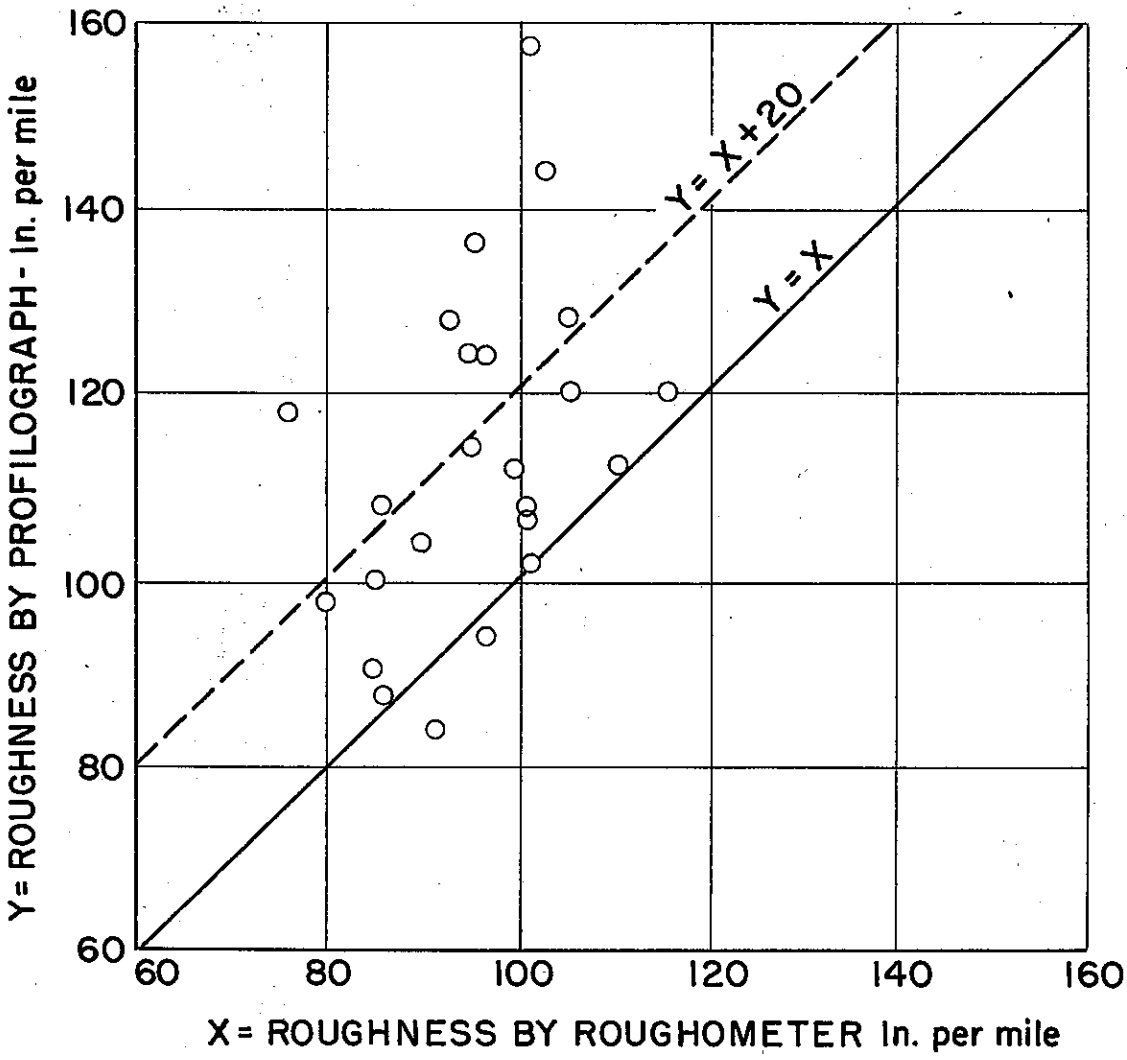
Fig. 2

The comparative roughness of each section as determined by the two instruments is plotted in Figure 2. It will be noted that in general, the roughness indicated by the profilograph exceeds that of the roughometer by about 10 inches per mile. In nine of the 24 sections the roughness indicated by

COMPARATIVE ROUGHNESS OF TEST SECTIONS AS INDICATED BY ROUGHOMETER AND PROFILOGRAPH

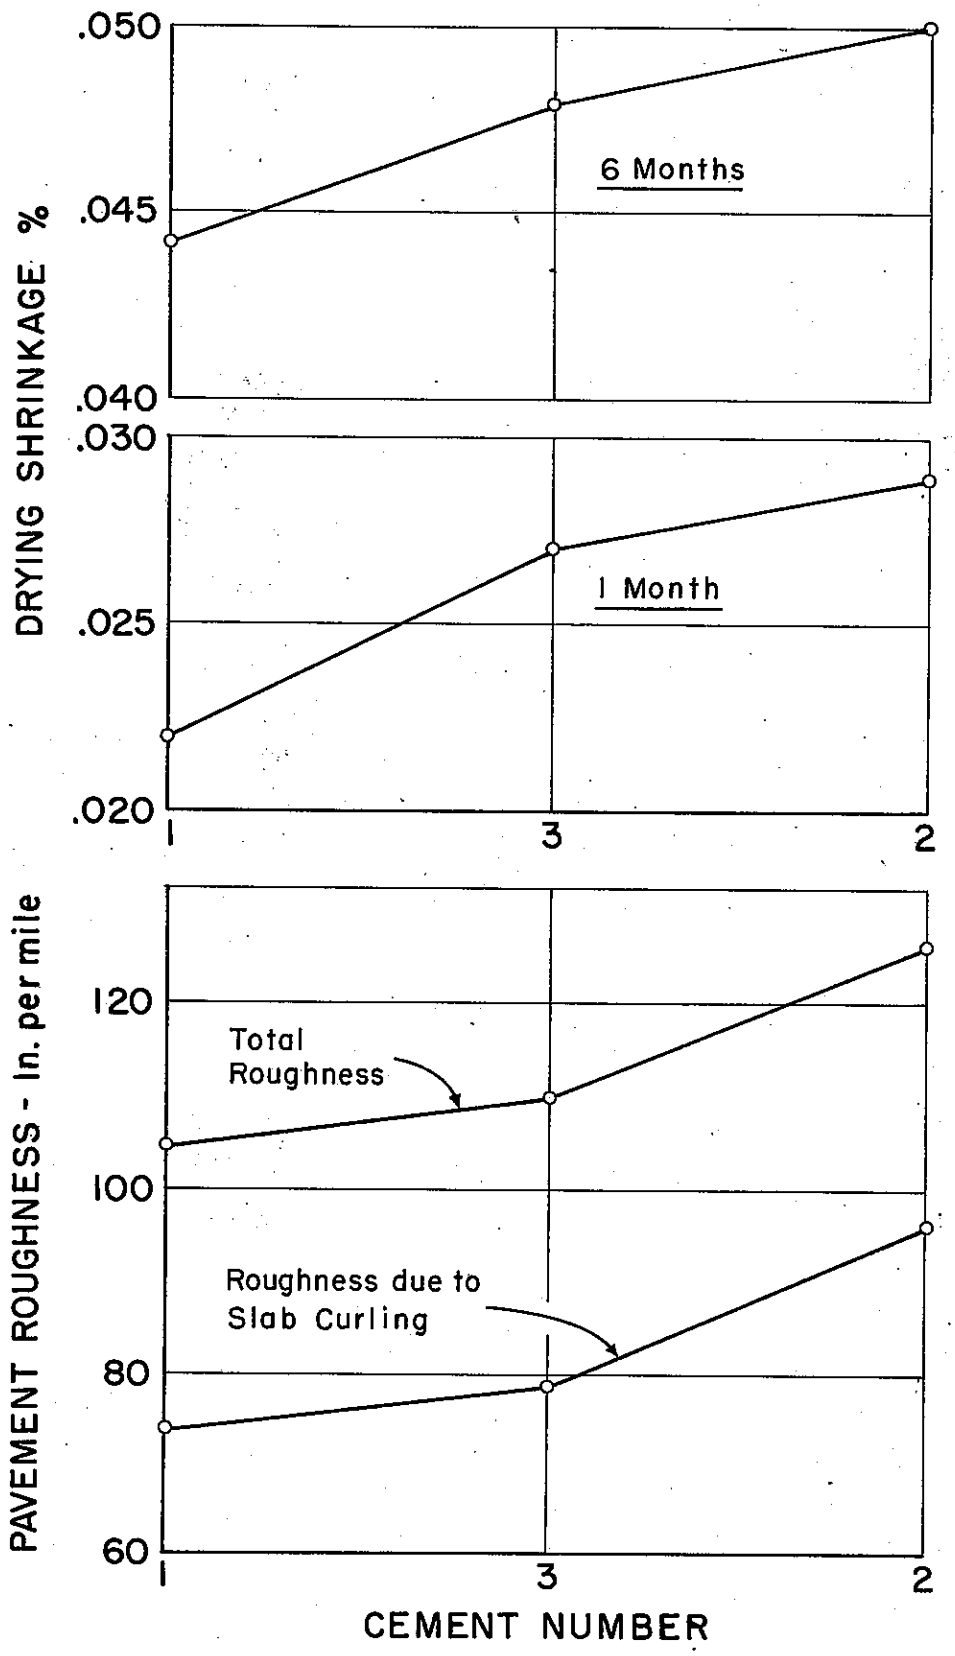
Figure 3 shows the total roughness developed in the Topeka test sections, the roughness due to slab curling alone and the test results for drying shrinkage. It is obvious that the trend of the plotted curves is in the same direction for pavement roughness and drying shrinkage. The significance of this finding would of course, be greater if more cements were involved.

DRYING SHRINKAGE AND PAVEMENT ROUGHNESS AS RELATED TO CEMENT
