### Representative Geologic Profile for Zone 3

# Zone 3 (to I-210)

# Summary of Findings

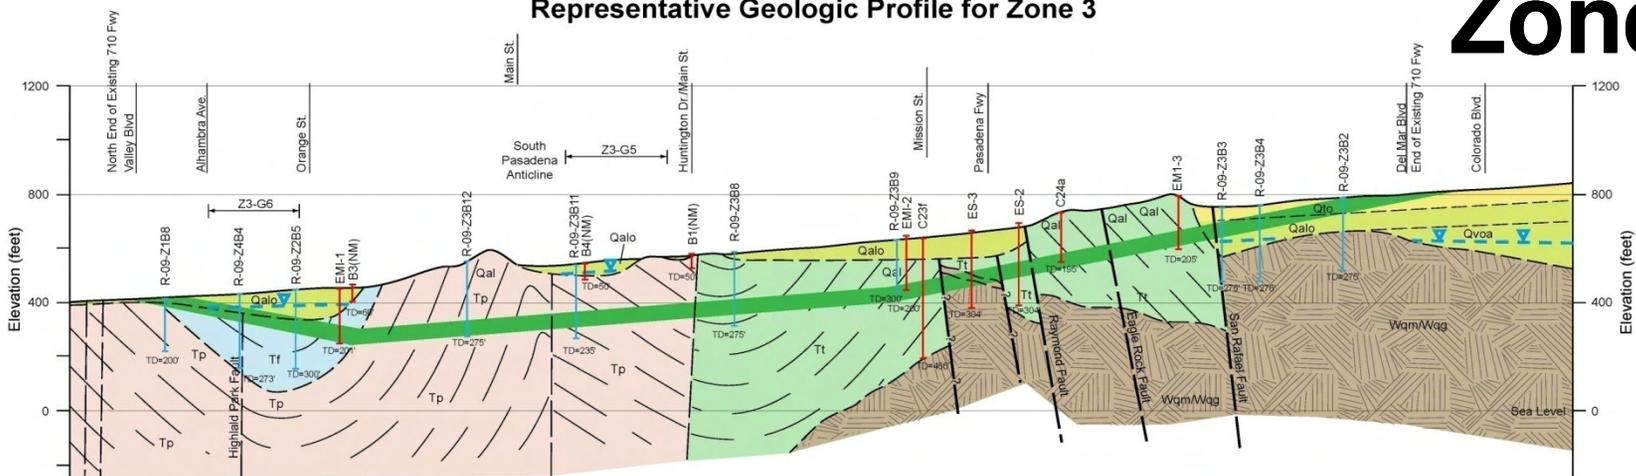
- **Variable geologic conditions**
  - **Alluvium**
  - **Sedimentary Rock (Fernando, Puente, Topanga Formations)**
  - **Igneous and Metamorphic Rock**
- **Northern portion of the zone in alluvium**
- **North of Eagle Rock Fault cobbles and boulders may be encountered**
- **Variable geologic structures (faults, folds, etc)**
- **Raymond Fault considered active and a groundwater barrier**
- **Several inactive faults**
- **Variable groundwater depths**

- Alluvial Soil (Qal0)
- Fernando Formation (Tf)
- Puente Formation (Tp)
- Topanga Formation (Tt)
- Wilson Quartz Diorite (Wqm)
- Tunnel

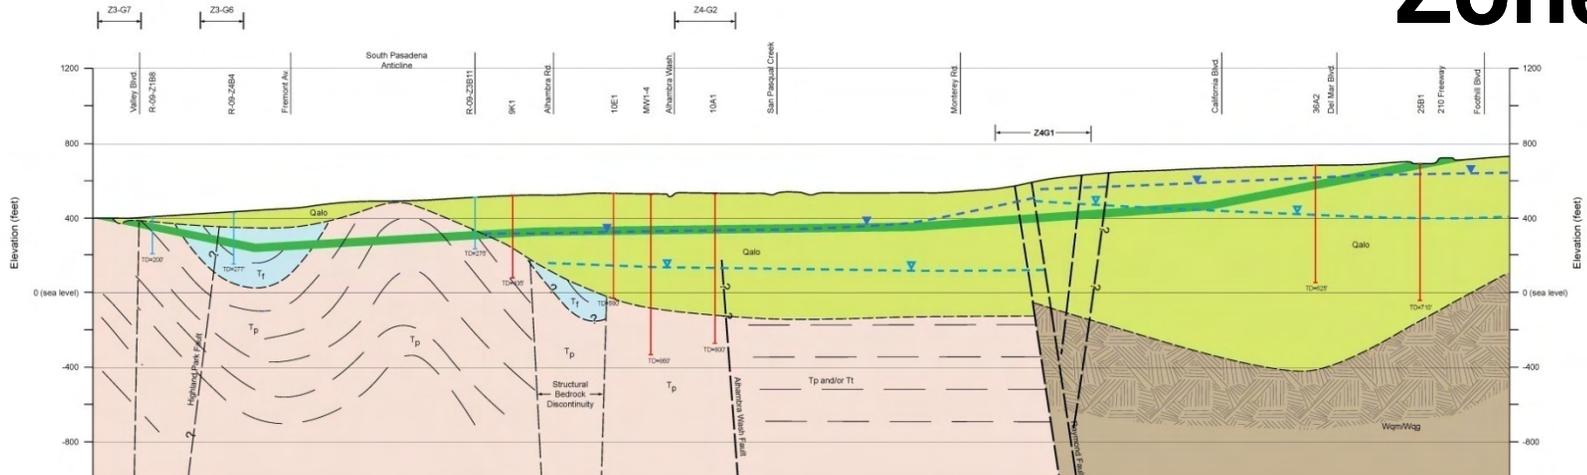
Representative Geologic Profile for Zone 4

- **Mostly alluvium with some Fernando and Puente Formation rock near south end**
  - **Alluvium may contain cobbles and boulders**
  - **Fernando Formation: mudstone**
  - **Puente Formation: sandstone, siltstone, and mudstone**
- **Raymond and Alhambra Wash Faults are considered active and act as a groundwater barrier**
- **Potential for high groundwater inflows in alluvium**
- **Potential for caving soils**
- **Groundwater levels not uniform across the zone**
- **Superfund site located in the central portion**

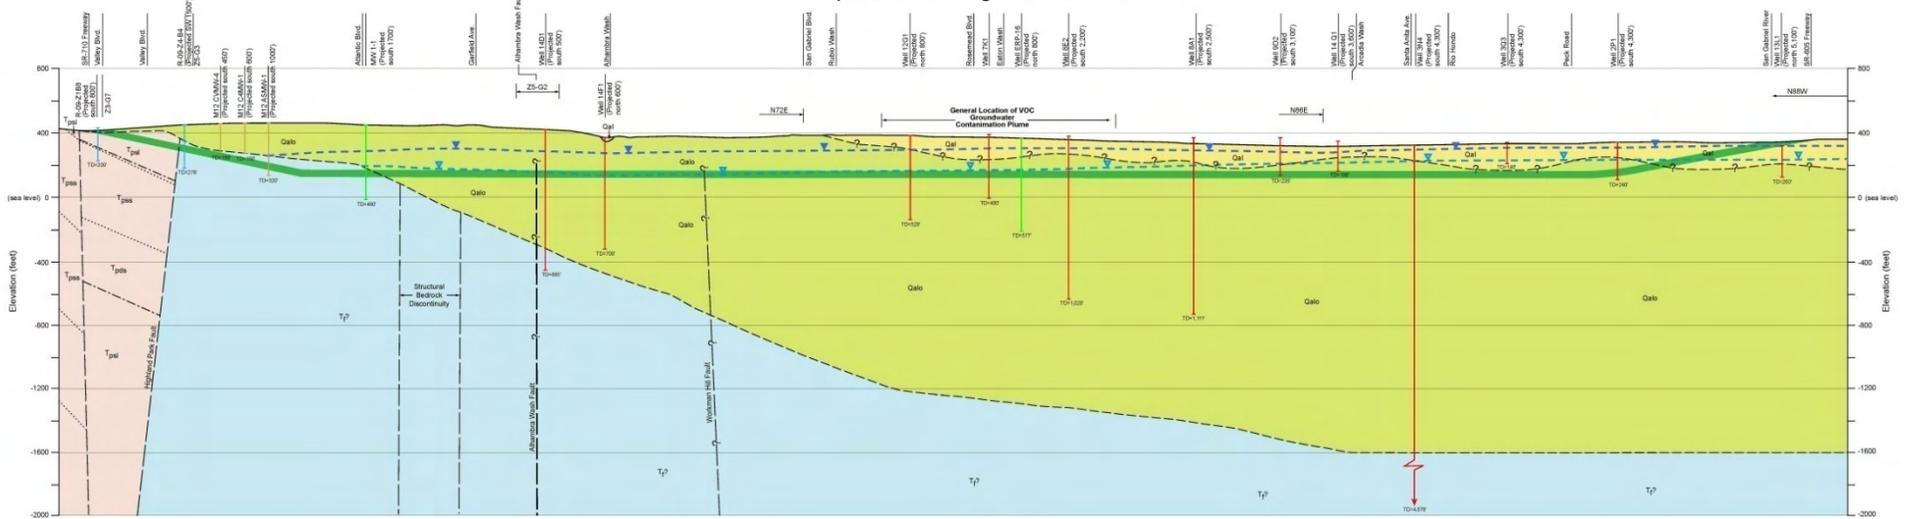
Representative Geologic Profile for Zone 5

- **Mostly alluvium with some Fernando and Puente Formation rock near south end**
  - **Alluvium may contain cobbles and boulders**
  - **Fernando Formation: mudstone**
  - **Puente Formation: sandstone, siltstone, and mudstone**
- **Alhambra Wash Fault is considered active**
- **Potential for high groundwater inflows in alluvium**
- **Groundwater levels not uniform across the zone**
- **Superfund site located in the south central portion**
- **Perennial Rio Hondo and San Gabriel Rivers and recharge lakes at eastern portion**
