**SR - 710 Tunnel Technical Study
Steering Committee
Meeting No. 6
Crowell Library
November 18, 2009**

Scope of Tunnel Study

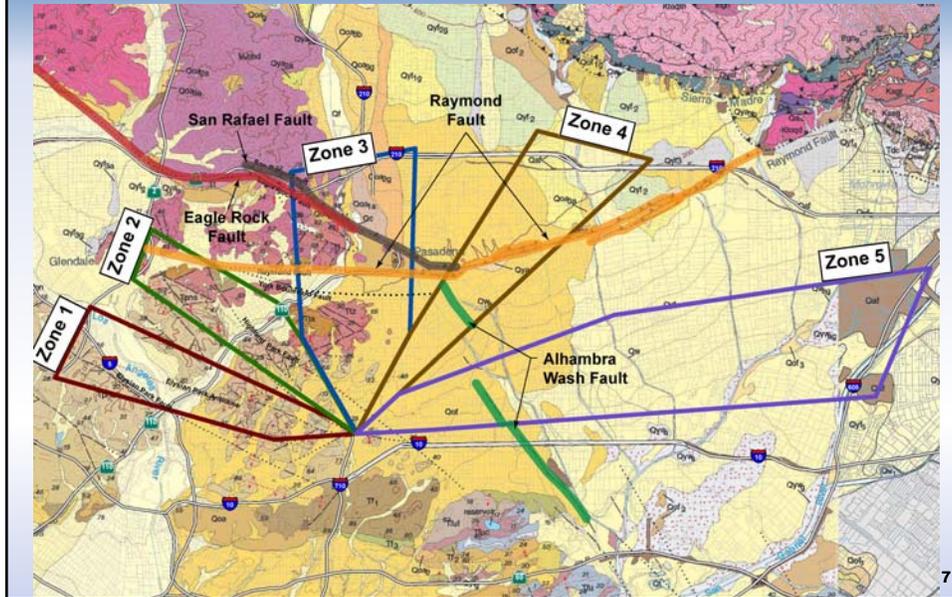
Study Zones

- A total of 5 potential zones were investigated
- Collected geotechnical, geological, and hydro-geological information for each zone
- Information to be used for screening purposes

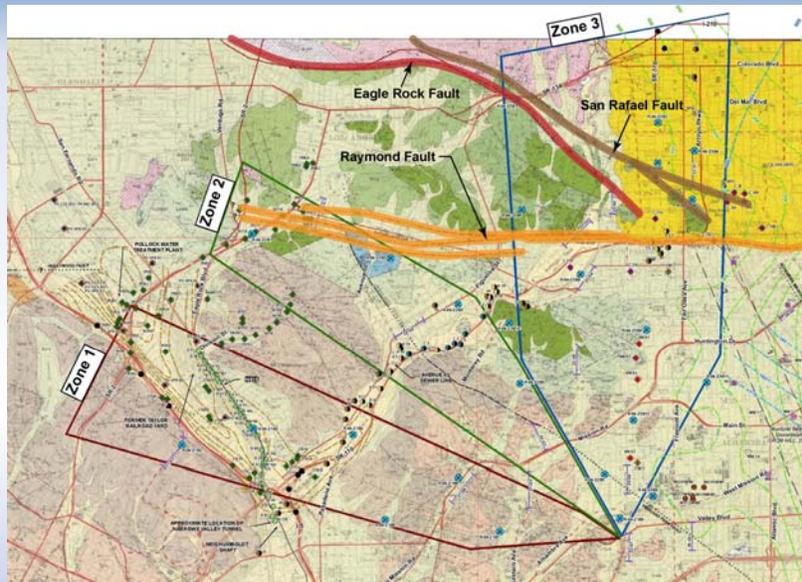
Summary of Data and Faulting Zones 1, 2, and 3 (Section 4)

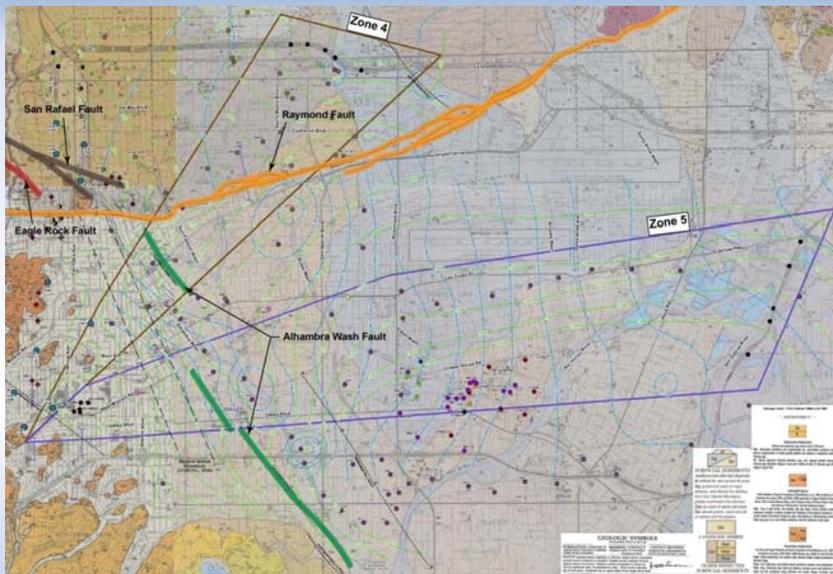
Summary of Data and Faulting, Zones 4 and 5 (Section 4)

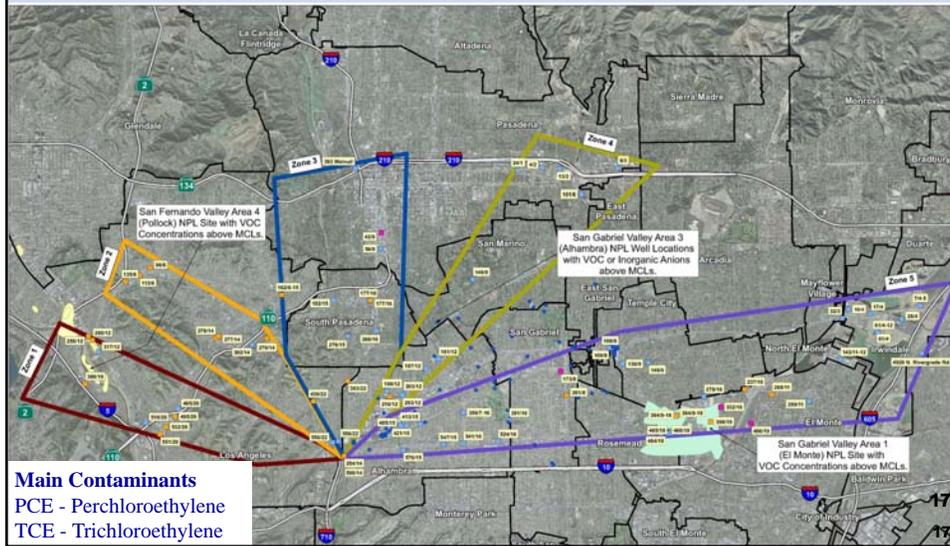
Limits of Potential Groundwater Contamination

Status of Contaminated Groundwater Sites Per EPA

- **Zone 1**
 - Containment in place
 - Groundwater treatment began in 1998
- **Zone 4**
 - Currently evaluating extent of contamination
 - Record of Decision to be completed in next few years
 - Remedial and containment plans to be developed after Record of Decision
- **Zone 5**
 - Plan for containment is being evaluated, Installation of containment planned to begin in next few years
 - Cleaning up of the SUPERFUND site to be determined later

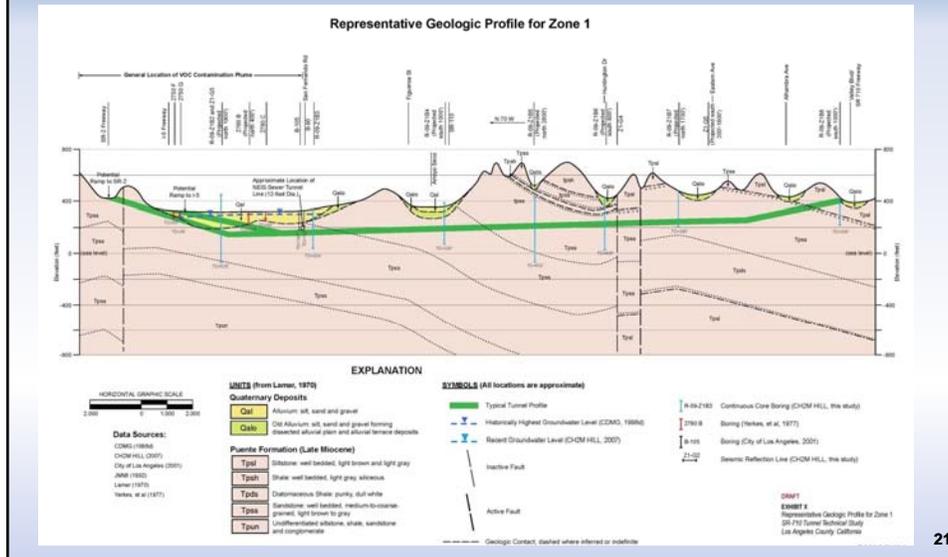
Representative Geologic Cross Section for Zone 1

Zone 1 (to SR-2 at I-5) – Section 7

- Uniform geologic conditions consisting mainly of Puente Formation
 - Weak sandstone with thin siltstone interbeds
- Alluvium has potential for high groundwater inflows
- Several inactive faults within the Zone
- Potential gassy conditions
- Superfund site located in the northwest portion
- Groundwater is approximately 20 to 50 feet below surface

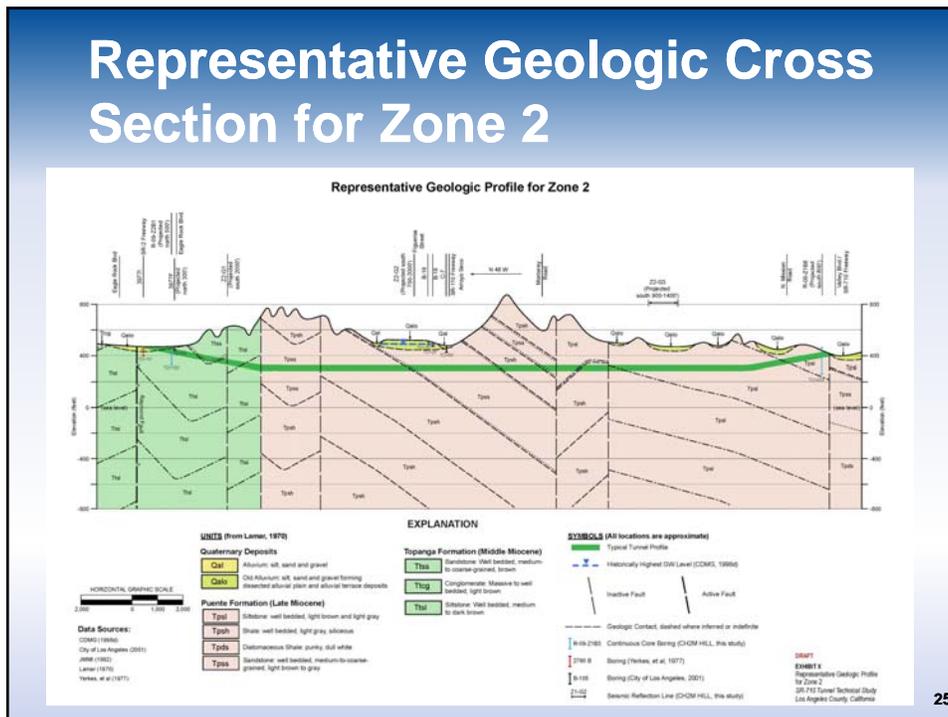
Representative Geologic Cross Section for Zone 2

Zone 2 (to SR-2) – Section 8

- **Topanga, Puente and Fernando Formations:**
 - Topanga Formation (siltstone, sandstone)
 - Puente Formation (sandstone, siltstone, shale)
 - Fernando Formation (sandstone, conglomerate)
- **Shallow alluvium at northwest end**
- **Variable geologic structures**
- **Several inactive faults within the zone**
- **Raymond fault crosses near northwest end**
- **Groundwater locally up to 20 ft below surface**

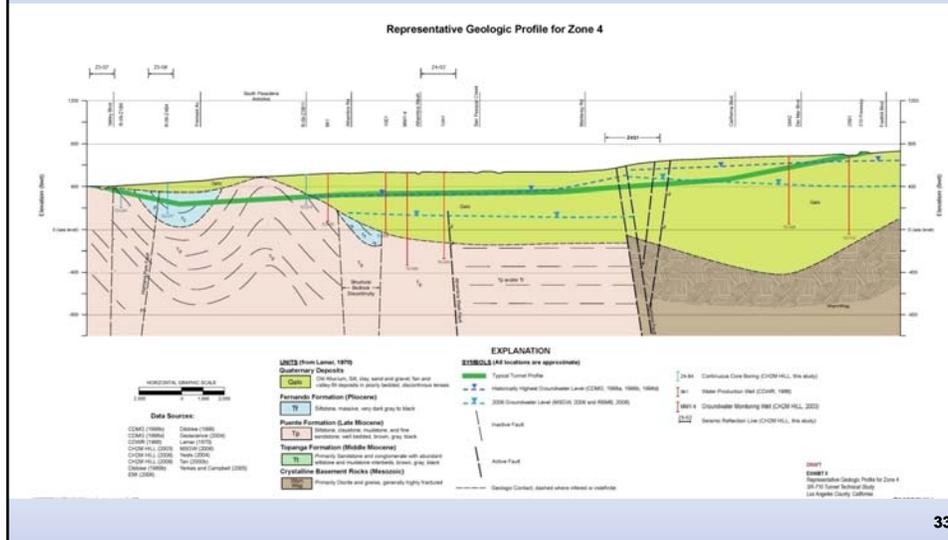
Representative Geologic Cross Section for Zone 4

Zone 4 (to I-210) – Section 10

- Mostly alluvium with some Fernando and Puente Formation rock near south end
 - Alluvium may contain cobbles and boulders
 - Fernando Formation: mudstone
 - Puente Formation: sandstone, siltstone, and mudstone
- Raymond and Alhambra Wash Faults are considered active and act as a groundwater barrier
- Potential for high groundwater inflows in alluvium
- Potential for caving soils
- Groundwater levels not uniform across the zone
- Superfund site located in the central portion

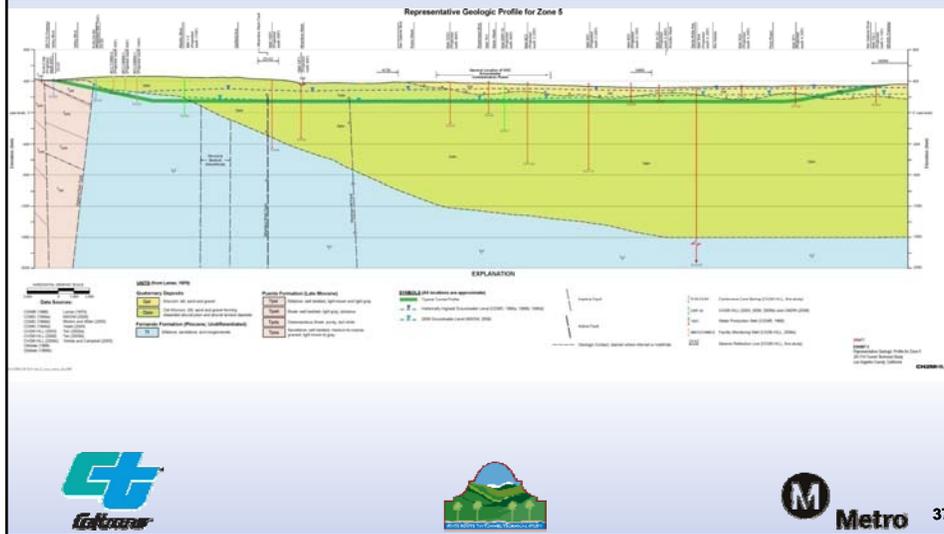
Representative Geologic Cross Section for Zone 5

Zone 5 (to I-605) – Section 11

- **Mostly alluvium with some Fernando and Puente Formation rock near south end**
 - Alluvium may contain cobbles and boulders
 - Fernando Formation: mudstone
 - Puente Formation: sandstone, siltstone, and mudstone
- **Alhambra Wash Fault is considered active**
- **Potential for high groundwater inflows in alluvium**
- **Groundwater levels not uniform across the zone**
- **Superfund site located in the south central portion**
- **Perennial Rio Hondo and San Gabriel Rivers and recharge lakes at eastern portion**

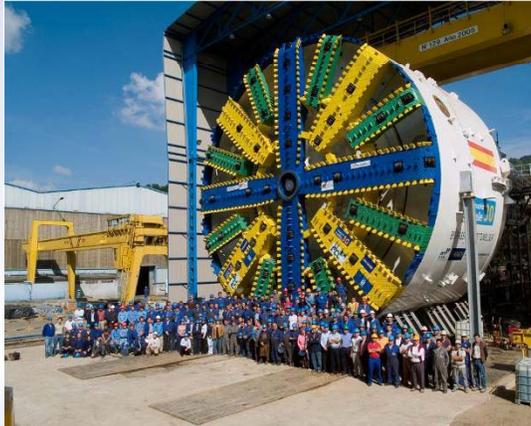
Special Pressurized Face Tunneling Machines

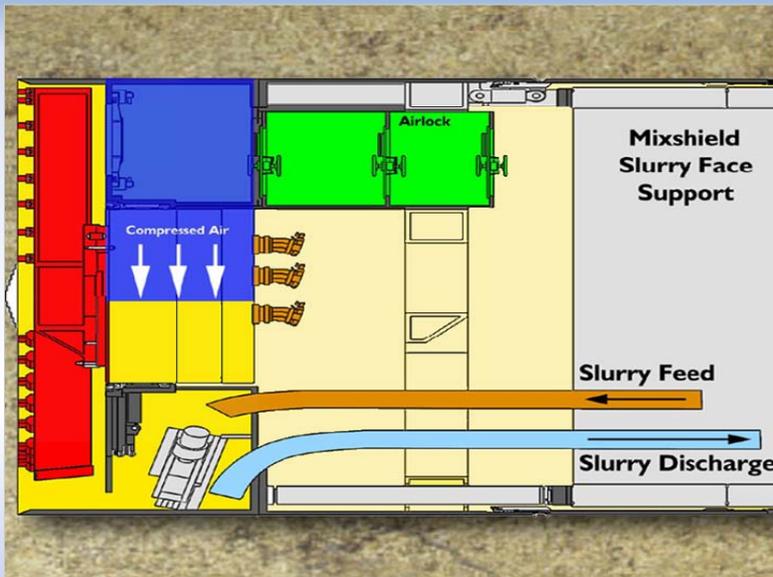
Slurry TBM

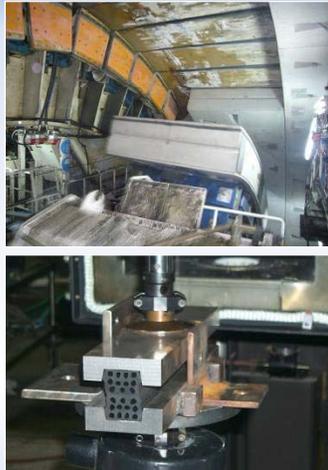
Watertight Segmental Lining

- Designed to resist ground loads, hydrostatic pressures
- Gaskets provide watertight seal
- Significant structural capacity

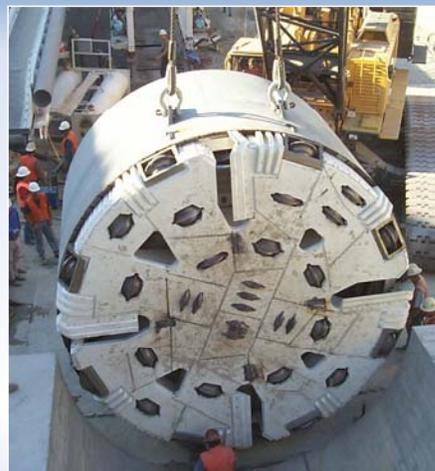
TBM with Rock/Soil Cutterhead

- **Riverside Badlands Tunnel**
- **Single TBM for 8-mile tunnel**
- **Weak sedimentary rock; hard rock (gneiss); and alluvium**

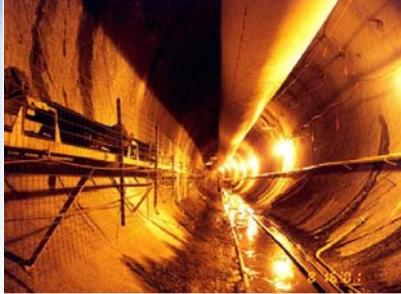
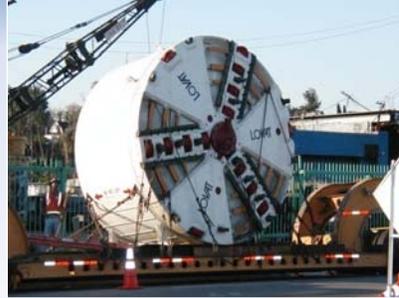
Natural Gas

- **Puente Formation – Zones 1 and 2**
- **Proper safety precautions necessary**
- **Regulated by Cal/OSHA**

Special Provisions to Deal with Gassy Conditions

- **Ventilation is critical**
- **Designed to prevent “dead spots”**
- **Spark-free electrical equipment**
- **Continuous gas monitoring**
- **Safety training**

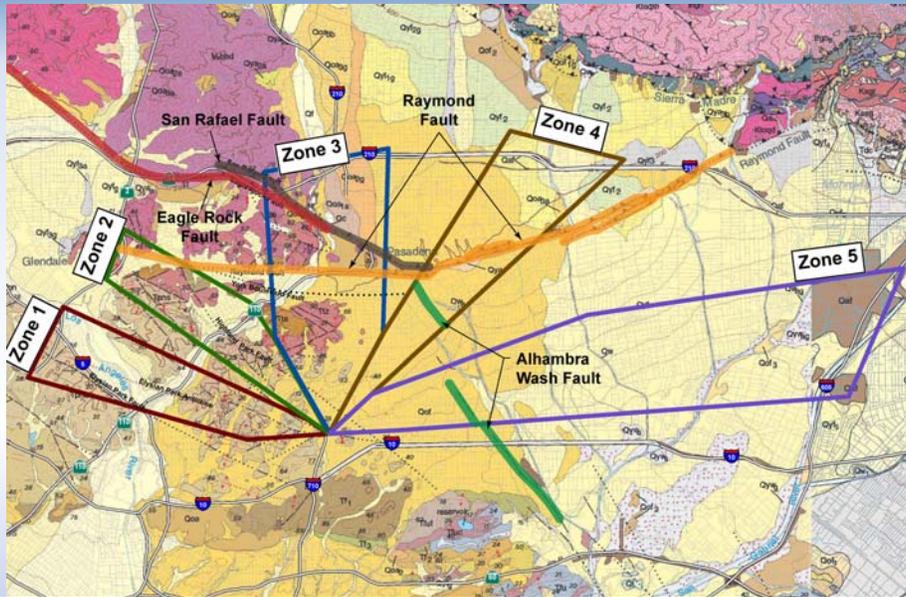
Active Faults in Zones 2, 3, 4, and 5

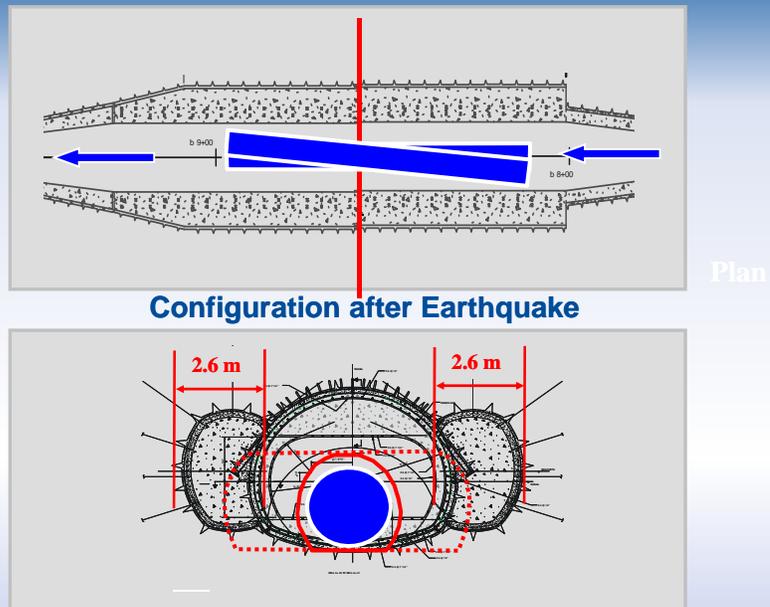
Oversized Vault Section

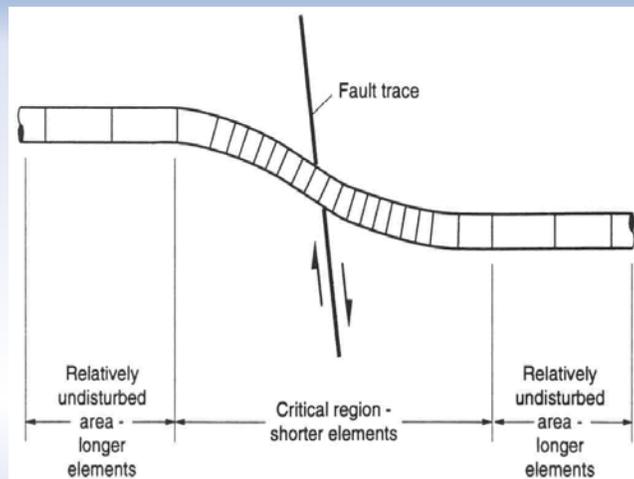
Fault Crossing with Segmental Tunnel
