December 1958

DEGRADATION OF AGGREGATES

F. N. Hveem*

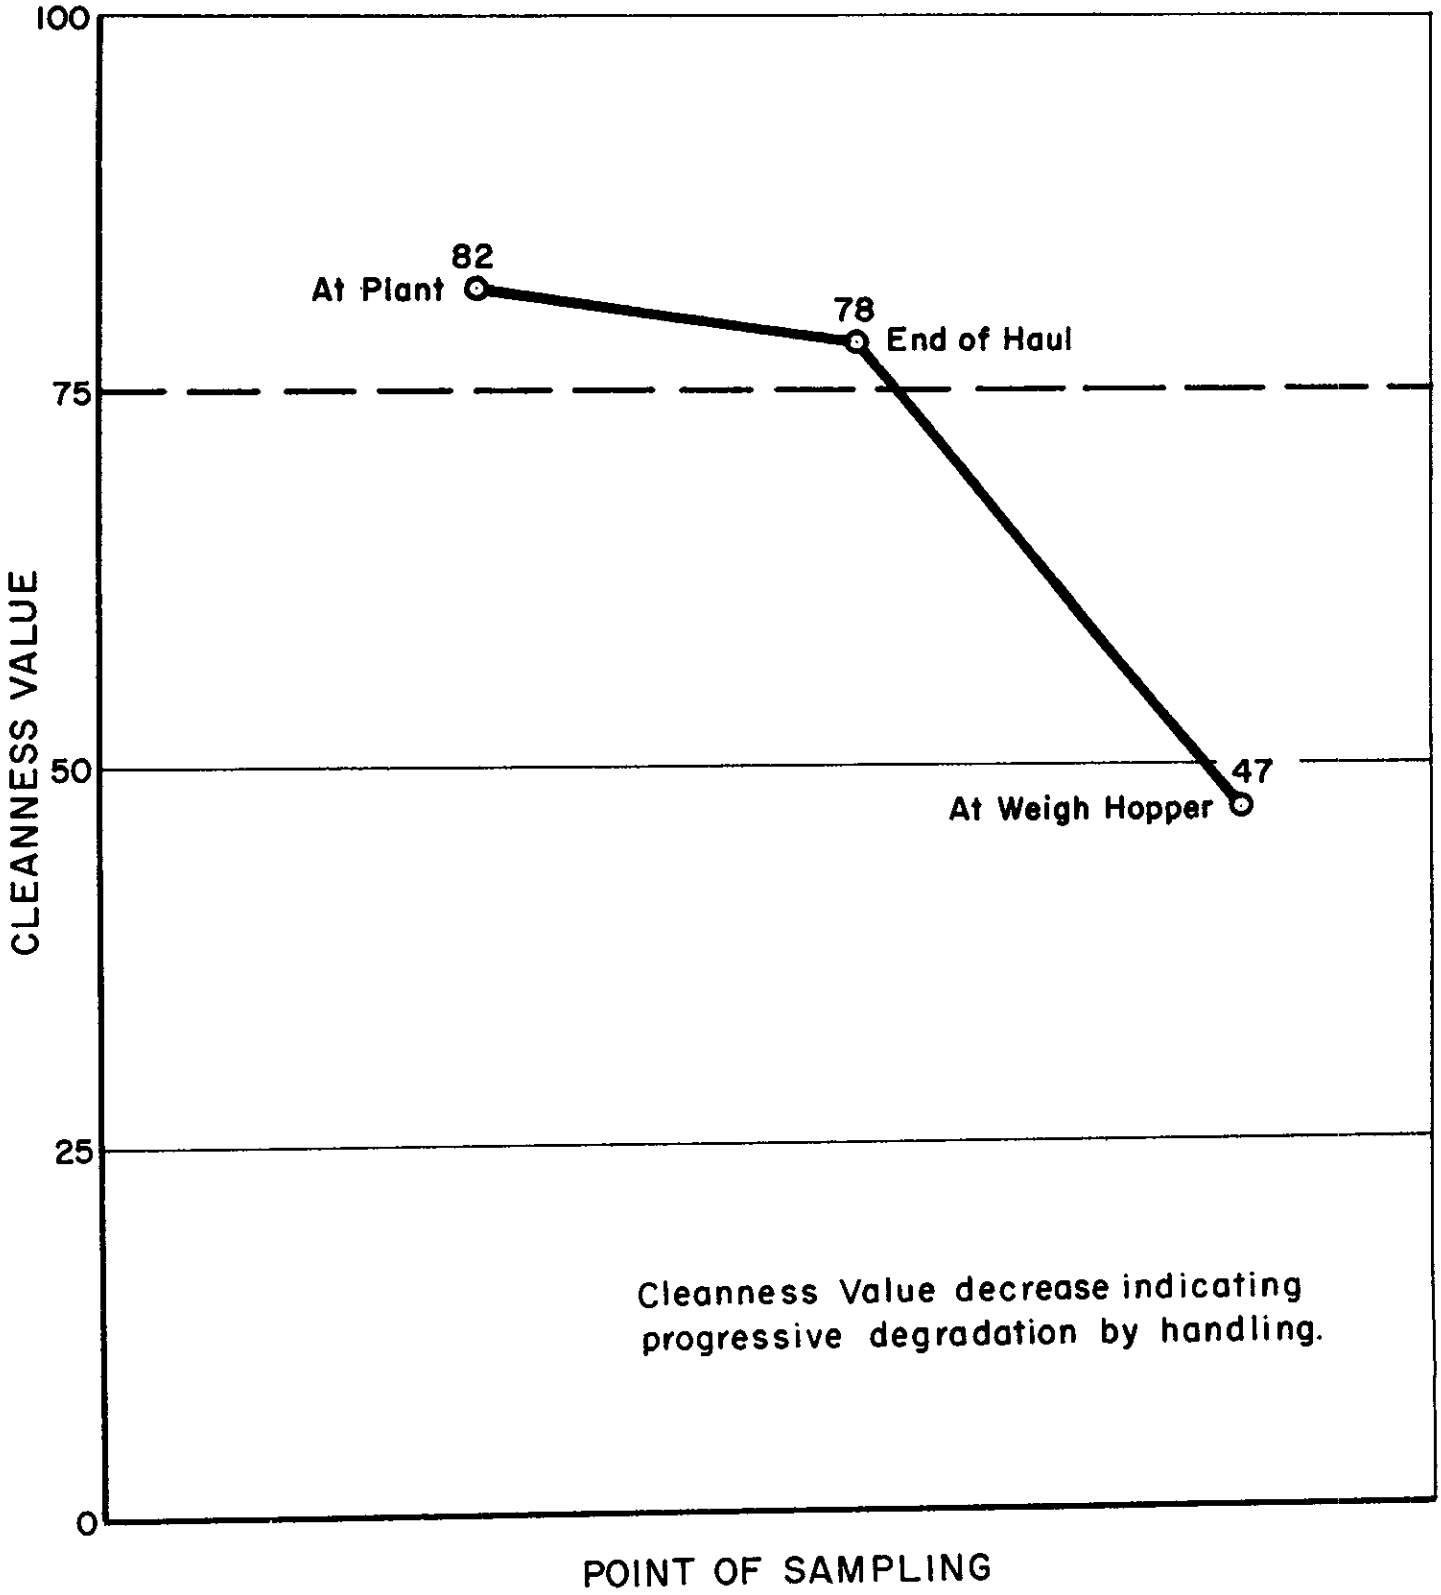
Figure No. 3

In a typical case, the aggregates are produced in a large commercial plant, at which time the material is washed thoroughly, and then as an additional precaution each truck load is flushed with a 6" stream of water during loading. Samples taken from the trucks at this point show a Cleanness value of 82. When sampled again from the same truck at the end of a 25 mile truck haul, the C.V. dropped to 78.

After unloading, going through the elevator and into the weigh hopper of the batching plant, the value dropped to 47, Fig. 3. An inspection of the aggregate at these three points indicated that this is by no means a vagary in the test method as the stone in the weigh hopper was virtually unrecognizable, being visibly coated with a heavy layer of dust and fine material, Fig. 4. This change in appearance from clean to dirty simply by the process of handling raised immediate problems as to time and place of sampling and the question of establishing the point where the materials must meet the specification.

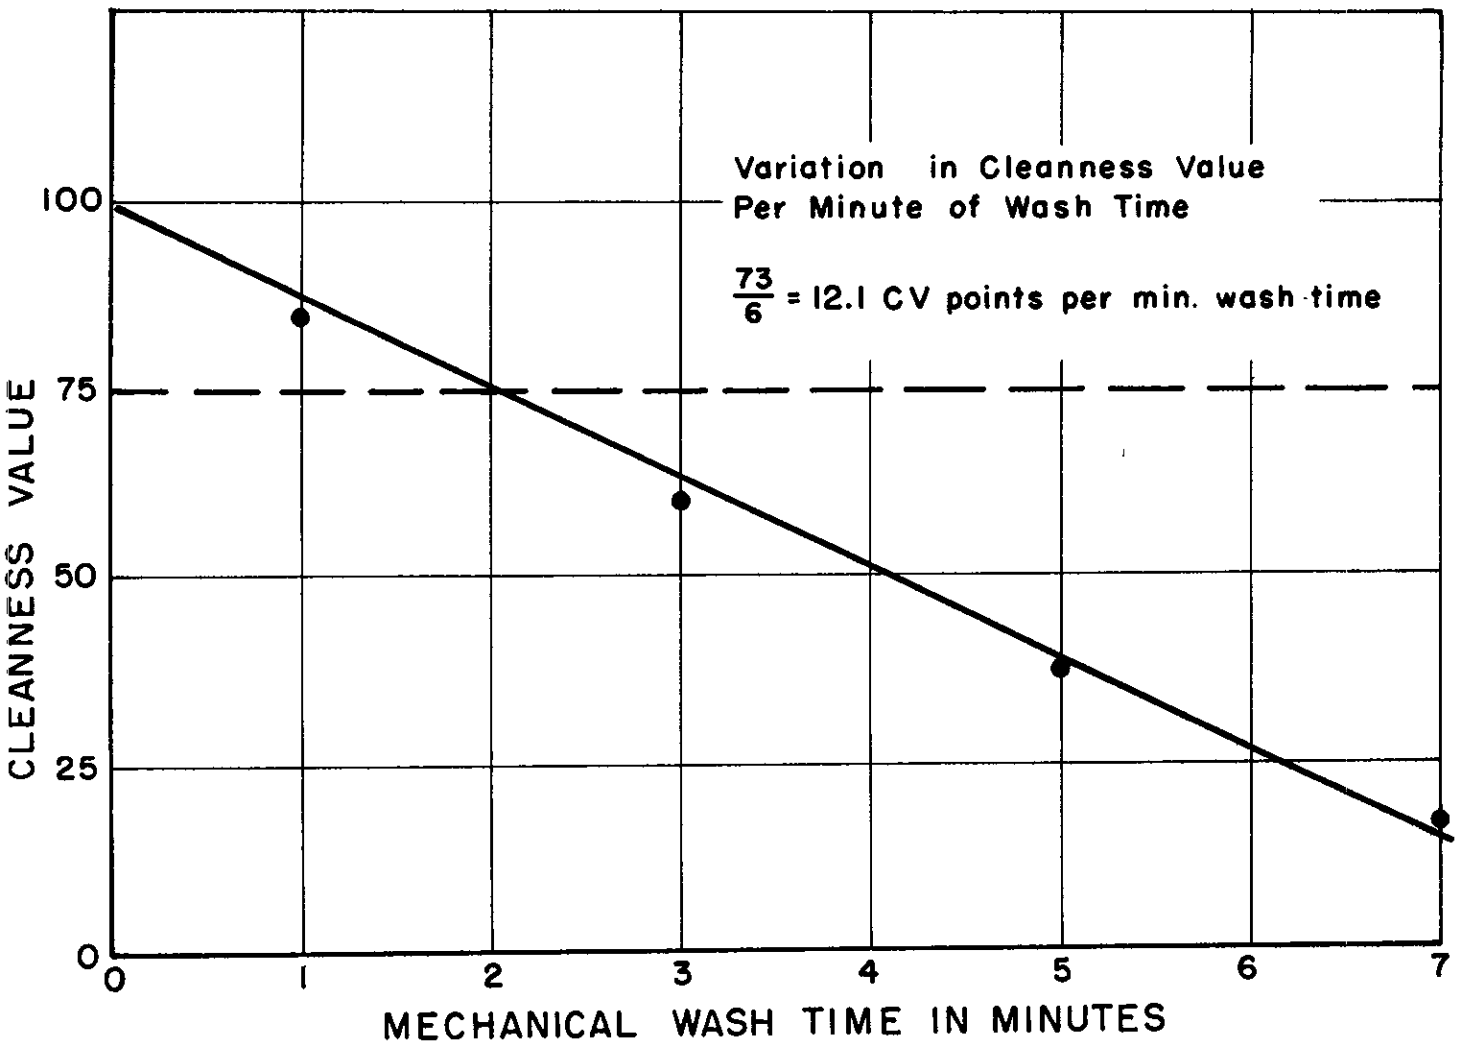
Figure No. 5

TESTS ON 1 1/2" X 3/4" PCC
AGGREGATES FROM PLANT A

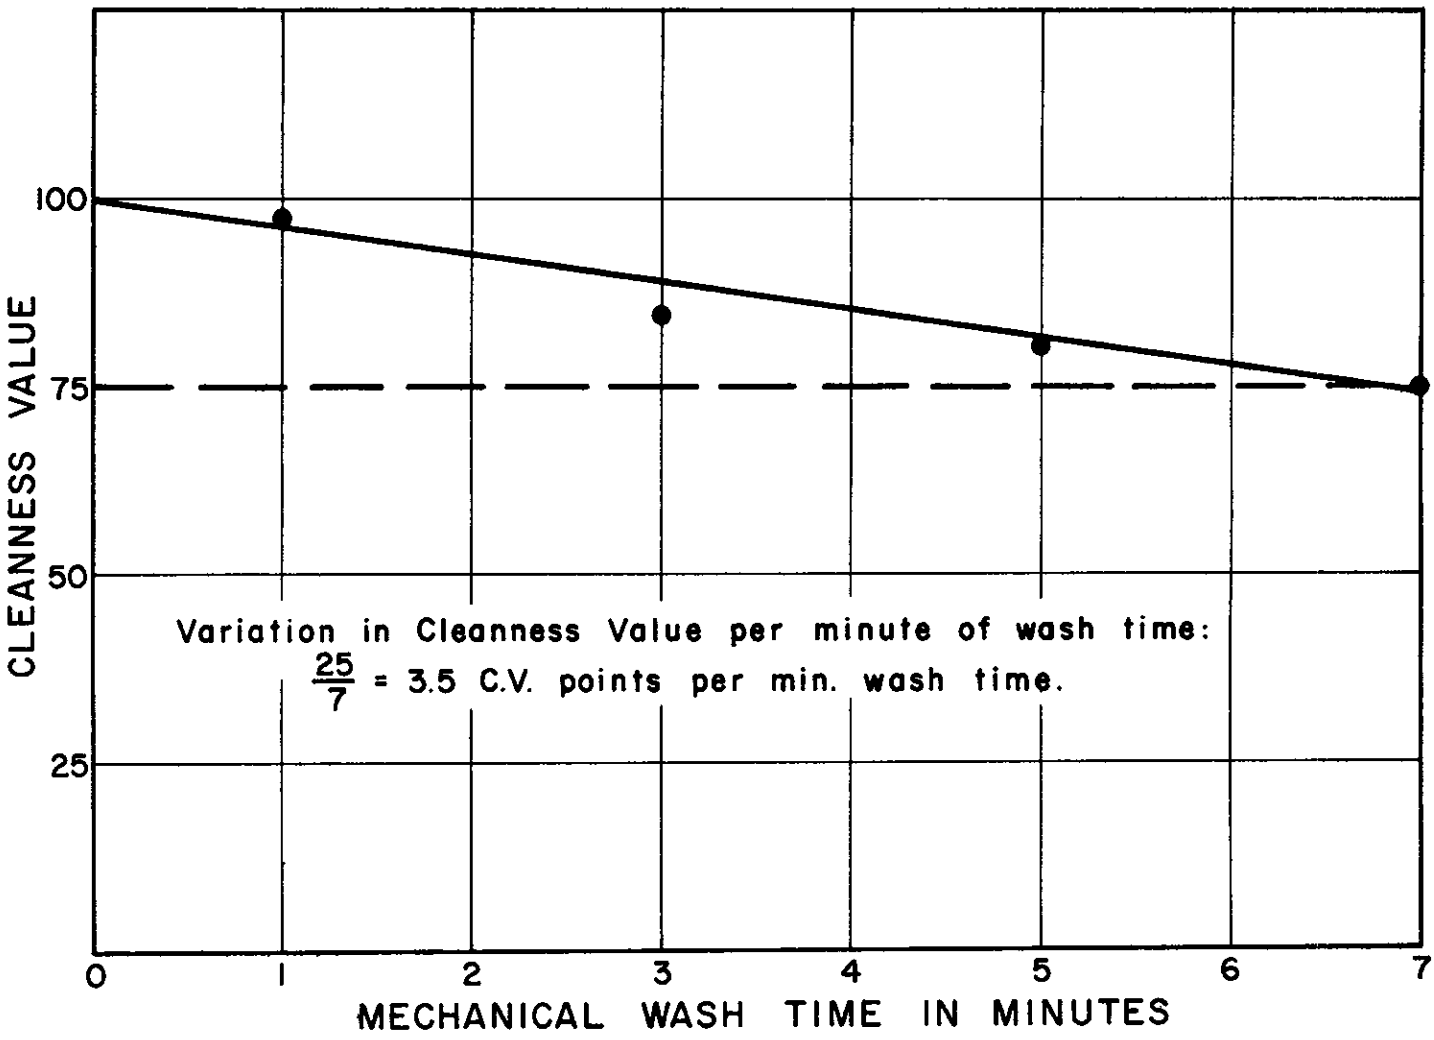
Figure No. 6

TESTS ON 1 1/2" X 3/4" PCC AGGREGATES

FROM PLANT B
