# GEOTECHNICAL REPORT

## STATE ROUTE 11 AND THE OTAY MESA EAST PORT OF ENTRY

**GEOTECHNICAL REPORT**

**PRELIMINARY GEOTECHNICAL STUDY  
CALTRANS/SR-11  
SAN DIEGO, CALIFORNIA**

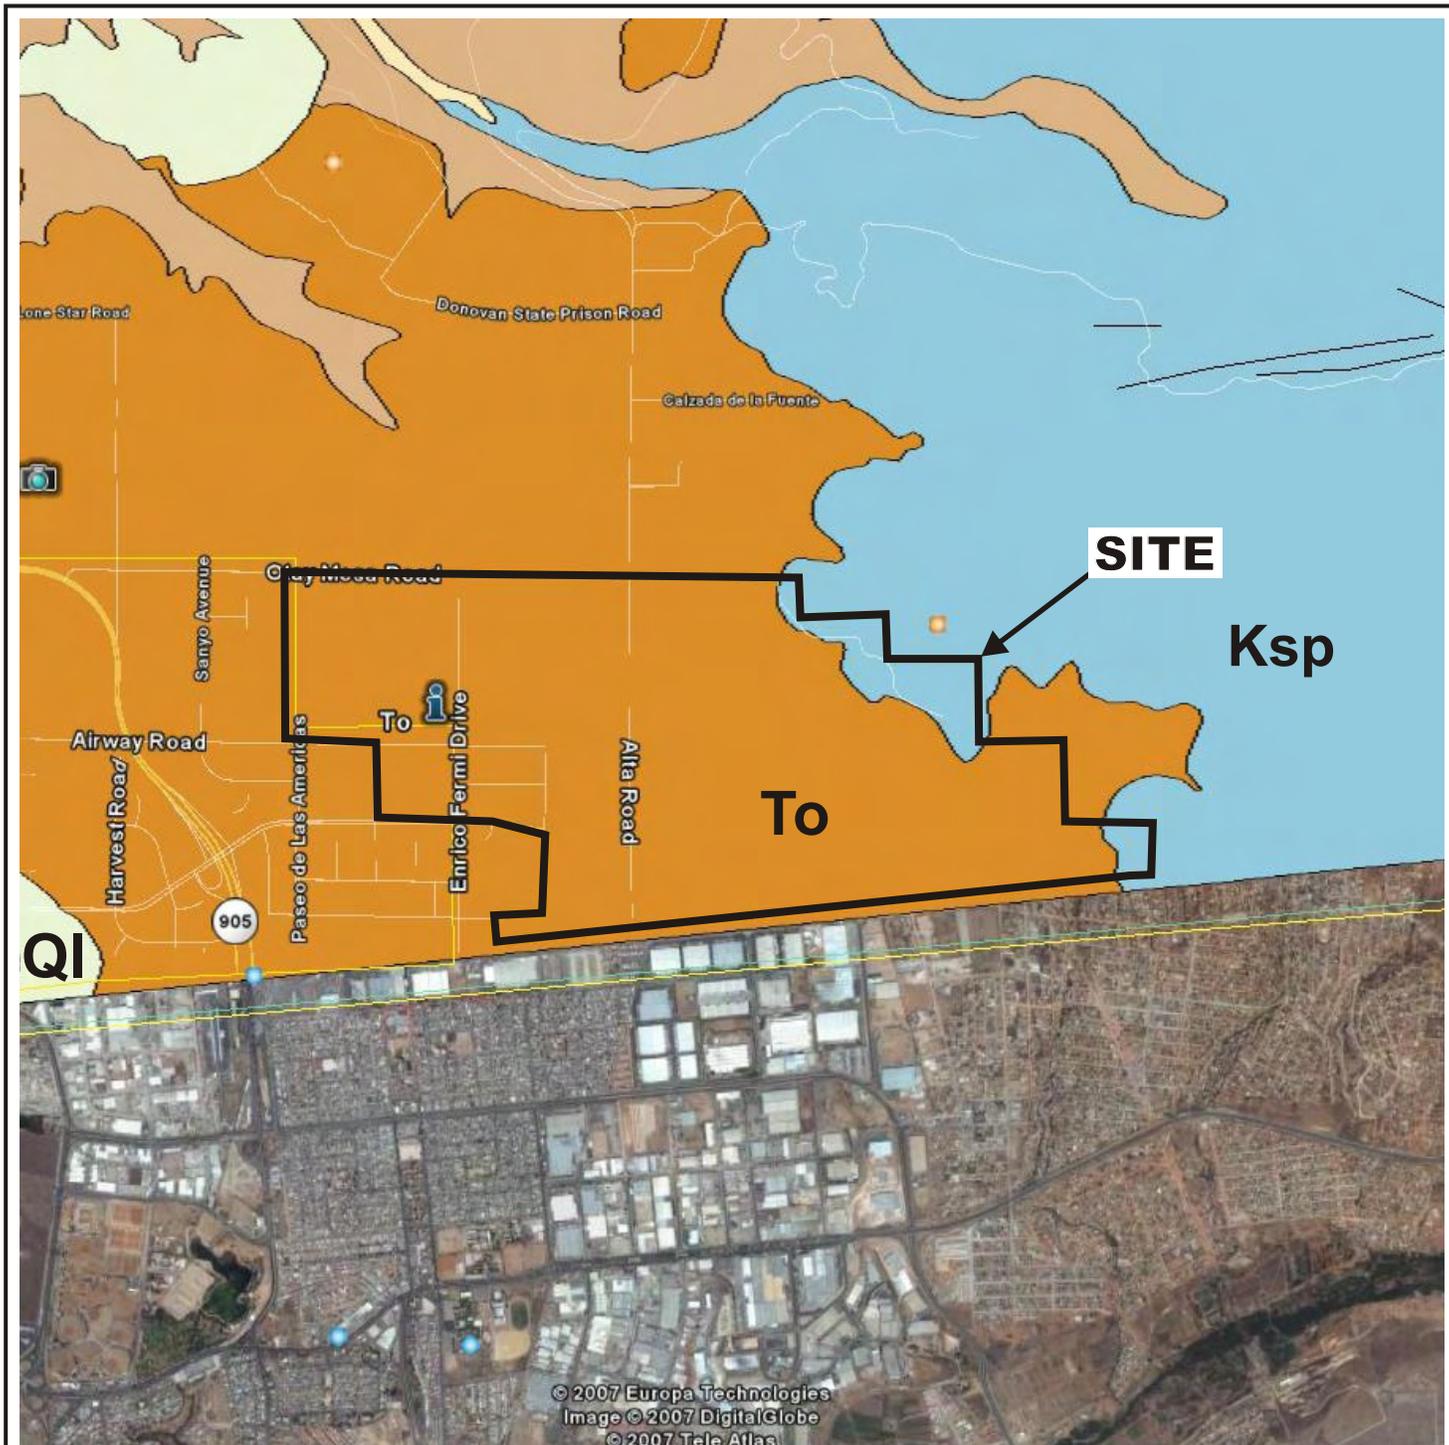
LEGEND	
<b>QI</b>	LINDAVISTA FORMATION
<b>To</b>	OTAY FORMATION
<b>Ksp</b>	SANTIAGO PEAK VOLCANICS

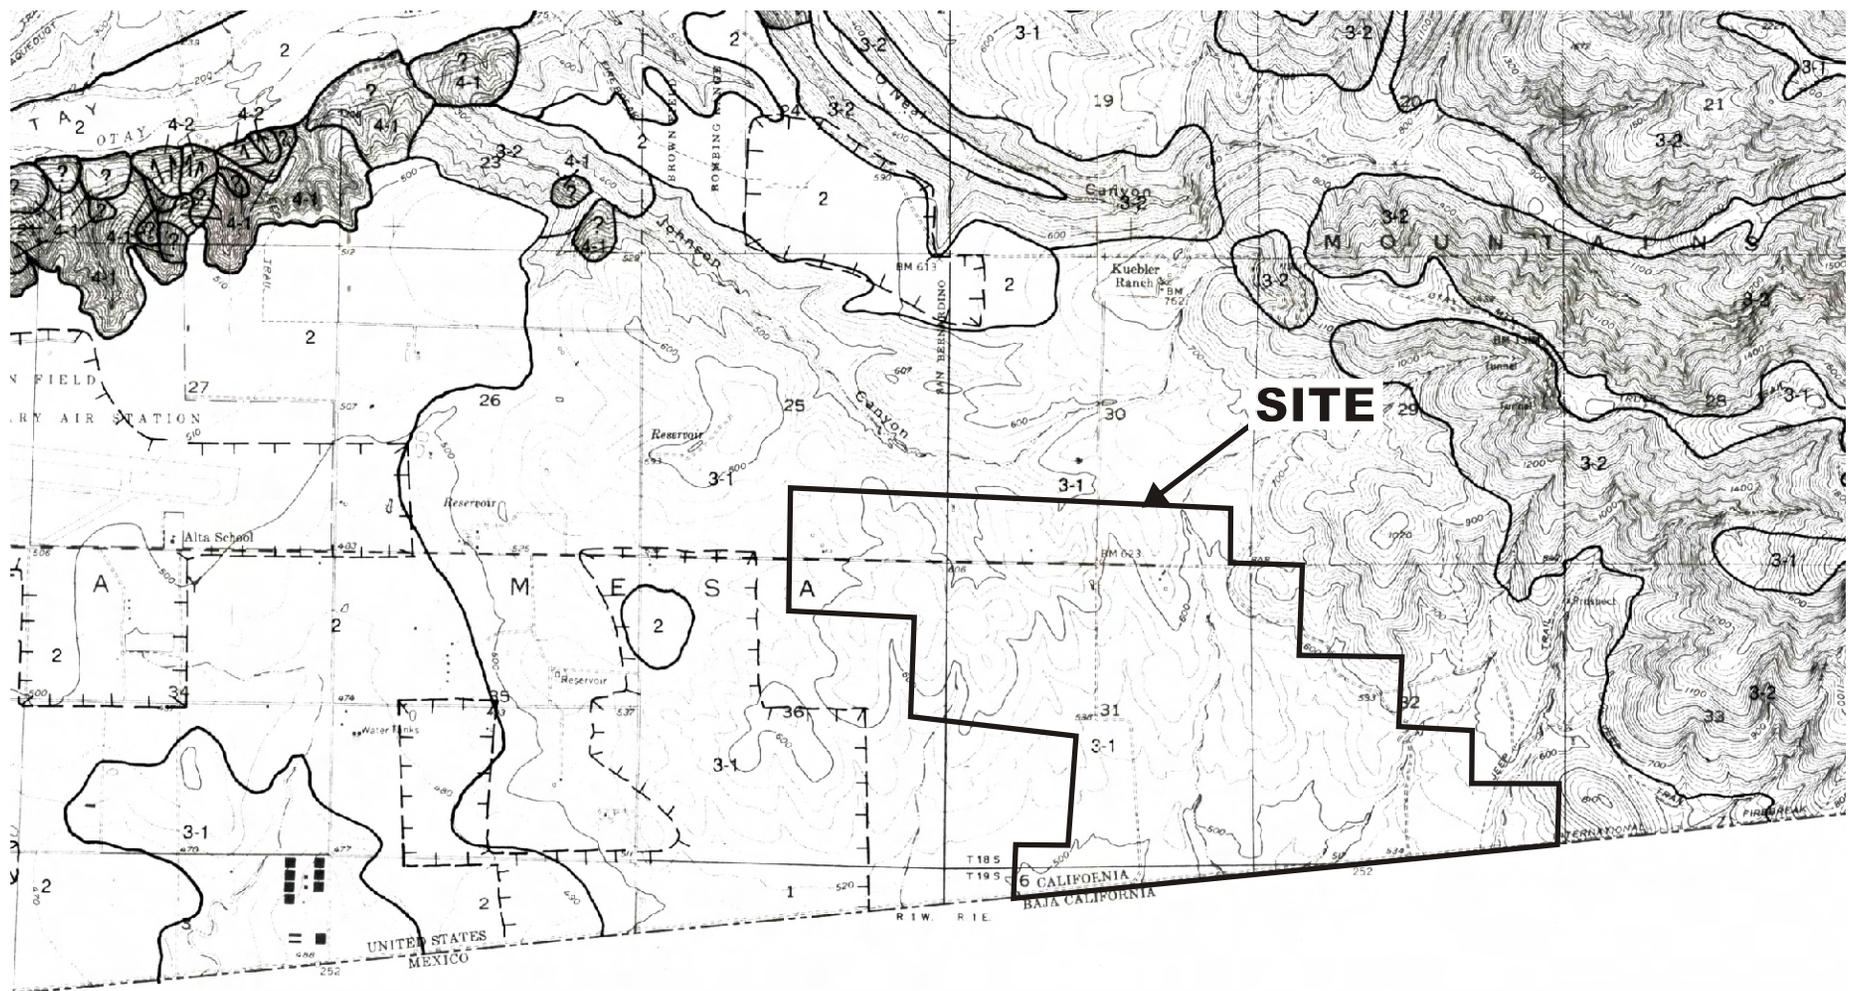
LEGEND	
	URBANIZED AREA BOUNDARY
	LANDSLIDE
	QUESTIONABLE LANDSLIDES

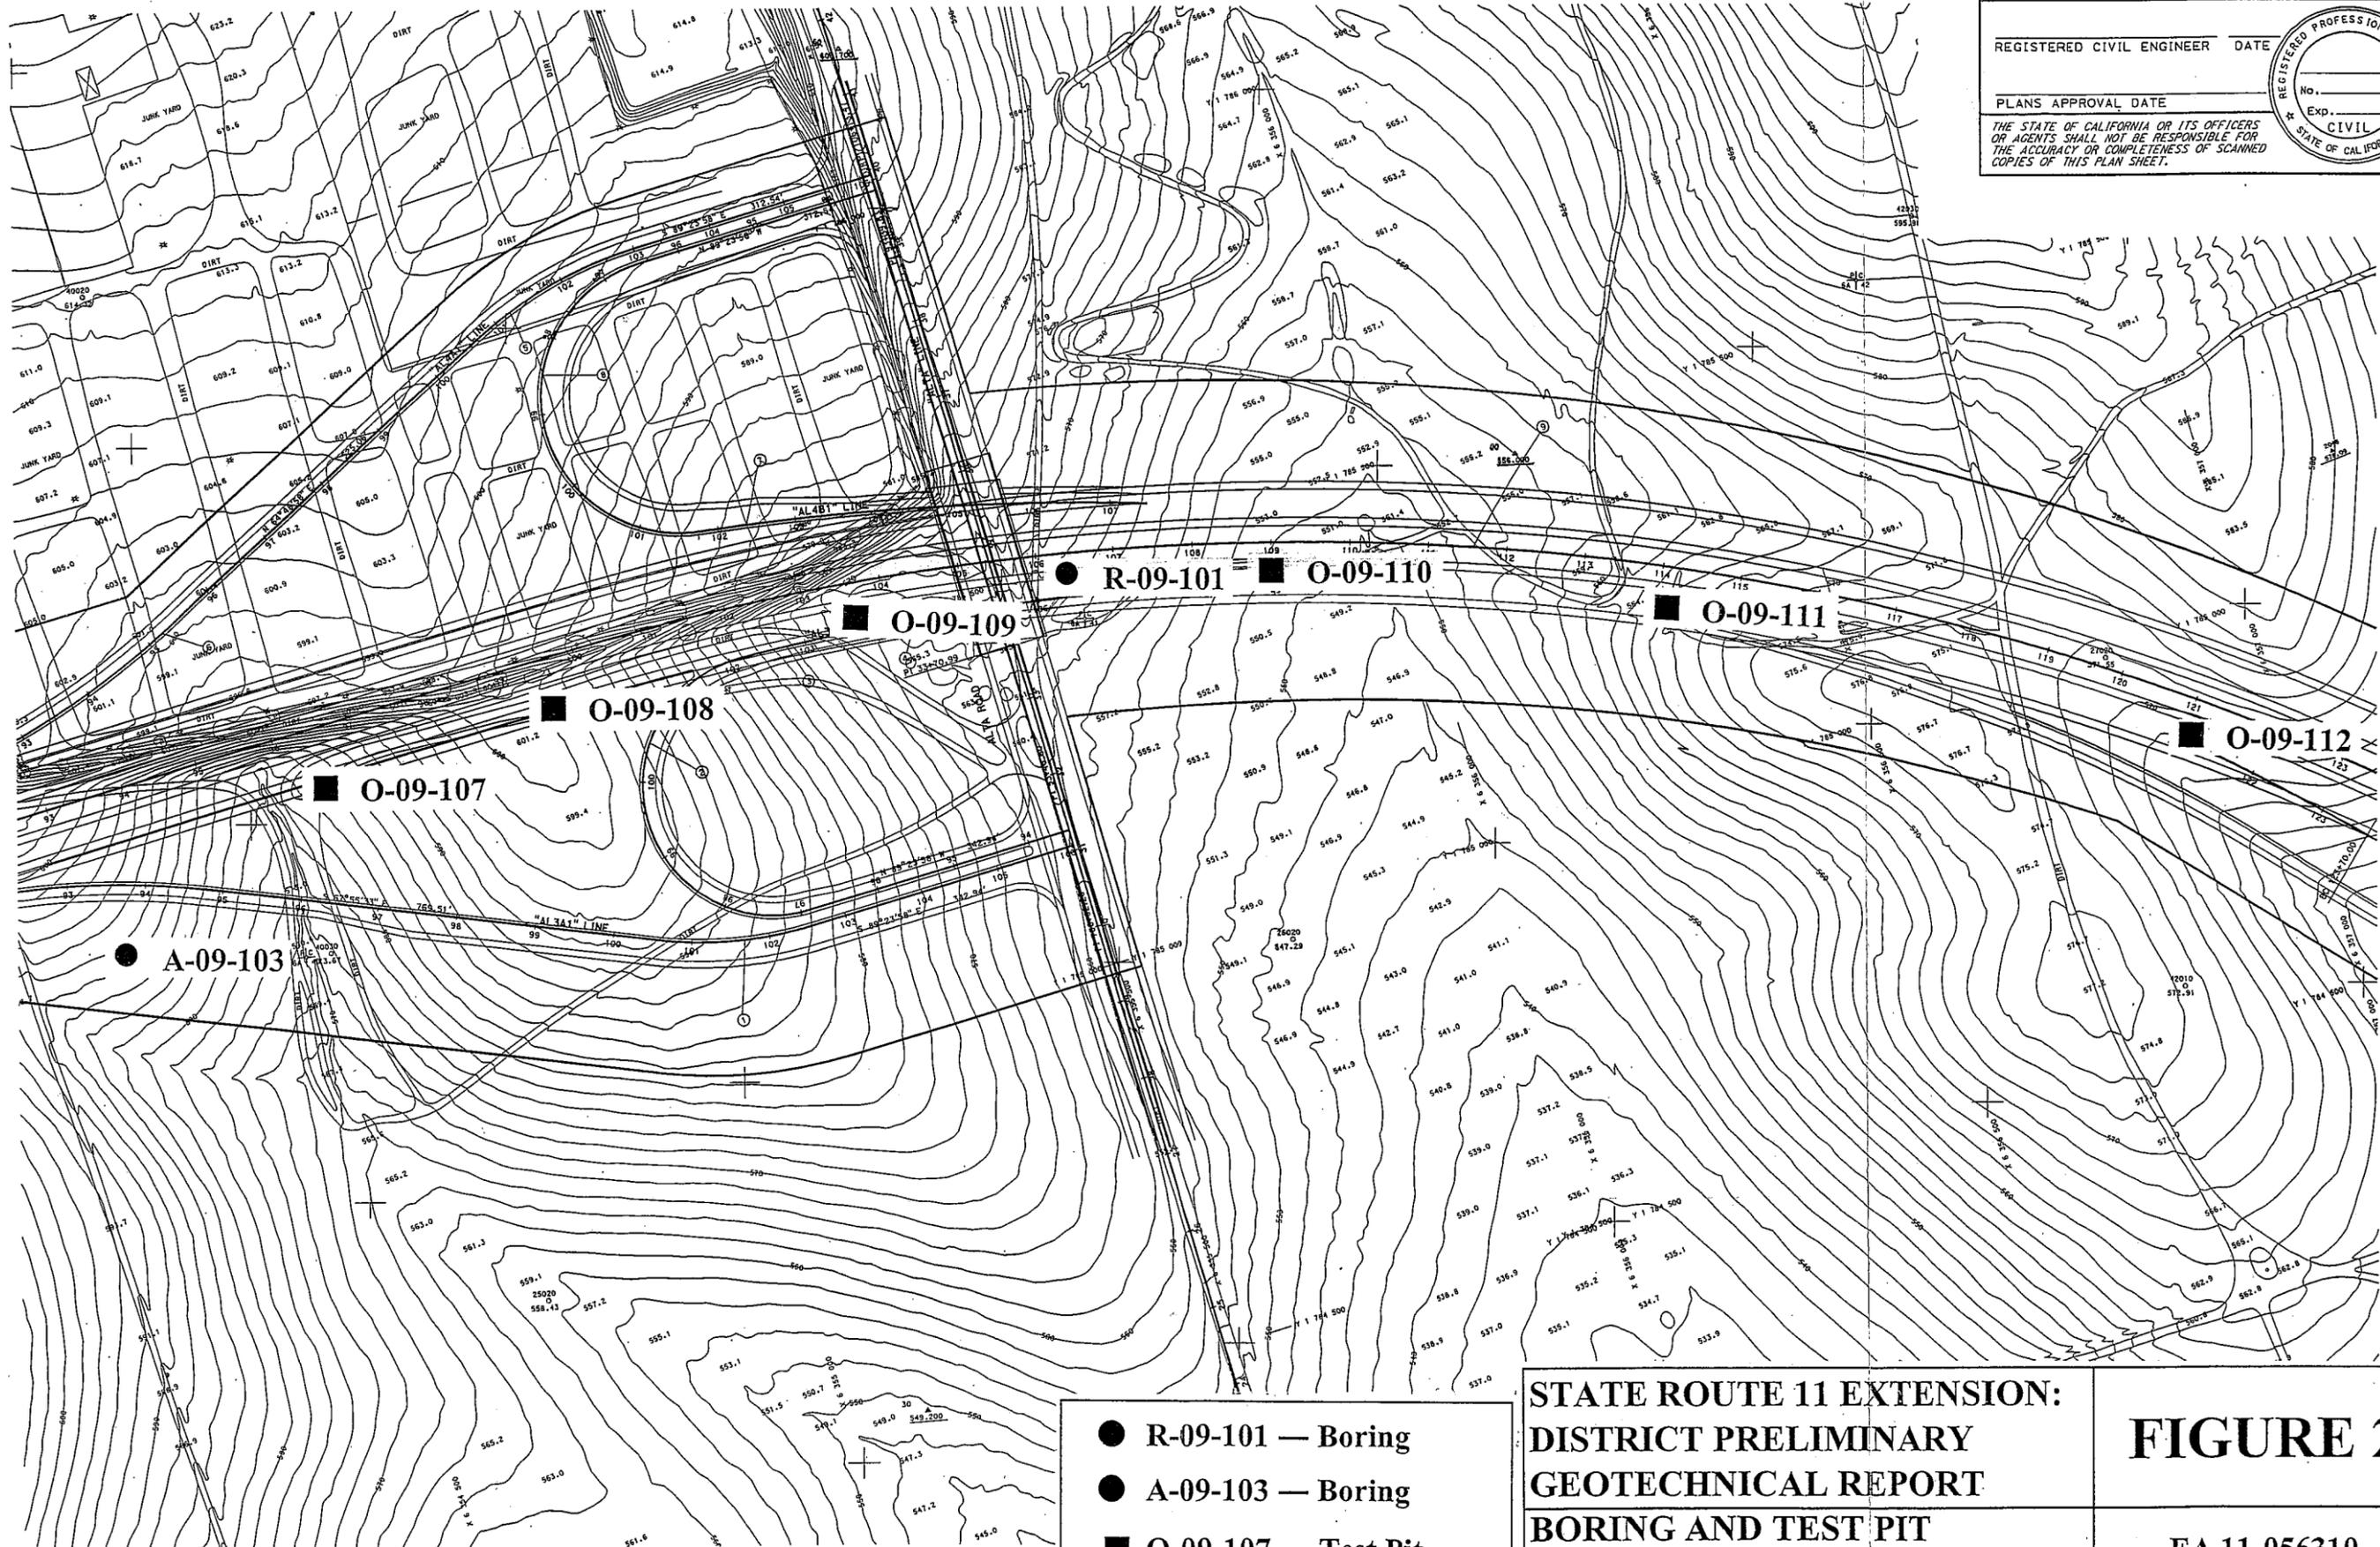
**STATE ROUTE 11 EXTENSION:  
DISTRICT PRELIMINARY  
GEOTECHNICAL REPORT  
BORING AND TEST PIT  
LOCATIONS**

- R-09-101 — Boring
- A-09-103 — Boring
- O-09-107 — Test Pit

1. Figure 1, Project Location
2. Figure 2, Boring Locations
3. Boring Records
4. Table 2, Subsurface soil conditions and estimated expansion potential at the locations of Test Pits

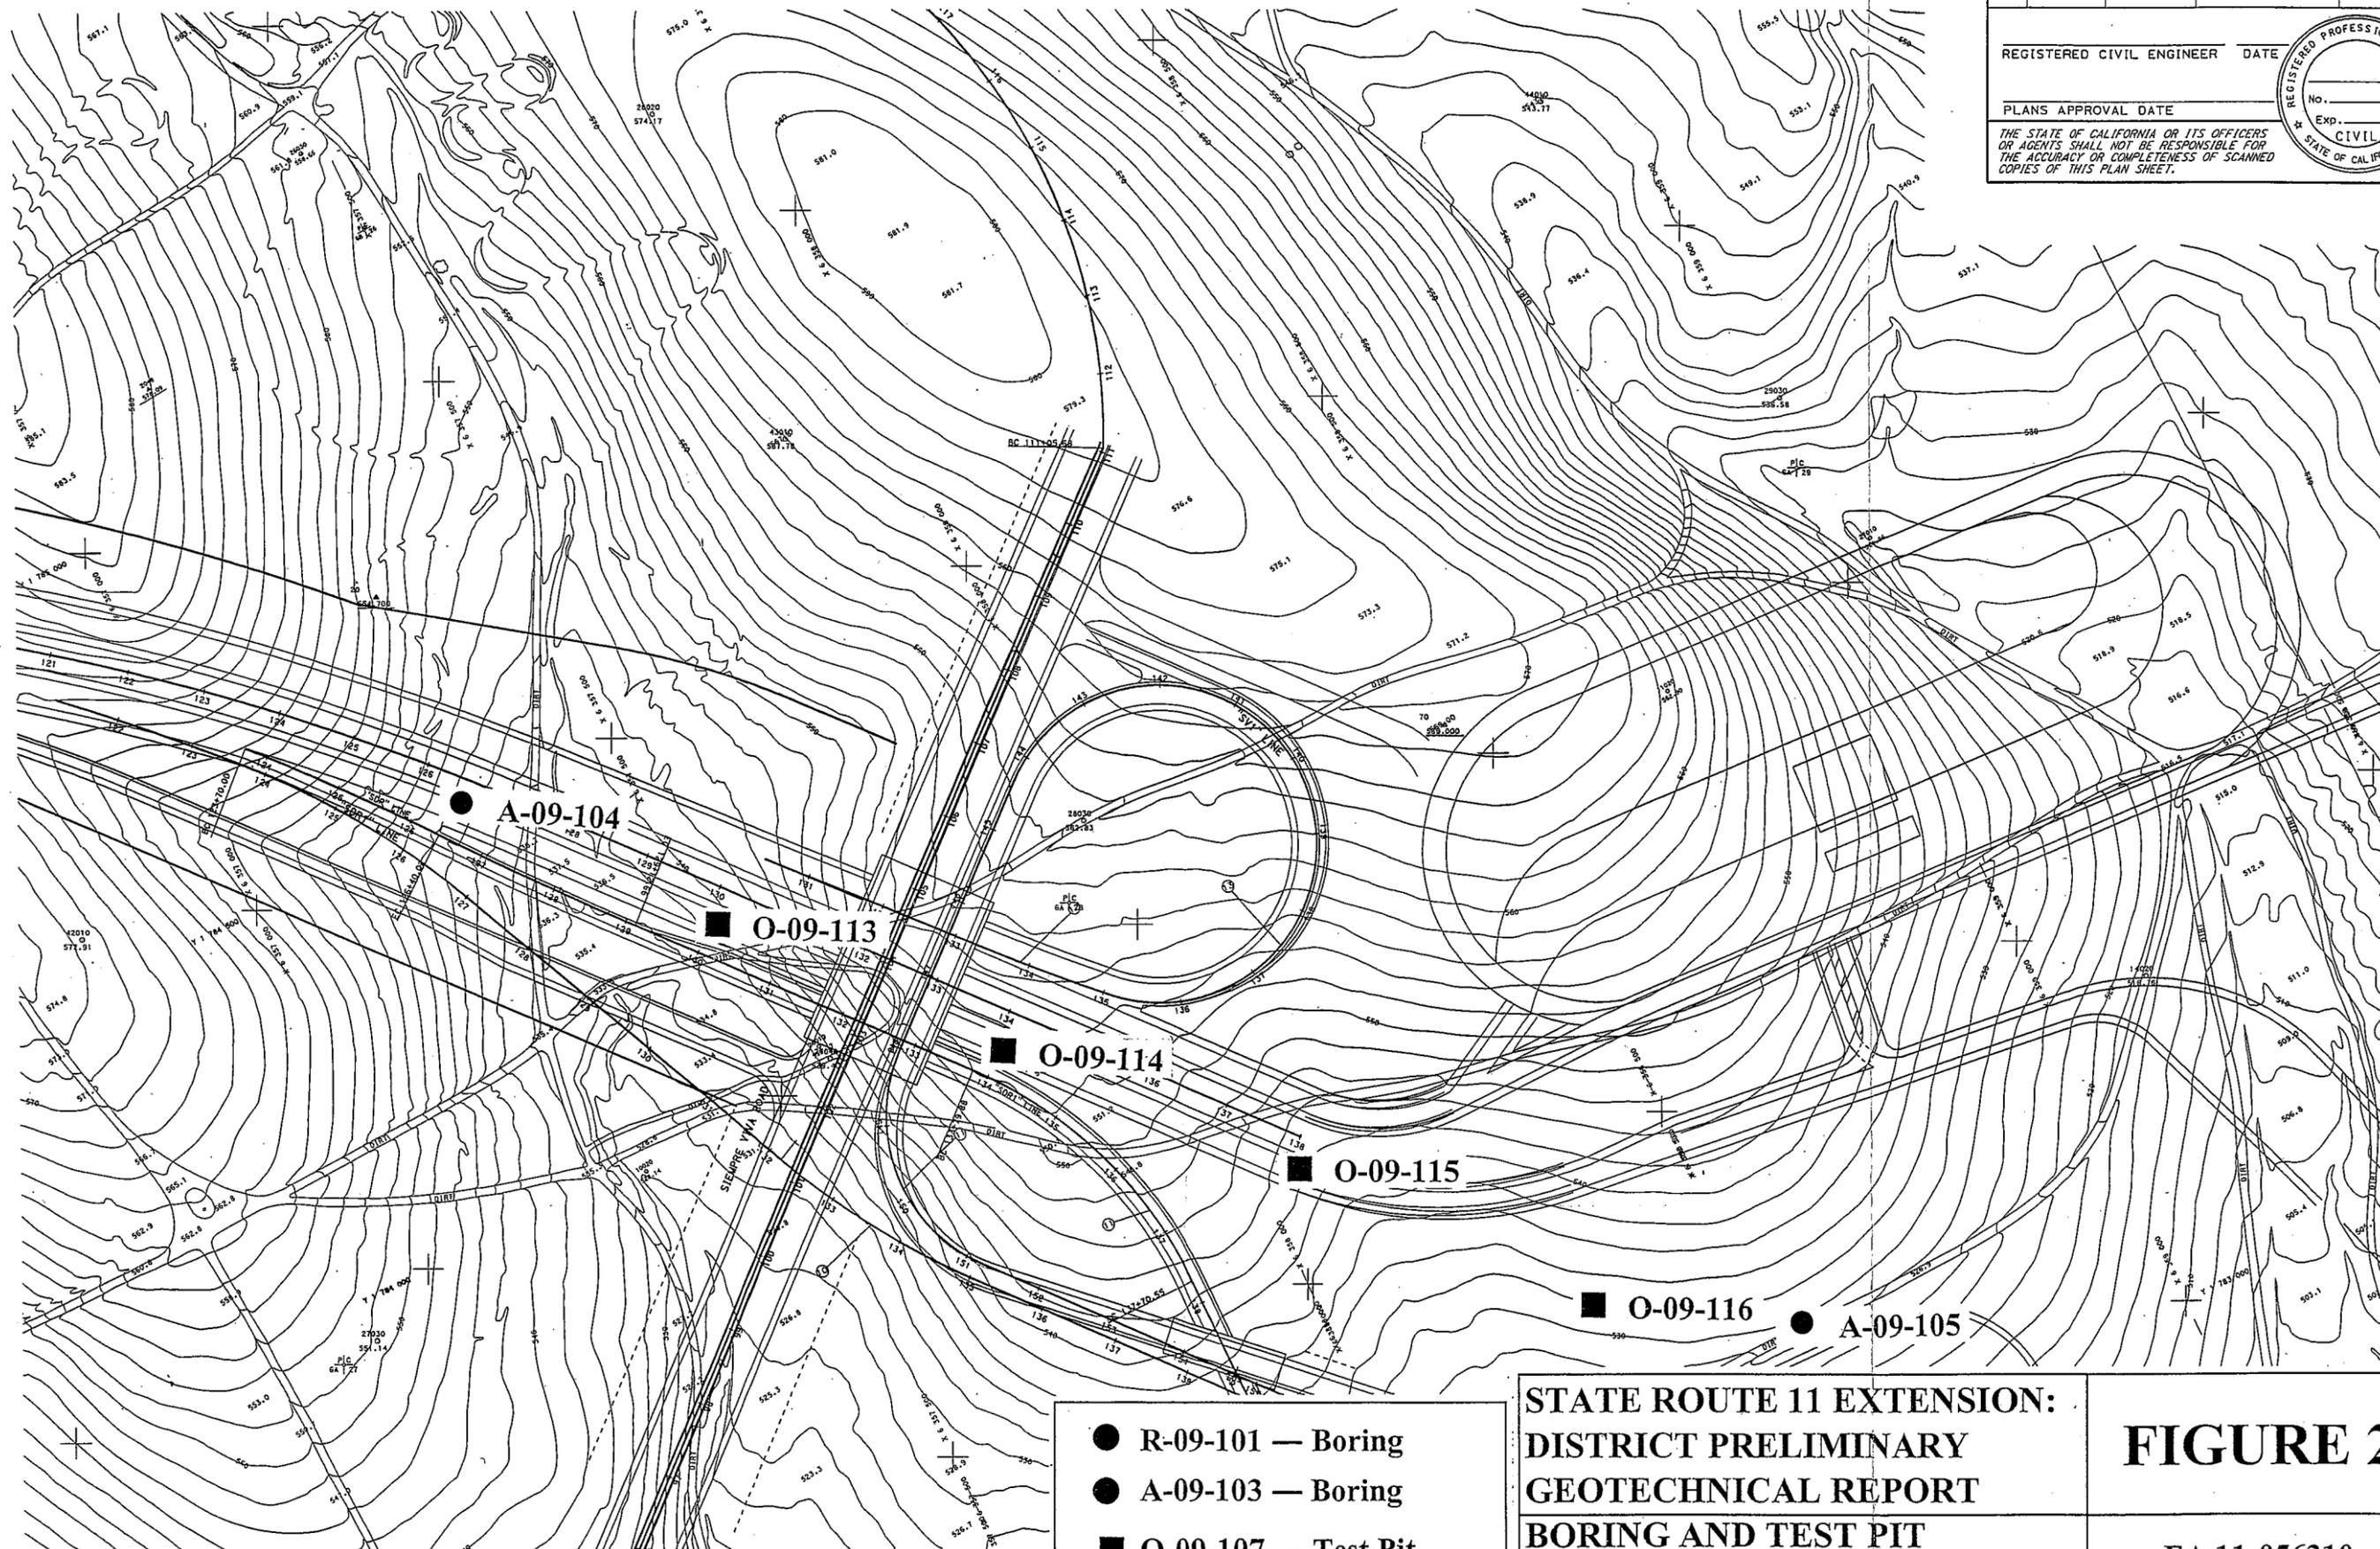
**STATE ROUTE 11 EXTENSION:  
 DISTRICT PRELIMINARY  
 GEOTECHNICAL REPORT  
 BORING AND TEST PIT  
 LOCATIONS**

- R-09-101 — Boring
- A-09-103 — Boring
- O-09-107 — Test Pit

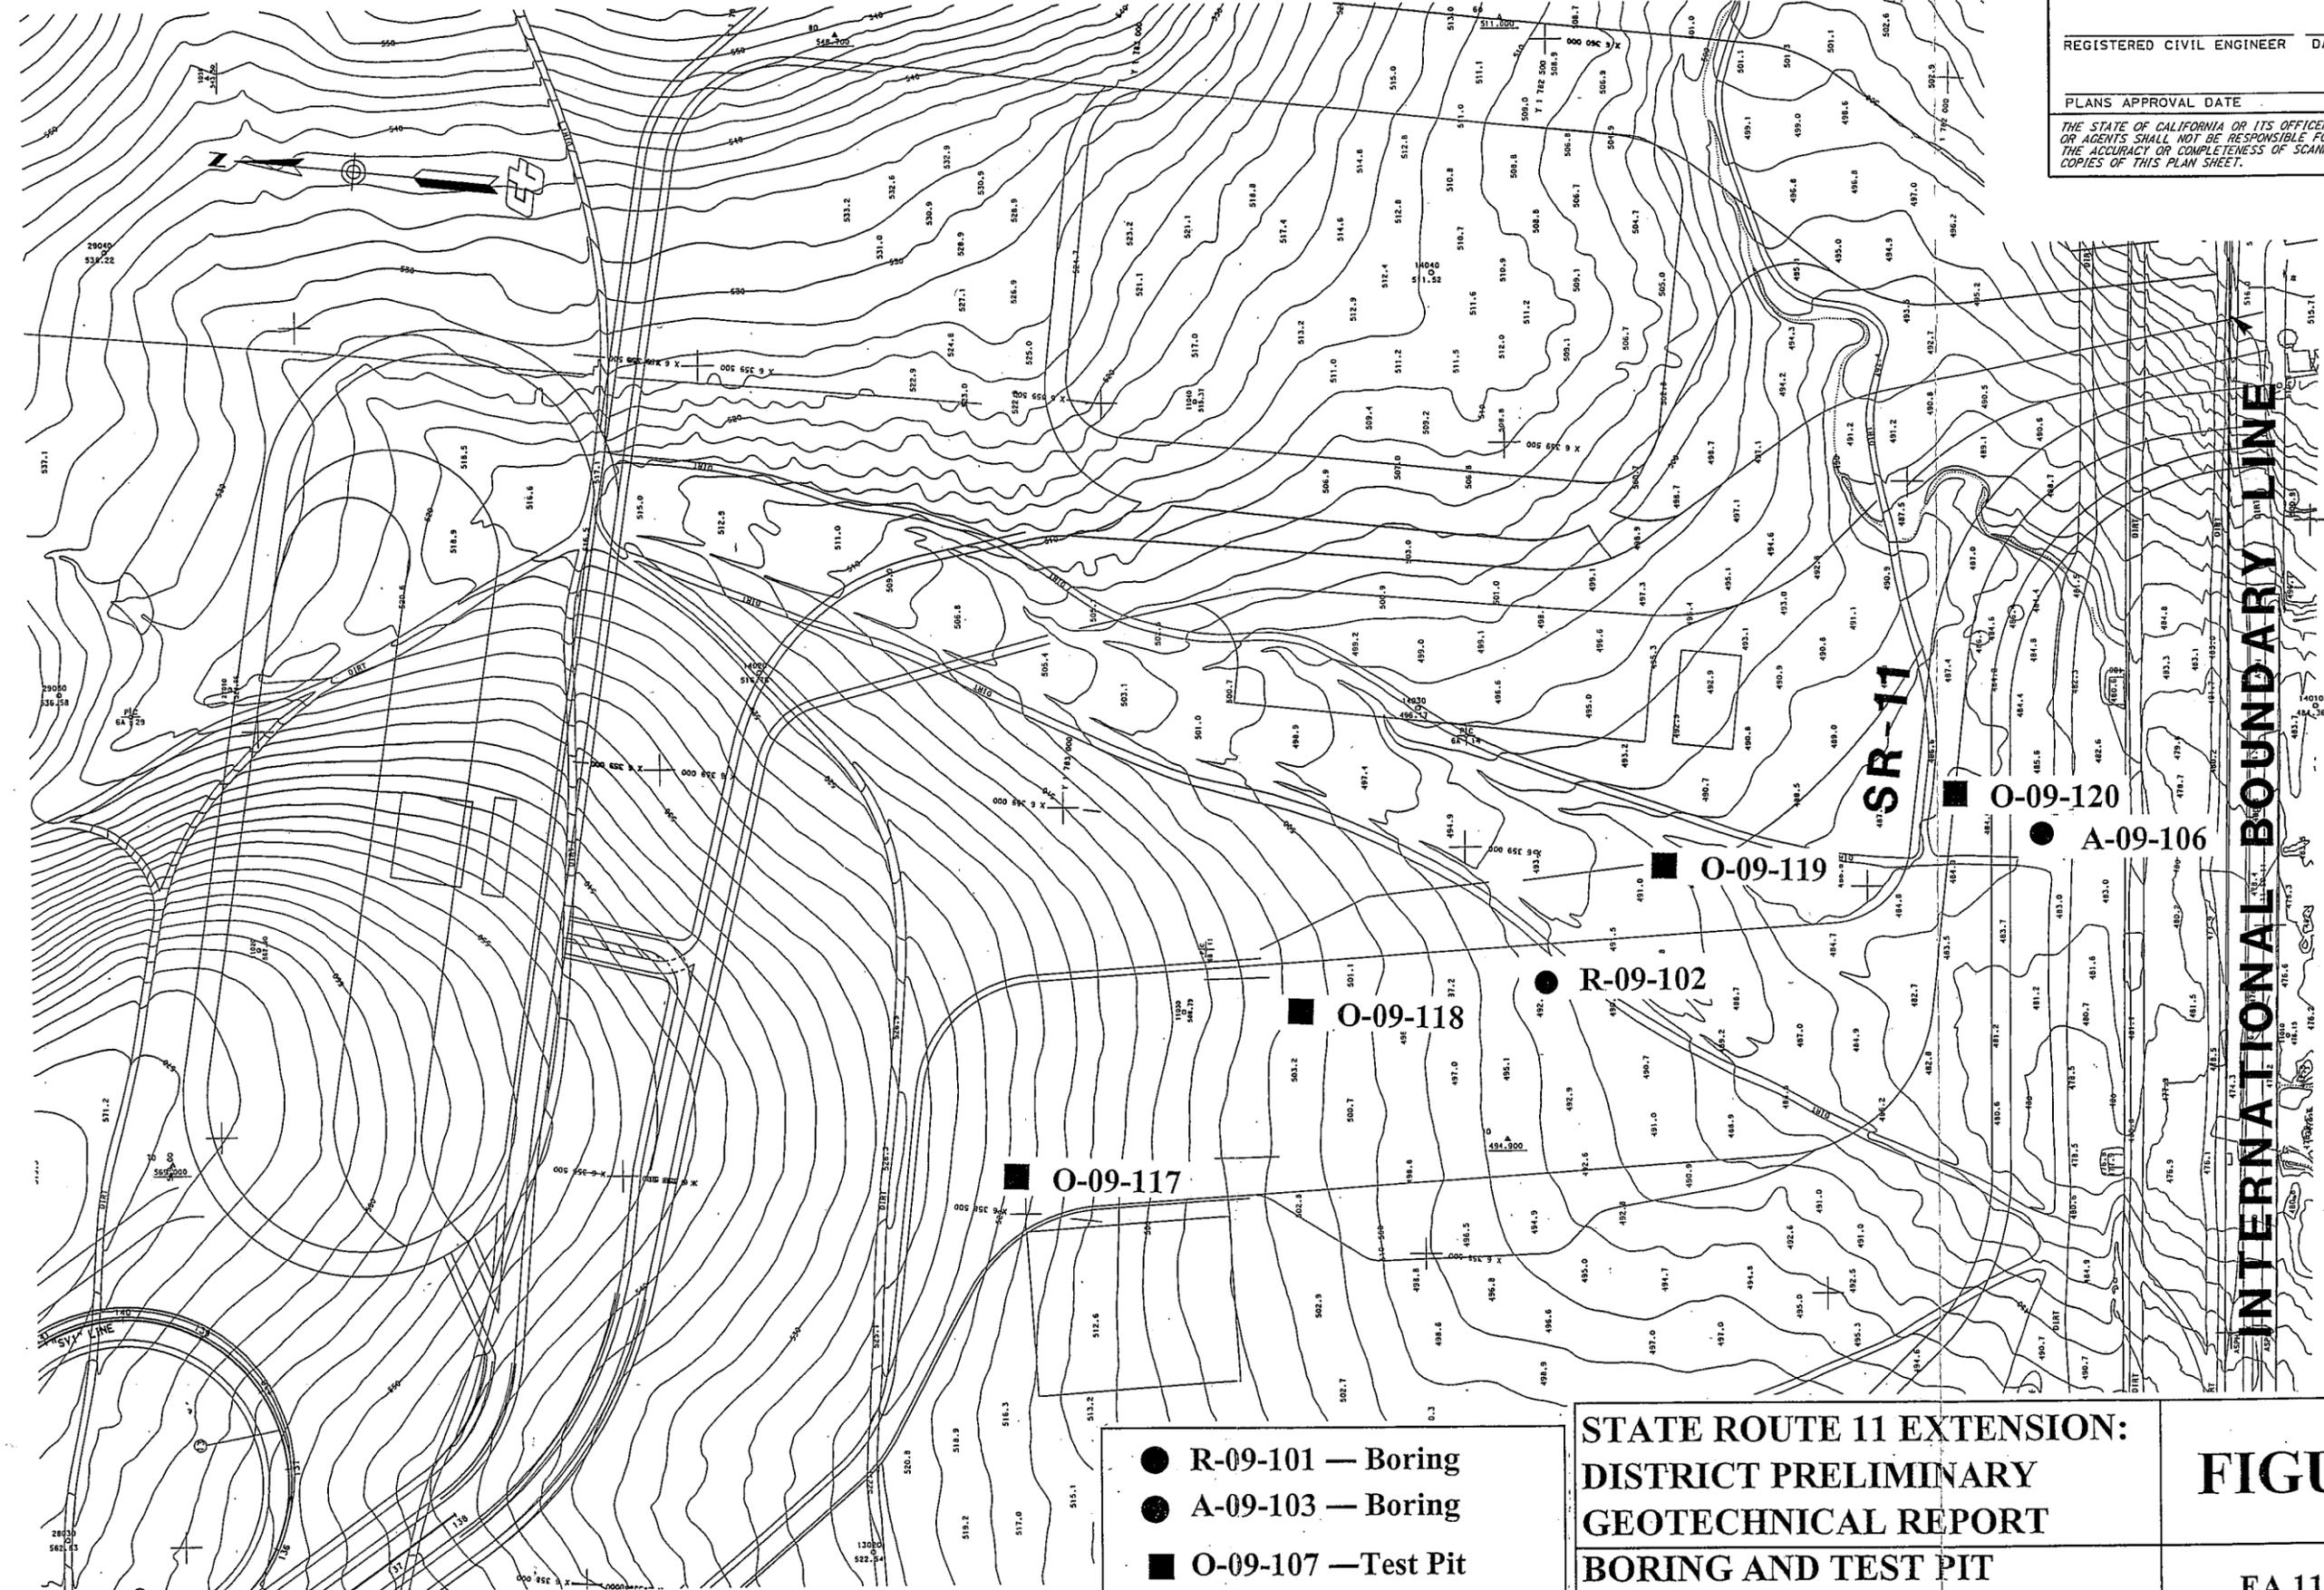
**STATE ROUTE 11 EXTENSION:  
DISTRICT PRELIMINARY  
GEOTECHNICAL REPORT  
BORING AND TEST PIT  
LOCATIONS**

- R-09-101 — Boring
- A-09-103 — Boring
- O-09-107 — Test Pit
