ENERGY ABSORBING HIGHWAY BARRIER MATERIALS INVESTIGATION

FINAL REPORT

FHWA-CA-TL-6405-77-17

JUNE 1977

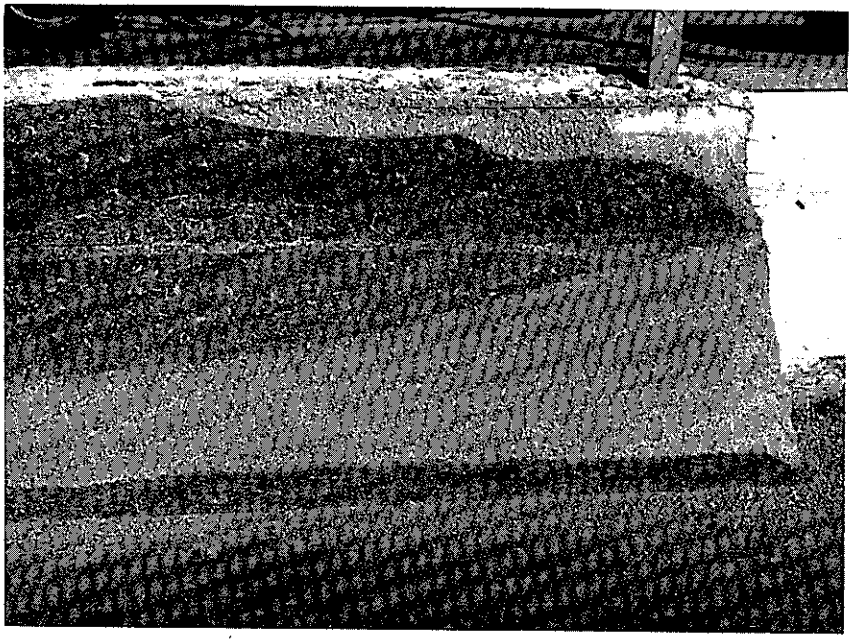
Figure 3 - Damage to Vermiculite Concrete Block From 12° (0.21 rad) Impact.

b. Test 2: 4900 lb./5 mph/12° (2222 kg/2.2 m/s/0.21 rad). The test vehicle approached the block in the same manner as in the first test except the approach angle was increased to about 12° (0.21 rad). The vehicle rode about 10 inches (254 mm) up onto the sloping face and dropped off the end of the block. The front quarter panel of the vehicle sustained some additional light scuffing damage. The vermiculite concrete test block was abraded to a depth of about 1/8 inch (3 mm) from tire scuffing and its downstream top edge was damaged as the test vehicle rode off the end, Figure 3.

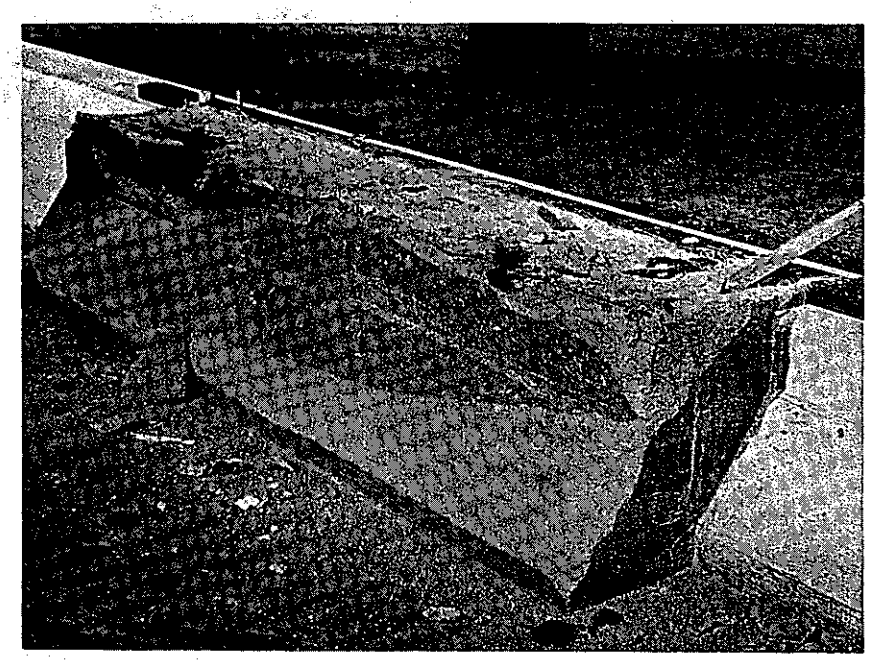
Figure 4 - Damage to Vermiculite Concrete Block From 25° (0.44 rad) Impact.

c. Test 3: 4900 lb./5 mph/25° (2222 kg/2.2 m/s/0.44 rad). The test vehicle approached the block as before at an angle of about 25° (0.44 rad). The left front wheel was forced to the left and rode up to the top of the block. There was no damage to the vehicle. The sloping face of the block was slightly abraded. The full length of the top front edge of the vermiculite block was damaged to a depth of about 1.5 inches (38 mm), Figure 4. The exposed vermiculite concrete was still damp, while the outside surface appeared dry.

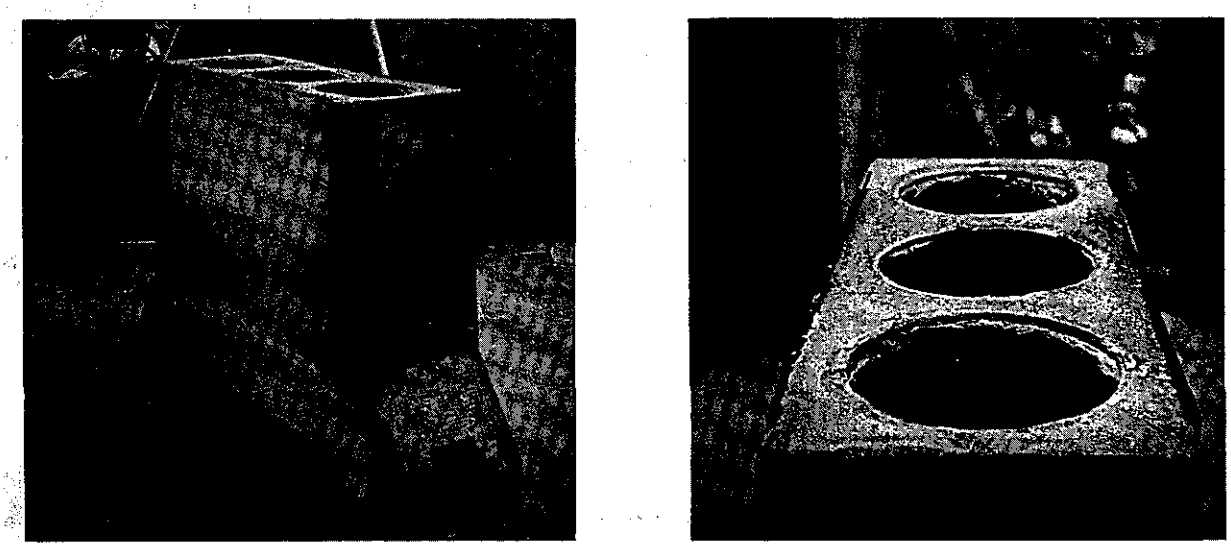
Figure 7 - First Full Size Precast Barrier Module

Some separation occurred between the vermiculite and the plywood diaphragms at the top edges of the barrier. This problem was corrected in the second module by bolting the diaphragms to the sonotube void forms.

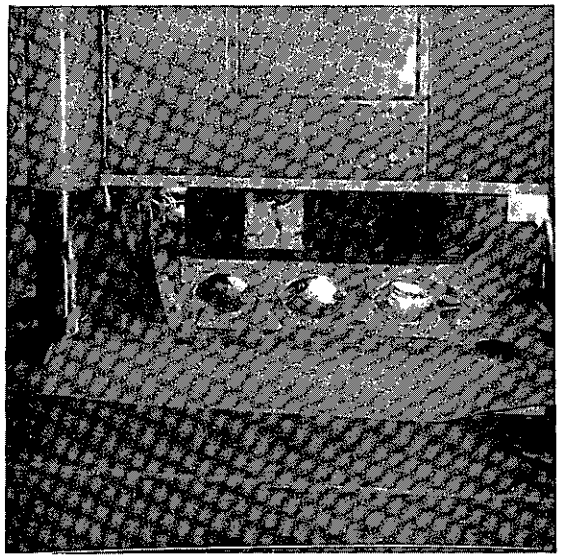
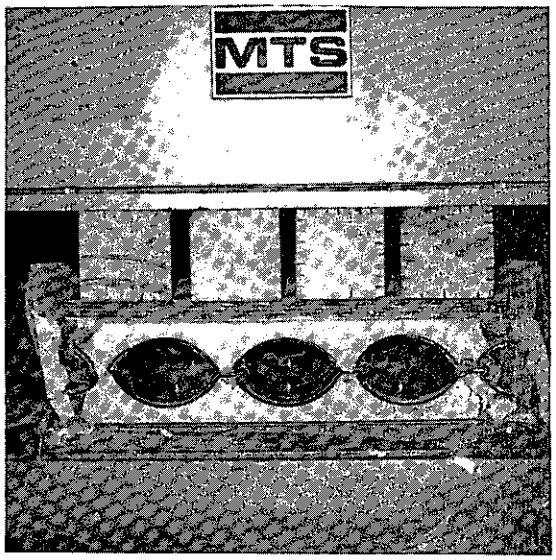
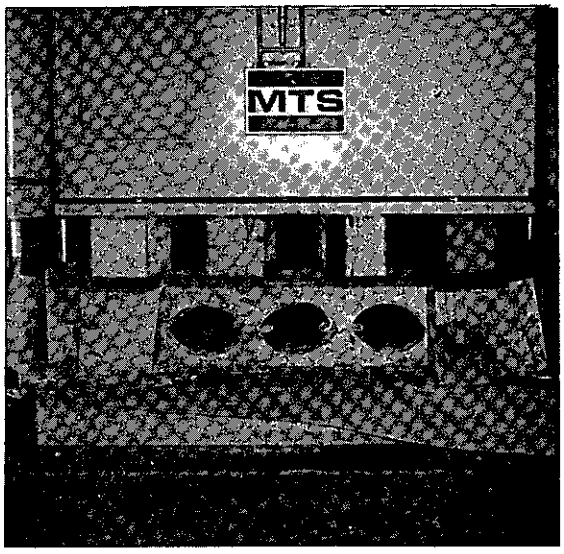
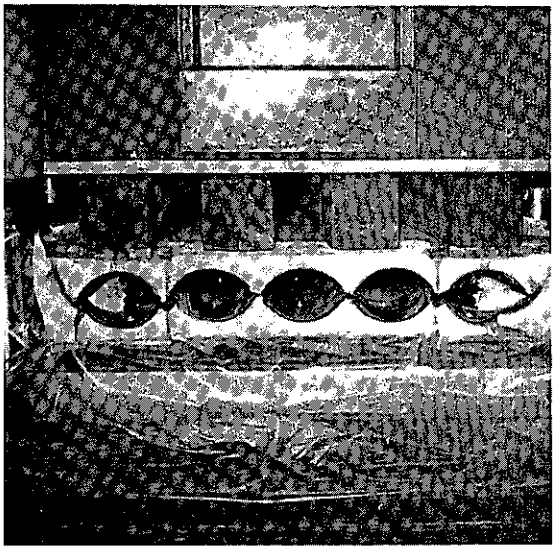
Figure 17 shows the failure modes of the modules during their static compression tests.

First Module Design = 41,210 foot - pounds (55.9 kJ)
Second Module Design = 32,100 foot-pounds (43.5 kJ)

The static energy absorbed by the second module came closest to the anticipated design energy of about 30,000 ft-lbs (40.7 kJ). This module would have been used in the back rows of a crash cushion. More crushable modules, capable of absorbing about 15,000 ft-lbs (20.3 kJ) of static energy, were to be used for the front half of the barrier.

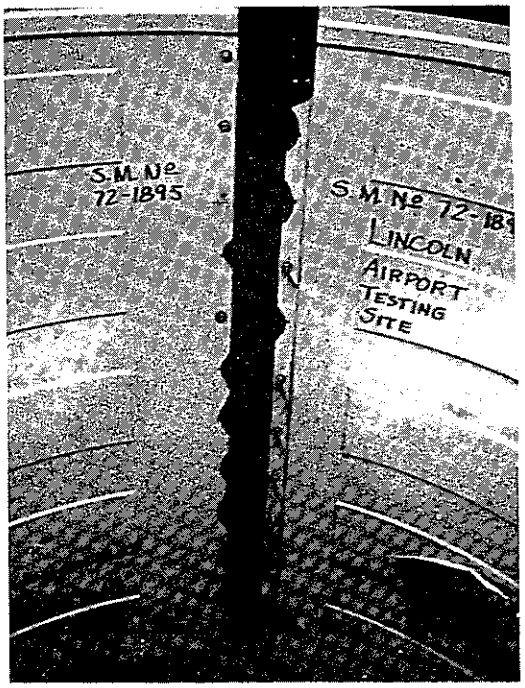
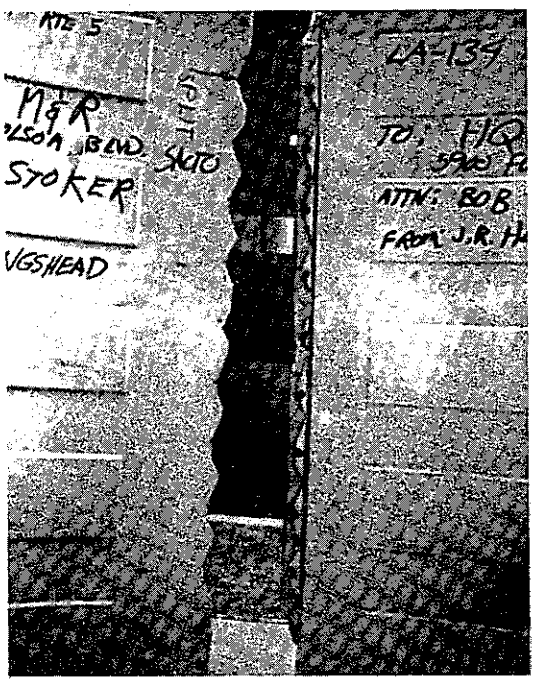
Figure 1 - Riveted Seam Failures

The plastic barrels are cast as two half-cylinders with a one inch overlap at the vertical seams. The overlapping seams are fastened by 3/16 inch (5 mm) diameter pop rivets on three inch (76 mm) centers.
