2.1.5 Visual/Aesthetics

The information presented in this section is based upon the analysis presented in the Visual Impact Assessment report (Parsons, 2007d) prepared for the proposed project.

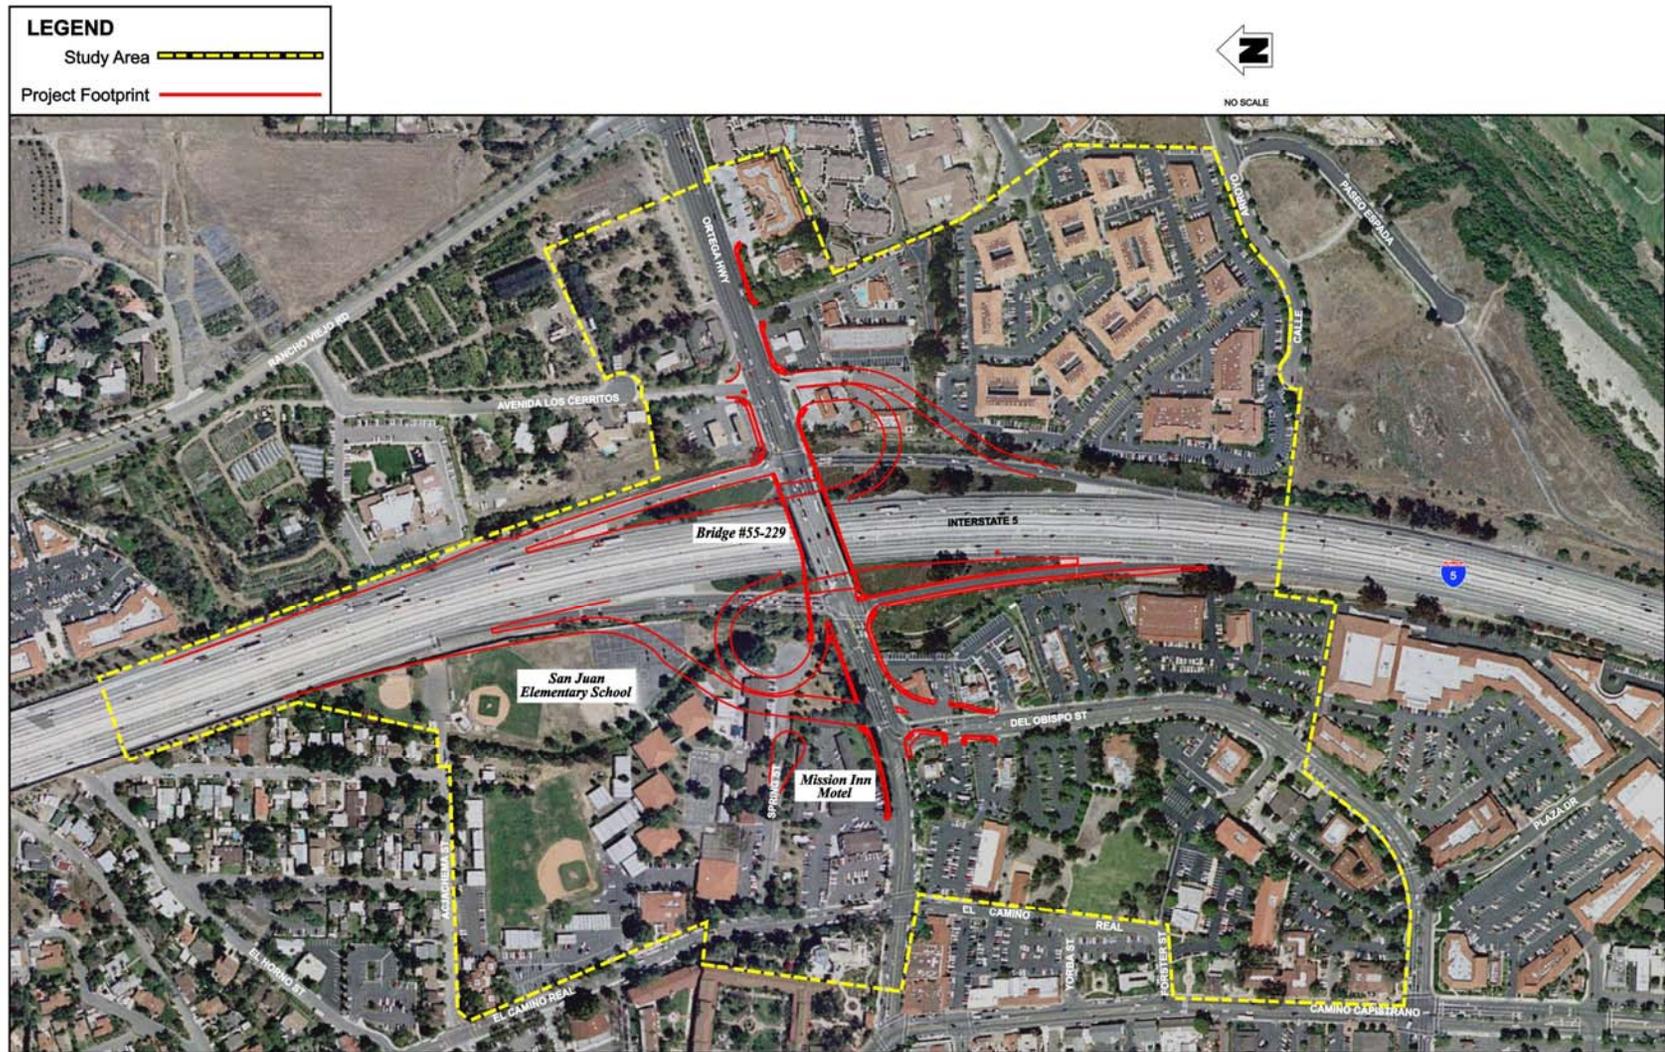
Figure 2.1.5-1
Study Area Visual Assessment

The approach used to assess the visual and aesthetic impacts of the proposed project is based on the FHWA guidelines for Visual Impact Assessment for Highway Projects (FHWA, 1981). This report also identifies important “key views” that would potentially be altered by the proposed project (see Figure 2.1.5-1 for Key Viewpoint Locations).

The project is located in a typical community for this portion of southern California. There is dense suburban-level development with some open/redeveloping sites still in the process of conversion. The development patterns are suburban, with low-rise office buildings that are typically two to three stories, commercial areas with large parking lots, and single-family homes on small lots. The surrounding hills appear undeveloped and provide a visual counterpoint to the manmade developments in the valley areas below. Figure 2.1.5-1 shows the study area for the visual assessment.

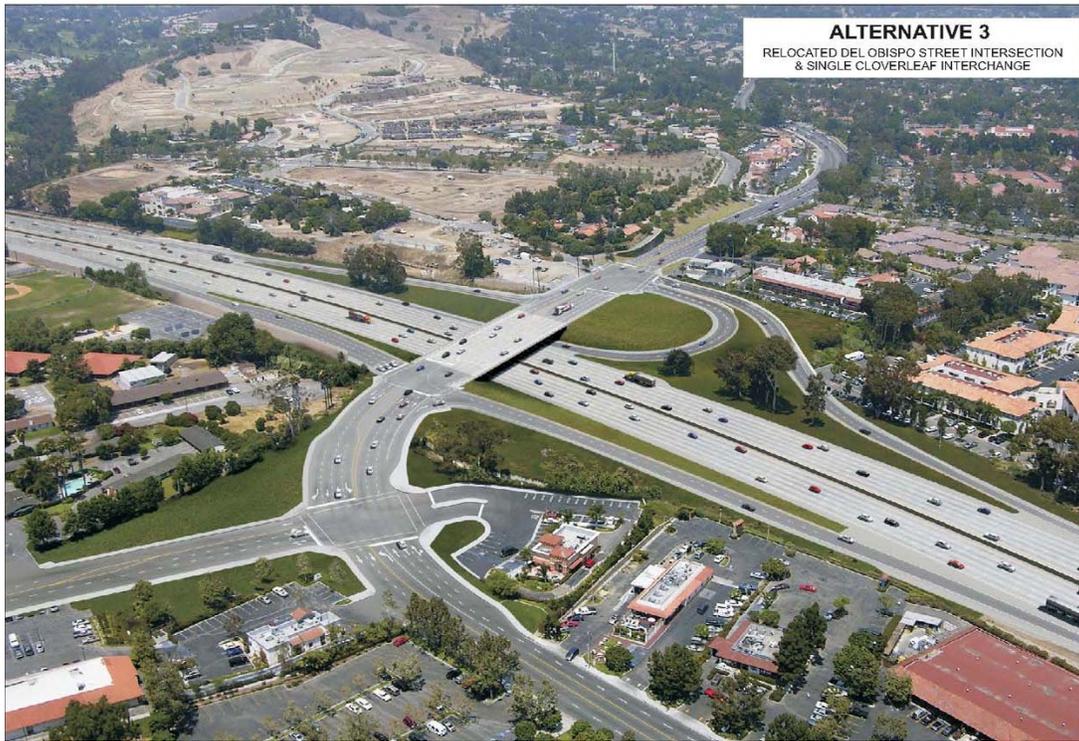
**Figure 2.1.5-2
Alternative 3 Aerial View of Proposed Improvements**

Alternative 3. Replacement of the Ortega Highway bridge would most likely not be visually apparent because the proposed changes would not be a big deviation from the existing. While the bridge would be slightly higher and longer, when viewed in whole from a vantage point on the freeway, the changes would be small.

Vividness¹ of the reconfigured interchange would be consistent and remain essentially the same. Given the increase in landscape areas, the intactness² and unity of the interchange as a composition could increase, depending on the treatments applied. As far as expectations of freeway and interchange users, the interchange would be consistent with the lines and images of the freeway/interchange. Residents and business owners/employees would see the changes as moderate and requiring some mitigation because the size of the interchange within the City would be visually larger. Figure 2.1.5-2 shows a visual simulation of Alternative 3.

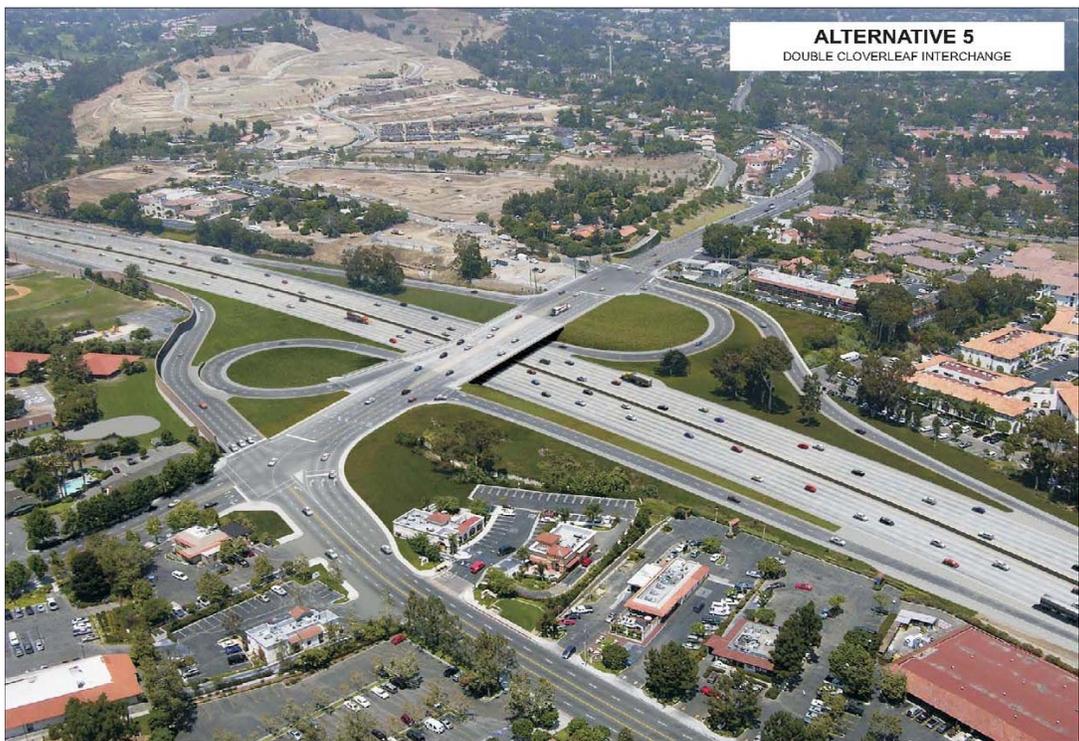
**Figure 2.1.5-3
Alternative 5 Aerial View of Proposed Improvements**

Travelers on Ortega Highway would notice more open views, but the west side would remain essentially the same west of Del Obispo Street. Residents and business owners/employees would see the aggregated changes as moderate and requiring some mitigation because the size of the interchange within the City would be visually larger. School users would see the changes as moderate to moderately high, requiring many mitigation measures. Figure 2.1.5-3 shows a visual simulation of Alternative 5.
