# Memorandum

File: 4-CC-24-PM 5.1/5.6  
04 – 3G1601  
Efis-0412000004-1  
Slope Stressing

Subject: Foundation Report for the Proposed Slope Stressing

This memorandum presents our geotechnical recommendations for the design of the proposed slope stressing to address the existing landslides for the above referenced project.

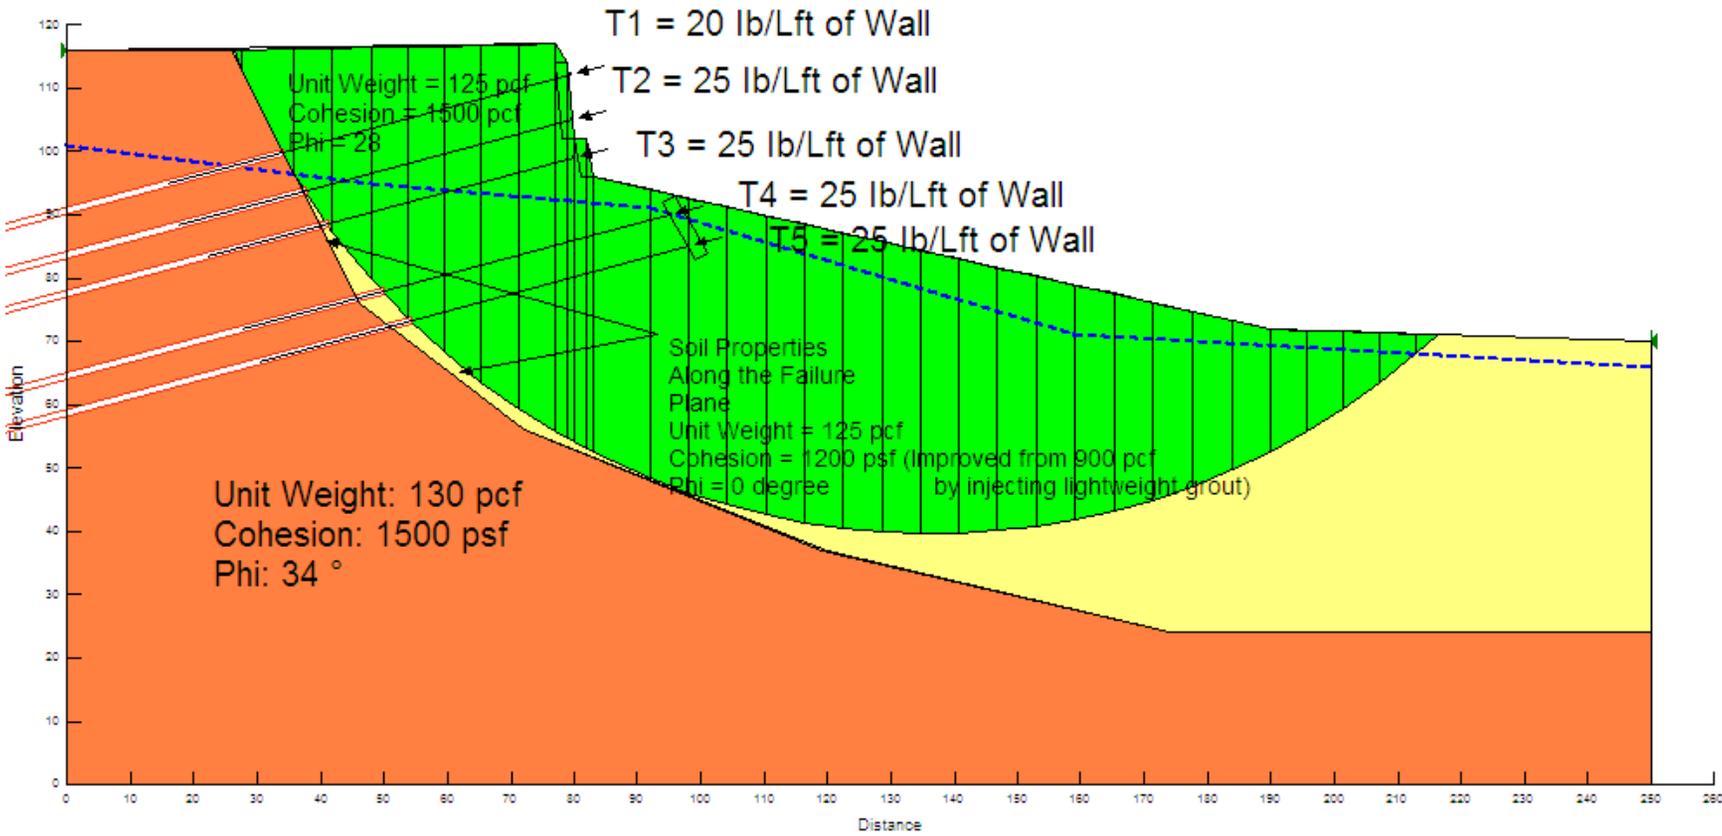
CC 24 PM 5.4  
 Risa Road Slope Stressing  
 04 - 3G1601  
 June 1, 2013

Seismic Case

- The minimum factor of safety with seismic loading (pseudo-static):  $FOS_{dynamic} = 1.0$ ; a horizontal pseudo-static coefficient of 0.20 g was used to simulate seismic loading conditions.
- The maximum spacing of the nails ( $S_v \times S_h$ ),
