**SUBCONTRACTOR REPORTS  
FINAL GEOTECHNICAL  
SITE CHARACTERIZATION**

**SAN FRANCISCO-OAKLAND BAY BRIDGE  
EAST SPAN SEISMIC SAFETY PROJECT**

**VOLUME 2 OF 3  
(GeoTest Unlimited)**

Letter Report  
San Francisco Oakland Bay Bridge  
East Span Replacement Project  
Rock Testing Program

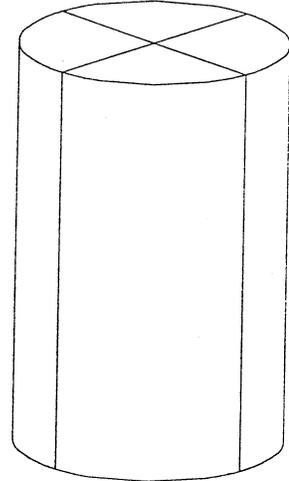
Comments: Failed by shear parallel to bedding & some splitting.

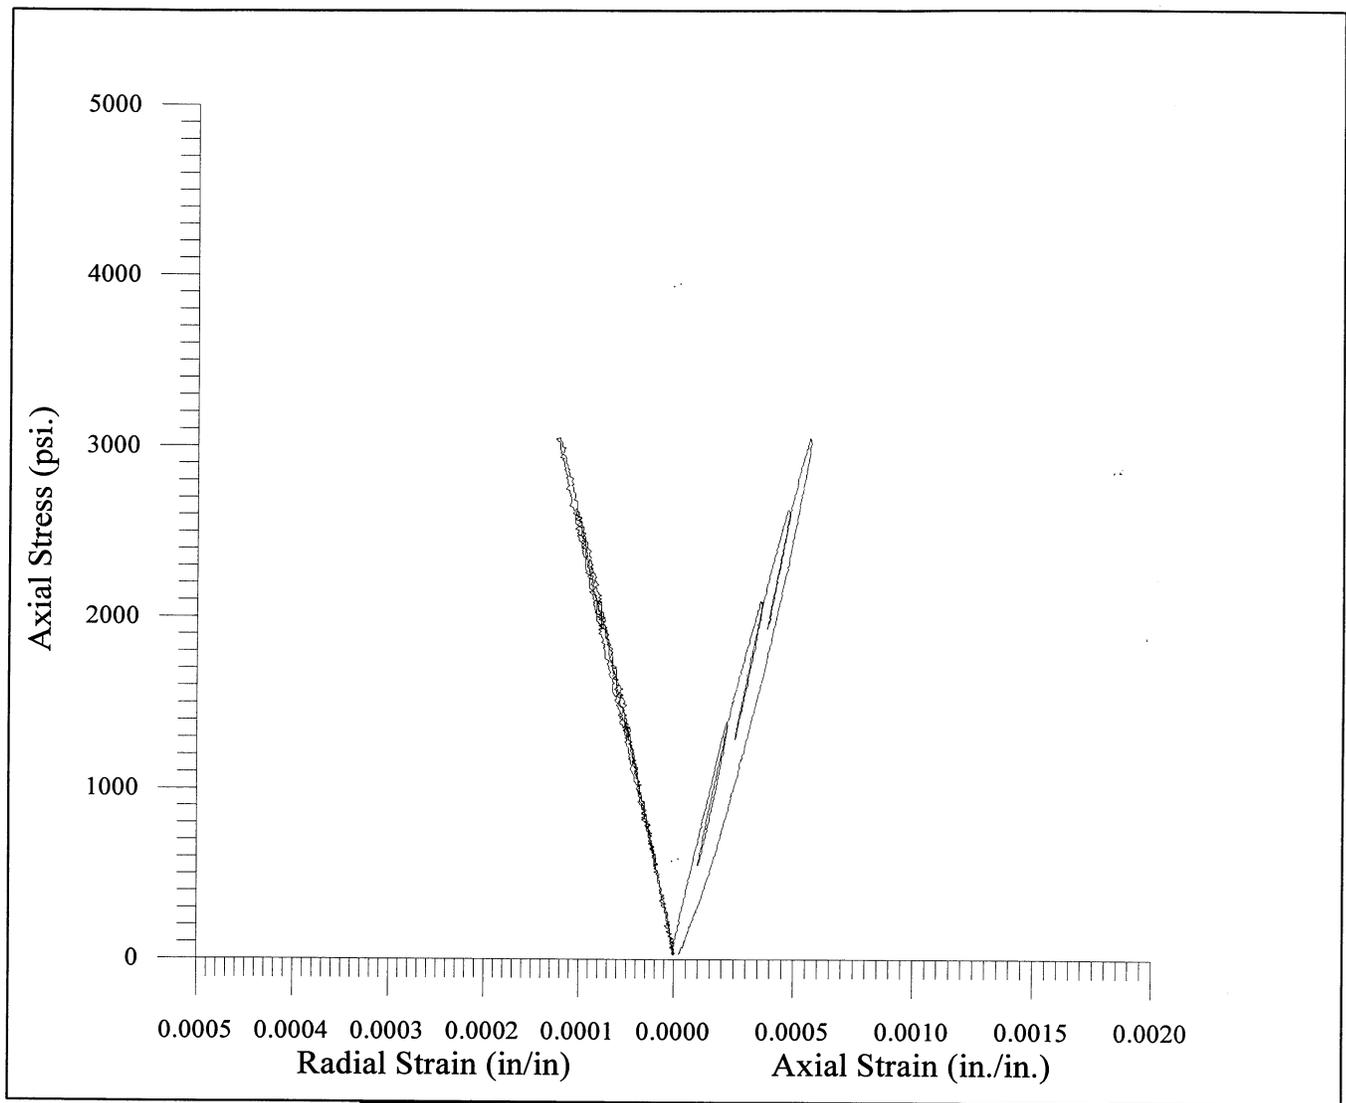
**ELASTIC MODULUS TEST**  
**Axial Stress vs. Axial & Radial Strain**

<p><b>SAMPLE ID:</b> Boring: 98-21  Sample: 26a  Depth: 72.5'</p> <p style="text-align: center;"><b>DESCRIPTION</b></p> <p>Medium gray sandstone with small claystone chips creating a bedded appearance with bedding about 45 degrees to the core axis.</p> <p><b>MODULUS:</b> 6,940,000 psi</p> <p><b>POISSON'S RATIO:</b> .27</p>	<div style="text-align: center;">

Sample ID	Depth (ft)	Description	Density (kN/m <sup>3</sup> ) (pcf)	UC Strength (Mpa) (psi)	Modulus (Gpa) (x10 <sup>6</sup> psi)	Poisson's Ratio
26a	72.5	Medium gray sandstone with small claystone chips creating a bedded appearance with bedding about 45 degrees to the core axis.	27.28 (167.3)	78.78 (11,426)	47.84 (6.94)	.27
29a	83	Dark gray claystone with a few irregular sandstone lenses. Contains many calcite healed hairline fractures parallel to the bedding about 53 degrees to the core axis.	26.47 (168.5)	26.11 (3787)	28.75 (4.17)	.35
31a	97	In one sample half, dark gray fine sandy siltstone and siltstone interbedded with claystone. The other half consists of claystone. Bedding about 25 degrees to the core axis.	26.36 (167.8)	36.10 (5236)	44.20 (6.41)	.29
32a	106.5	Medium gray bedded sandstone with a long claystone flake and two calcite healed bedding plane fractures, and many calcite healed fractures perpendicular to the bedding (50 degrees to the core axis).	26.30 (167.4)	60.38 (8757)	49.99 (7.25)	.22

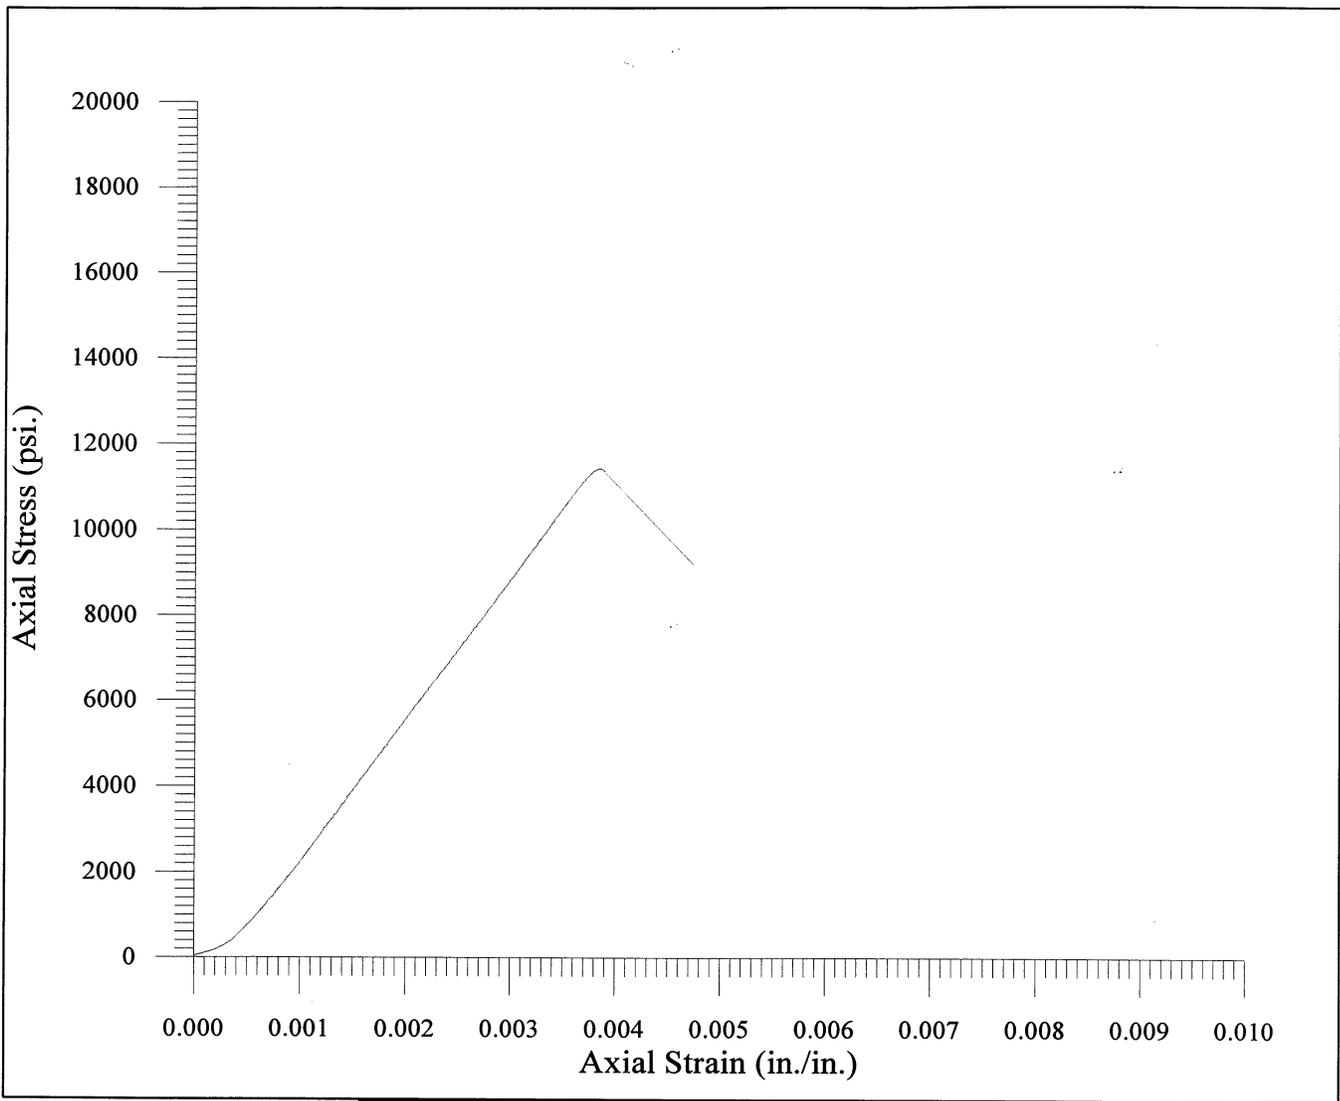
**UNCONFINED COMPRESSION TEST  
Axial Stress vs. Axial Strain**

<p><b>SAMPLE ID:</b> Boring : 98-21 Sample: 26a Depth: 72.5'</p>	<p align="center"> <i>Geo</i>

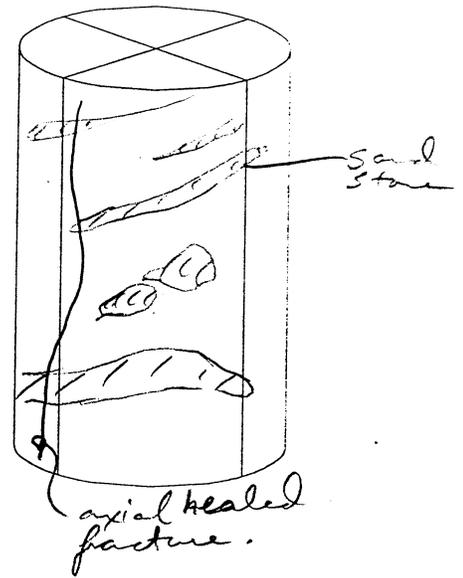
Comments: failed in shear along calcite  
healed hair line fractures, and by splitting.

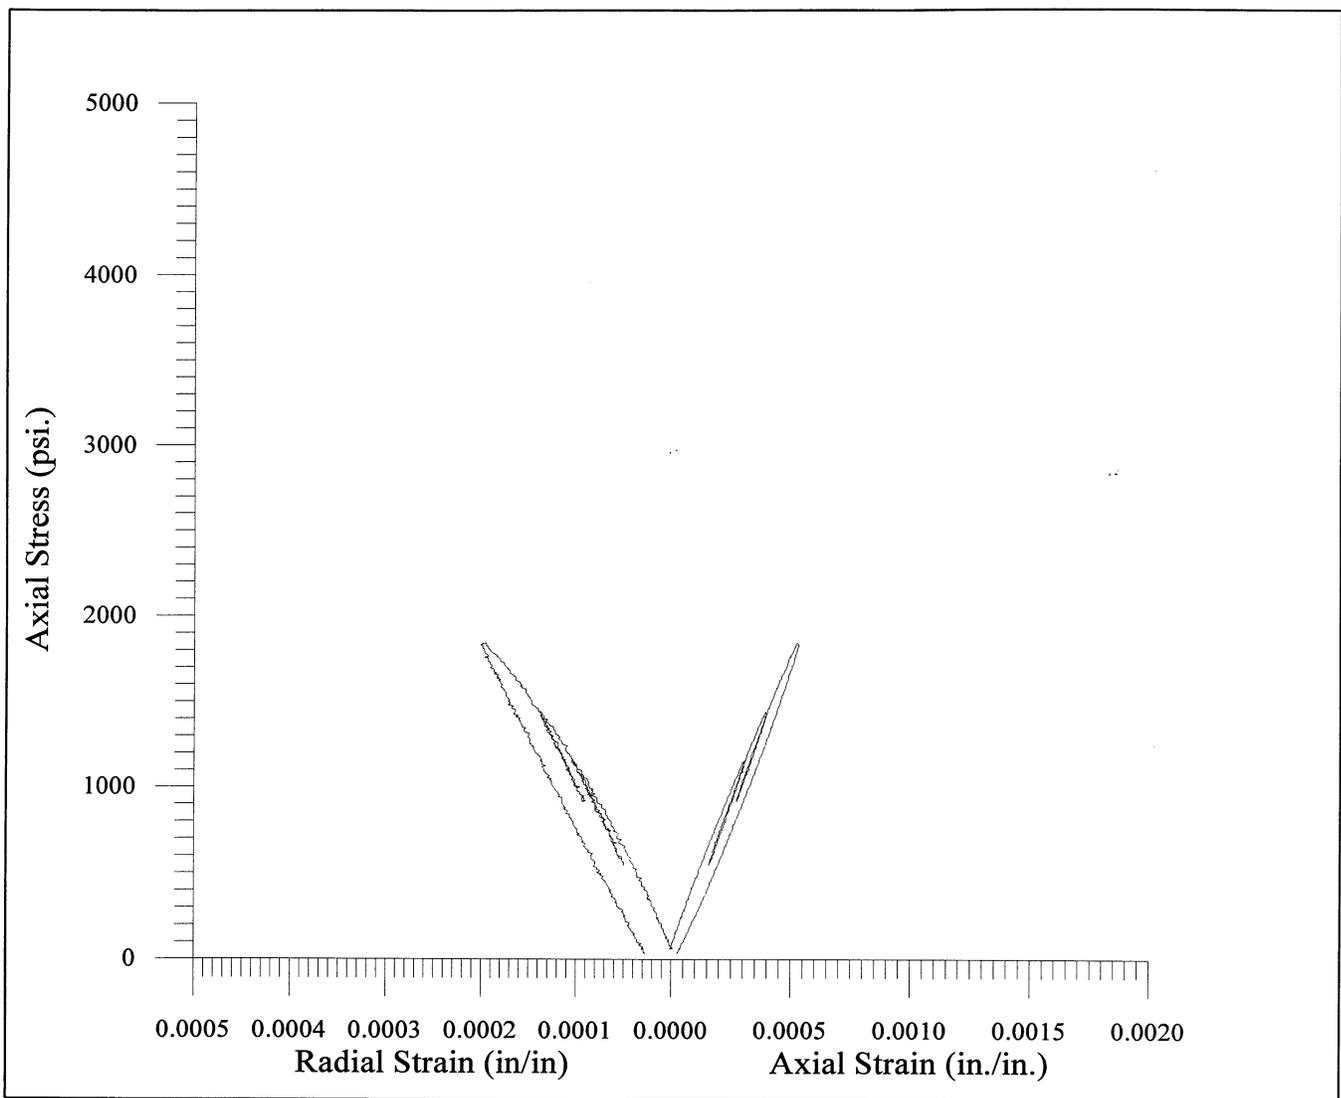
**ELASTIC MODULUS TEST**  
**Axial Stress vs. Axial & Radial Strain**

<p><b>SAMPLE ID:</b> Boring: 98-21  Sample: 29a  Depth: 83'</p> <p align="center"><b>DESCRIPTION</b></p> <p>Dark gray claystone with a few irregular sandstone lenses. Contains many calcite healed hairline fractures parallel to the bedding about 53 degrees to the core axis.</p> <p><b>MODULUS:</b> 4,170,000 psi  <b>POISSON'S RATIO:</b> .35</p>	<p align="center"> <i>Geo</i>

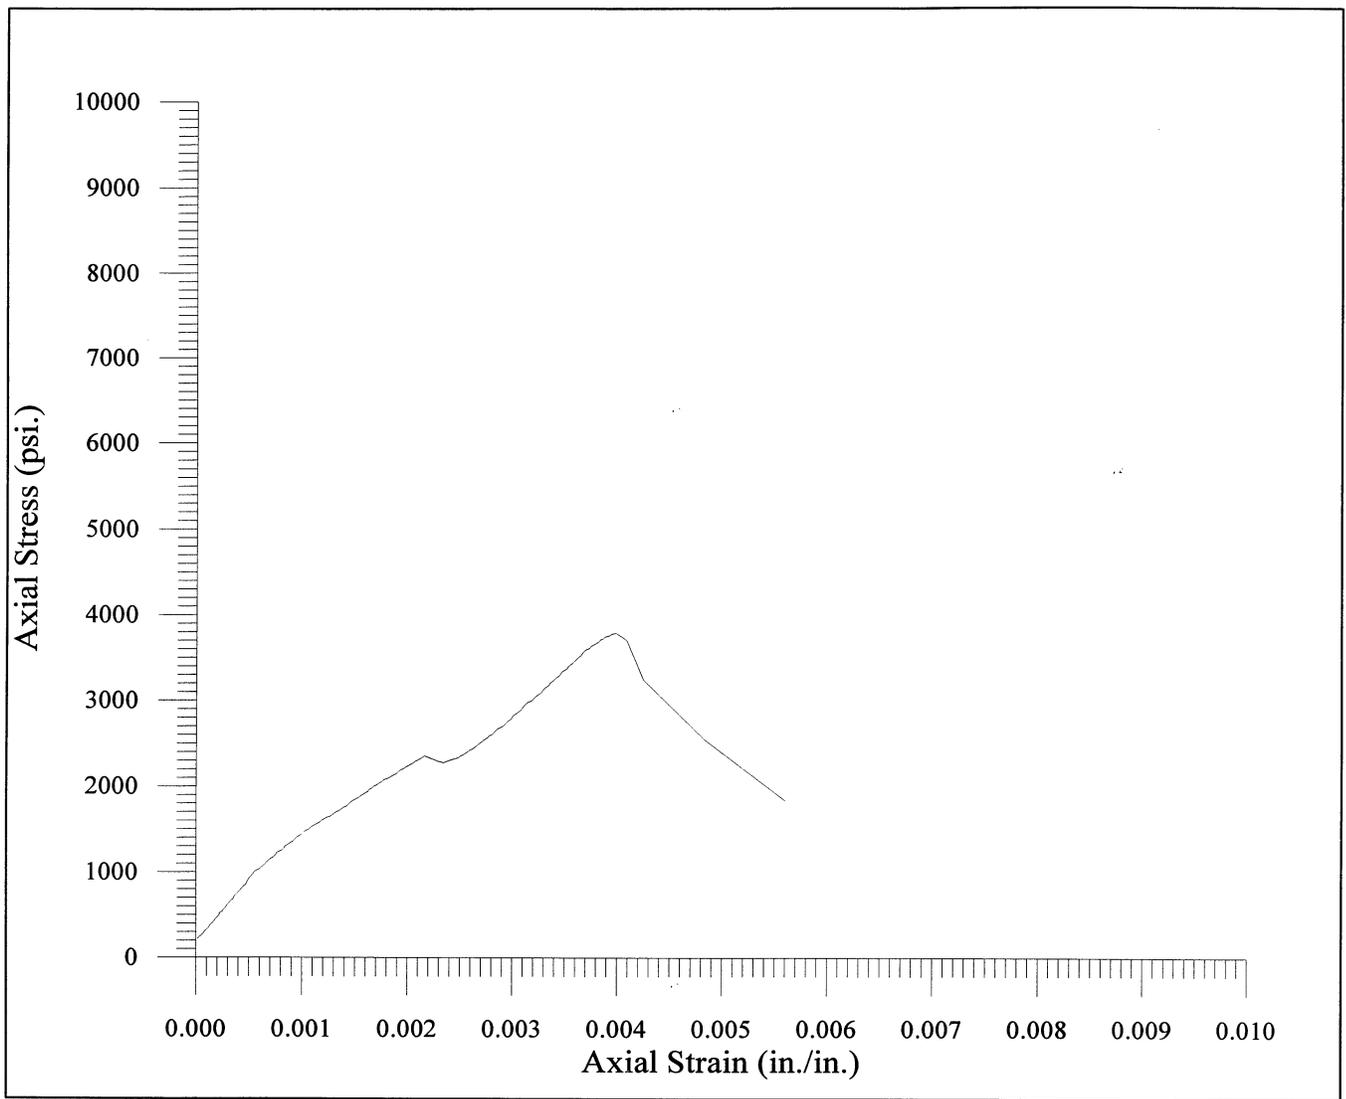
**UNCONFINED COMPRESSION TEST  
Axial Stress vs. Axial Strain**

<p><b>SAMPLE ID:</b> Boring : 98-21 Sample: 29a Depth: 83'</p> <p align="center"><b>DESCRIPTION</b></p> <p>Dark gray claystone with a few irregular sandstone lenses. Contains many calcite healed hairline fractures parallel to the bedding, about 53 degrees to the core axis.</p> <p><b>STRENGTH:</b> 3787 psi</p>	<p align="center"> <i>Geo</i>

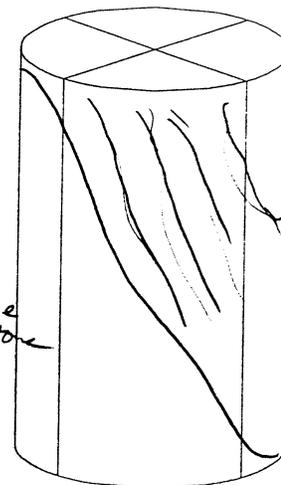
Comments: Failed by diagonal shear along interface

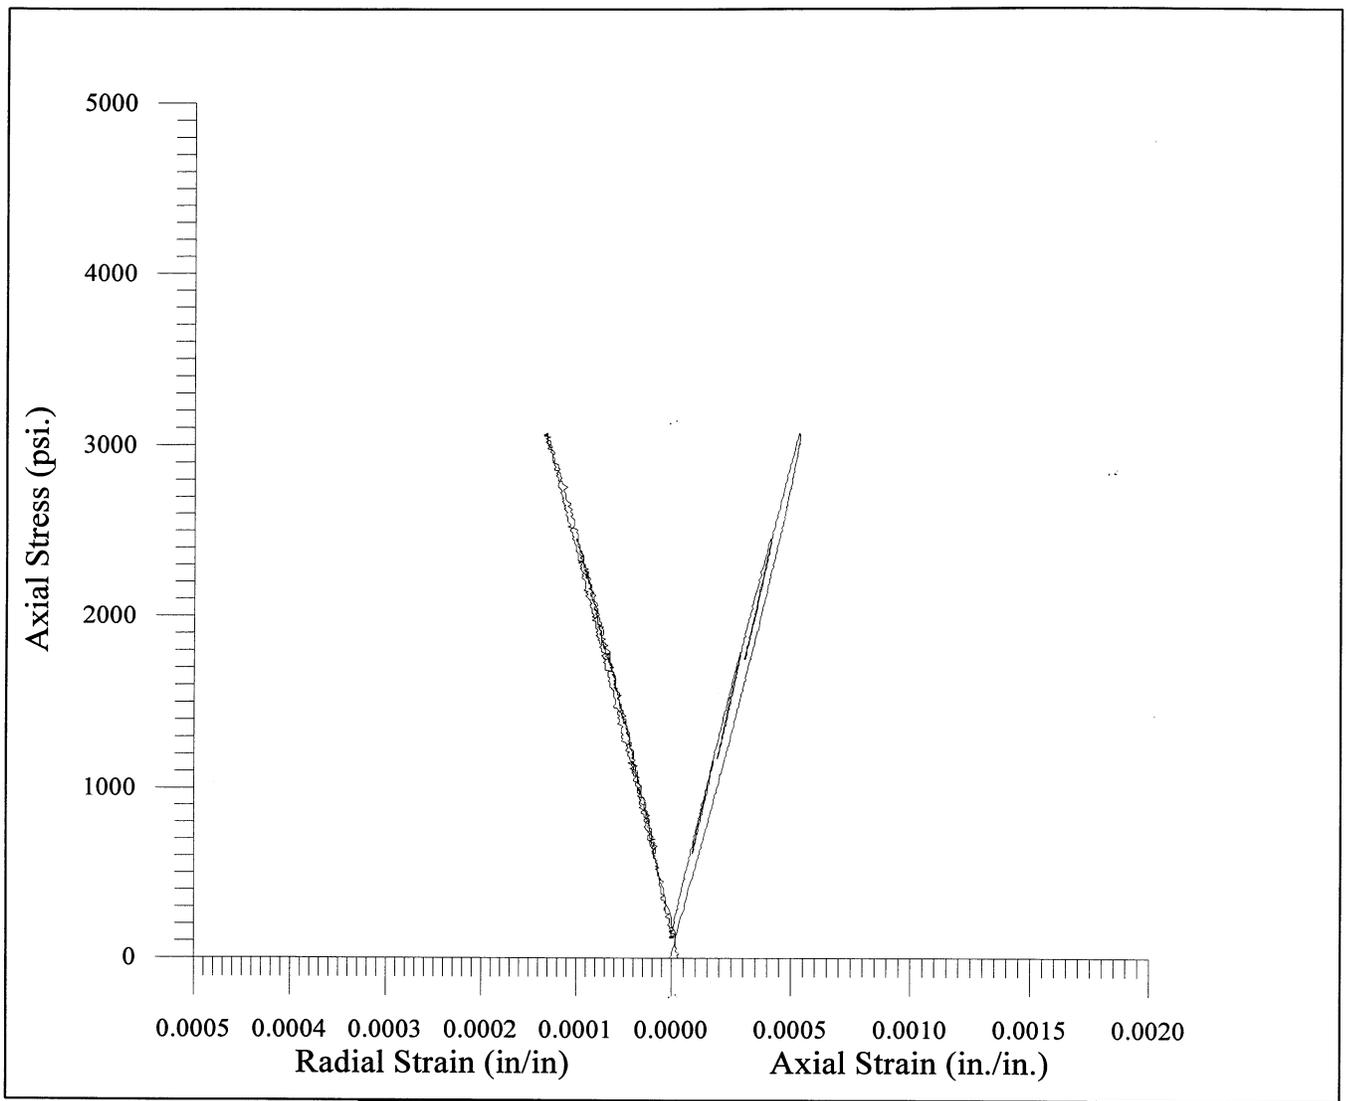
**ELASTIC MODULUS TEST**  
**Axial Stress vs. Axial & Radial Strain**

<p><b>SAMPLE ID:</b> Boring: 98-21  Sample: 31a  Depth: 97'</p> <p style="text-align: center;"><b>DESCRIPTION</b></p> <p>In one sample half, dark gray fine sandy siltstone and siltstone interbedded with claystone. The other half consists of claystone. Bedding about 25 degrees to the core axis.</p> <p><b>MODULUS:</b> 6,410,000 psi  <b>POISSON'S RATIO:</b> .29</p>	<div style="text-align: center;">

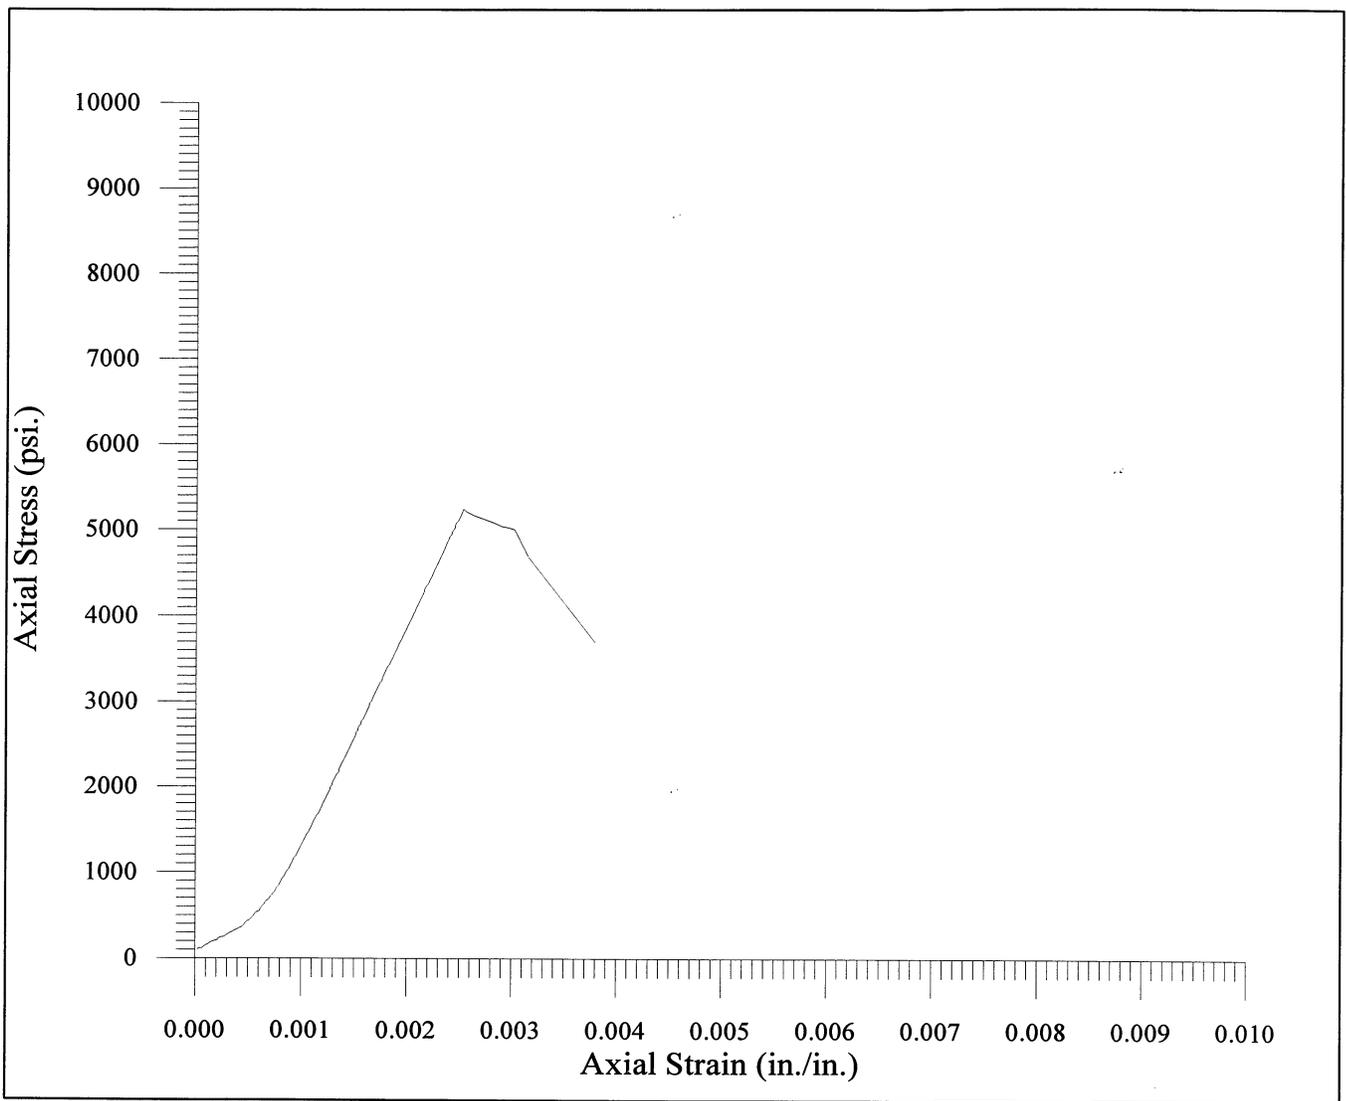
**UNCONFINED COMPRESSION TEST  
Axial Stress vs. Axial Strain**

**SAMPLE ID:** Boring : 98-21  
 Sample: 31a  
 Depth: 97'

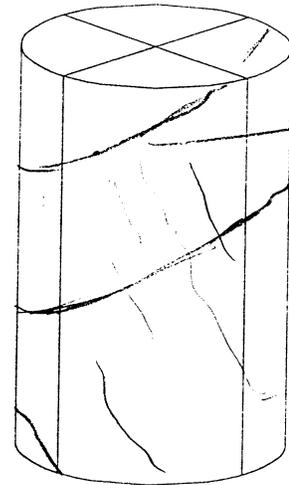
healed  
bedding  
fractures

Comments: Failed by shear on bedding fractures and axial splitting.

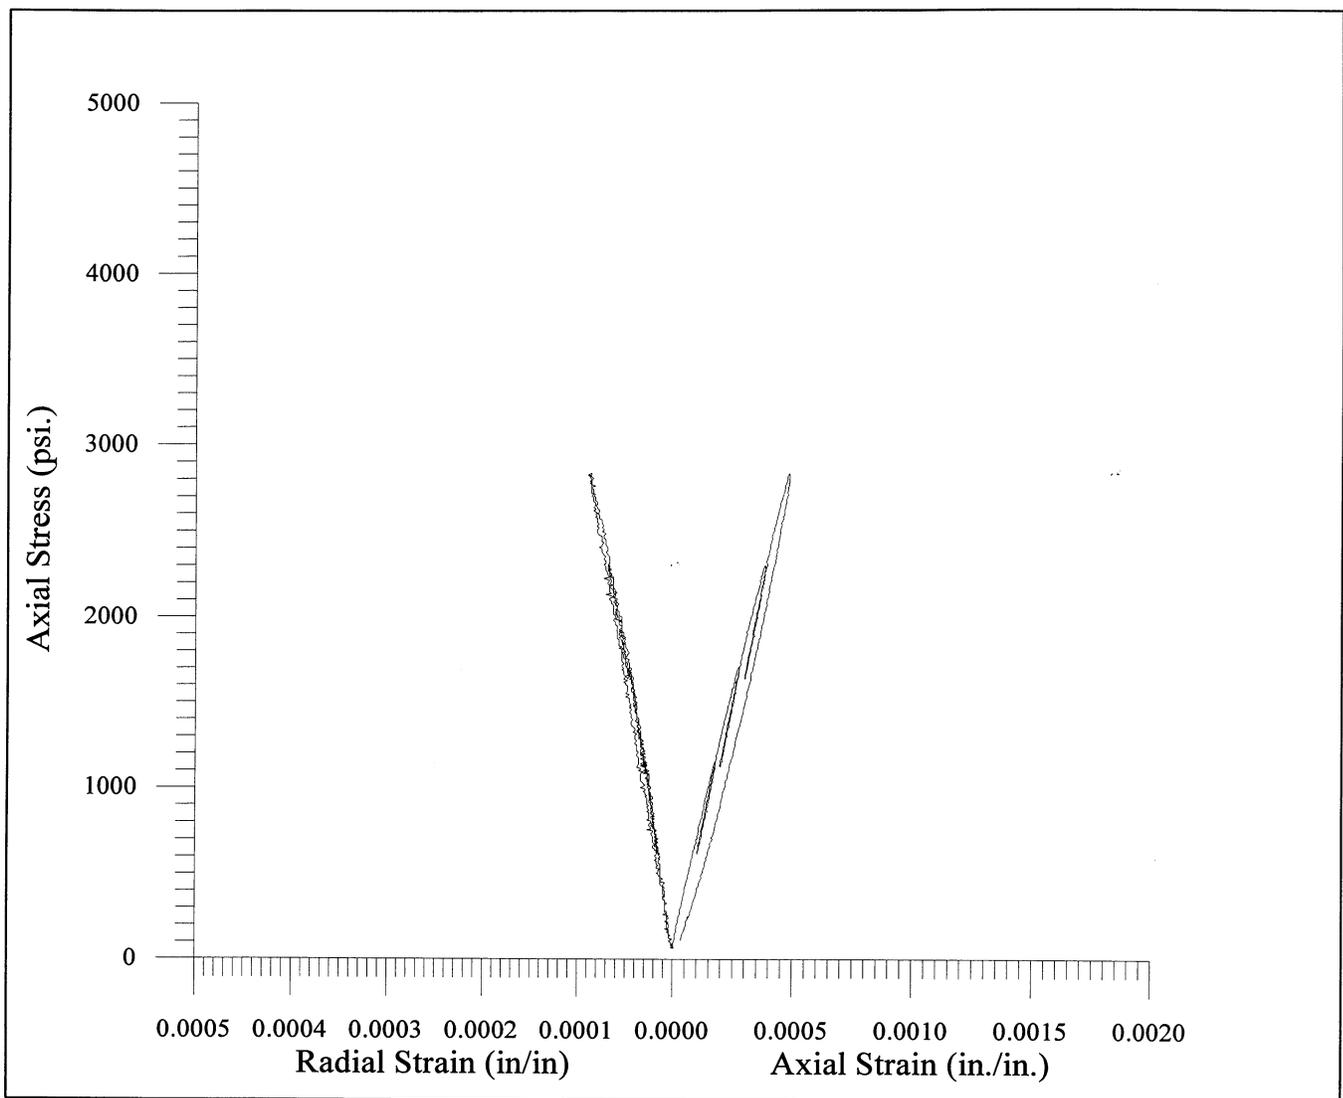
**ELASTIC MODULUS TEST**  
**Axial Stress vs. Axial & Radial Strain**

<p><b>SAMPLE ID:</b> Boring: 98-21  Sample: 32a  Depth: 106.5'</p> <p style="text-align: center;"><b>DESCRIPTION</b></p> <p>Medium gray bedded sandstone with a long claystone flake and two calcite healed bedding plane fractures, and many calcite healed hairline fractures perpendicular to the bedding (50 degrees to the core axis).</p> <p><b>MODULUS:</b> 7,250,000 psi  <b>POISSON'S RATIO:</b> .22</p>	<div style="text-align: center;">

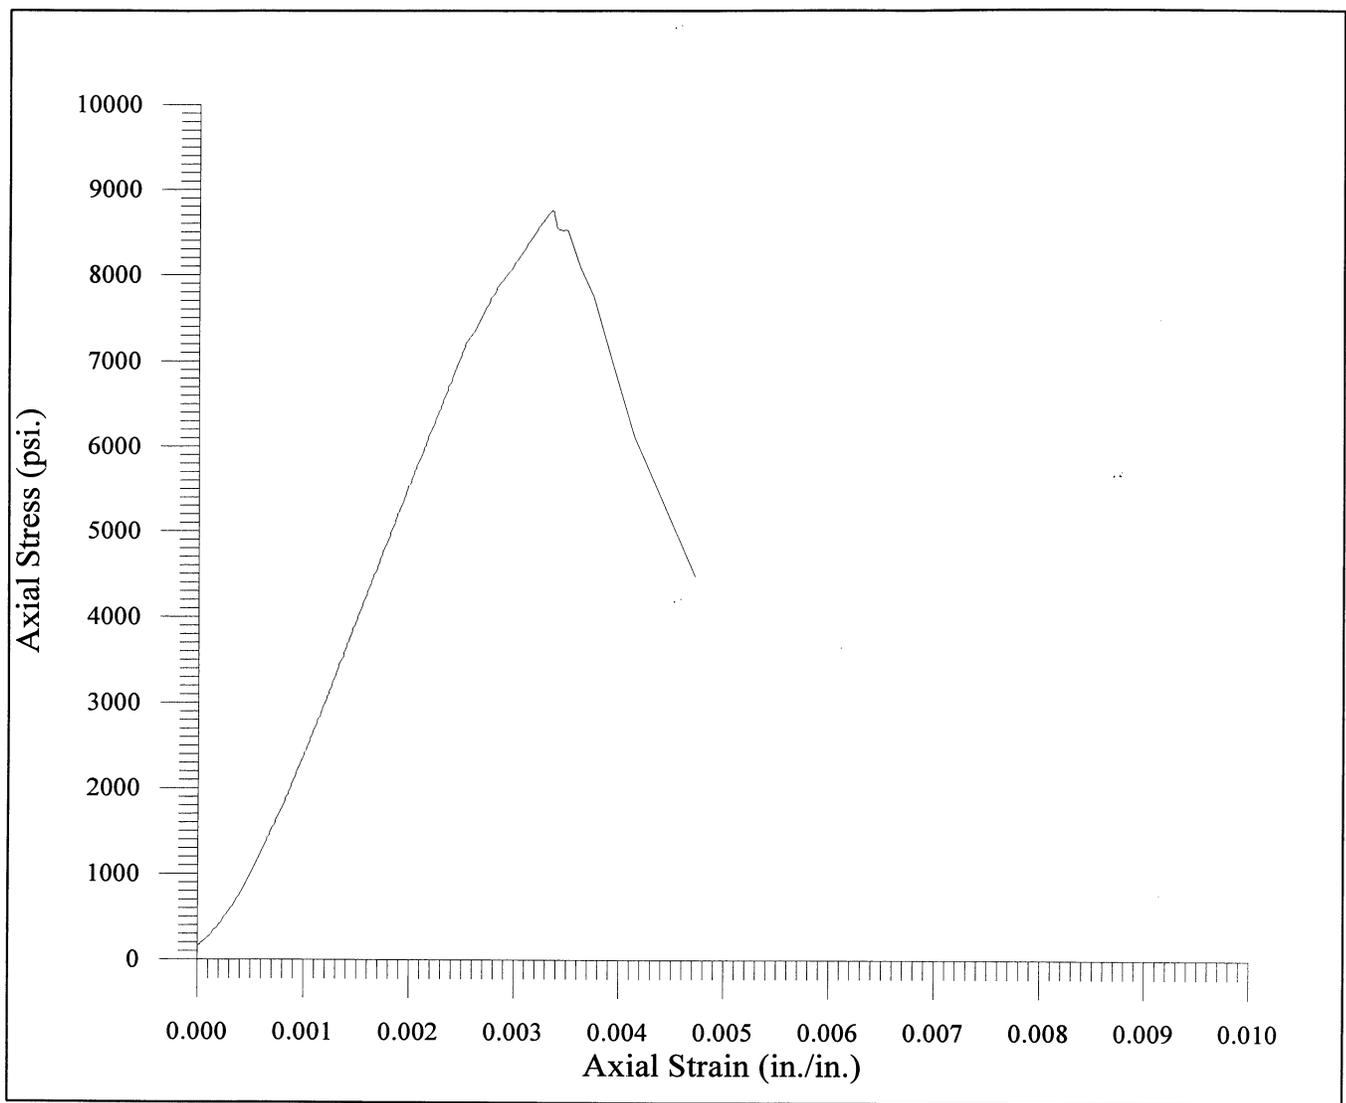
**UNCONFINED COMPRESSION TEST**  
**Axial Stress vs. Axial Strain**

**SAMPLE ID:** Boring : 98-21  
 Sample: 32a  
 Depth: 106.5'

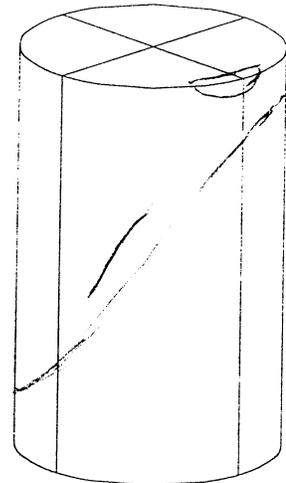
Comments: Failed by shear on healed fracture

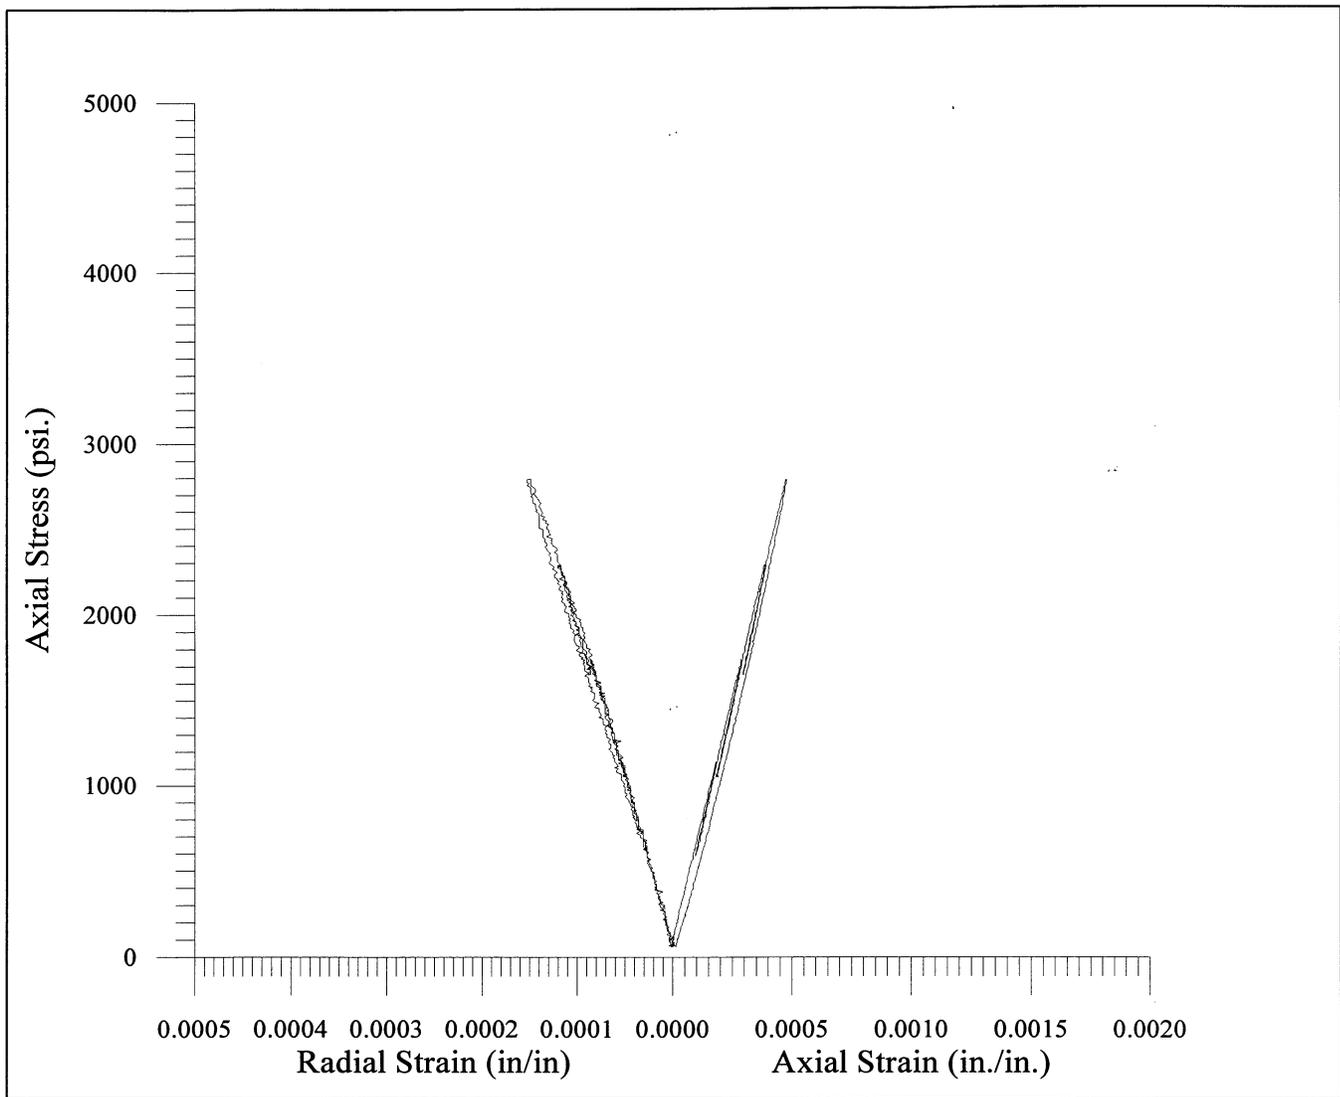
**ELASTIC MODULUS TEST**  
**Axial Stress vs. Axial & Radial Strain**

<p><b>SAMPLE ID:</b> Boring: 98-21          Sample: 34a          Depth: 122.5'</p>	<p align="center"> <i>Geo</i>

<i>Test</i>  <b>Unlimited</b> 800 Peralta Ave          San Leandro, CA 94577       </p>
<p align="center"><b>DESCRIPTION</b></p> <p align="center">Medium gray sandstone with a calcite healed hairline fracture about 32 degrees to the core axis.</p> <p><b>MODULUS:</b> 6,490,000 psi  <b>POISSON'S RATIO:</b> .32</p>	<p><b>Client:</b> Fugro West, Inc.          5855 Olivas Park Dr.          Ventura, CA 93003</p> <p><b>Project:</b> San Francisco Oakland Bay Bridge          East Span Replacement Project</p> <p><b>Job Number:</b> 98-42-0053</p>
	<p><b>Test Date:</b> October 27, 1998</p>

34a	122.5	Medium gray sandstone with a calcite healed hairline fracture about 32 degrees to the core axis.	26.50 (168.7)	81.30 (11,791)	44.75 (6.49)	.32
35a	130	Medium dark gray fine sandy siltstone to sandstone with a few claystone inclusions and one non-continuous calcite healed joint, about 24 degrees to the core axis.	26.55 (169.0)	93.63 (13,580)	53.85 (7.81)	.32

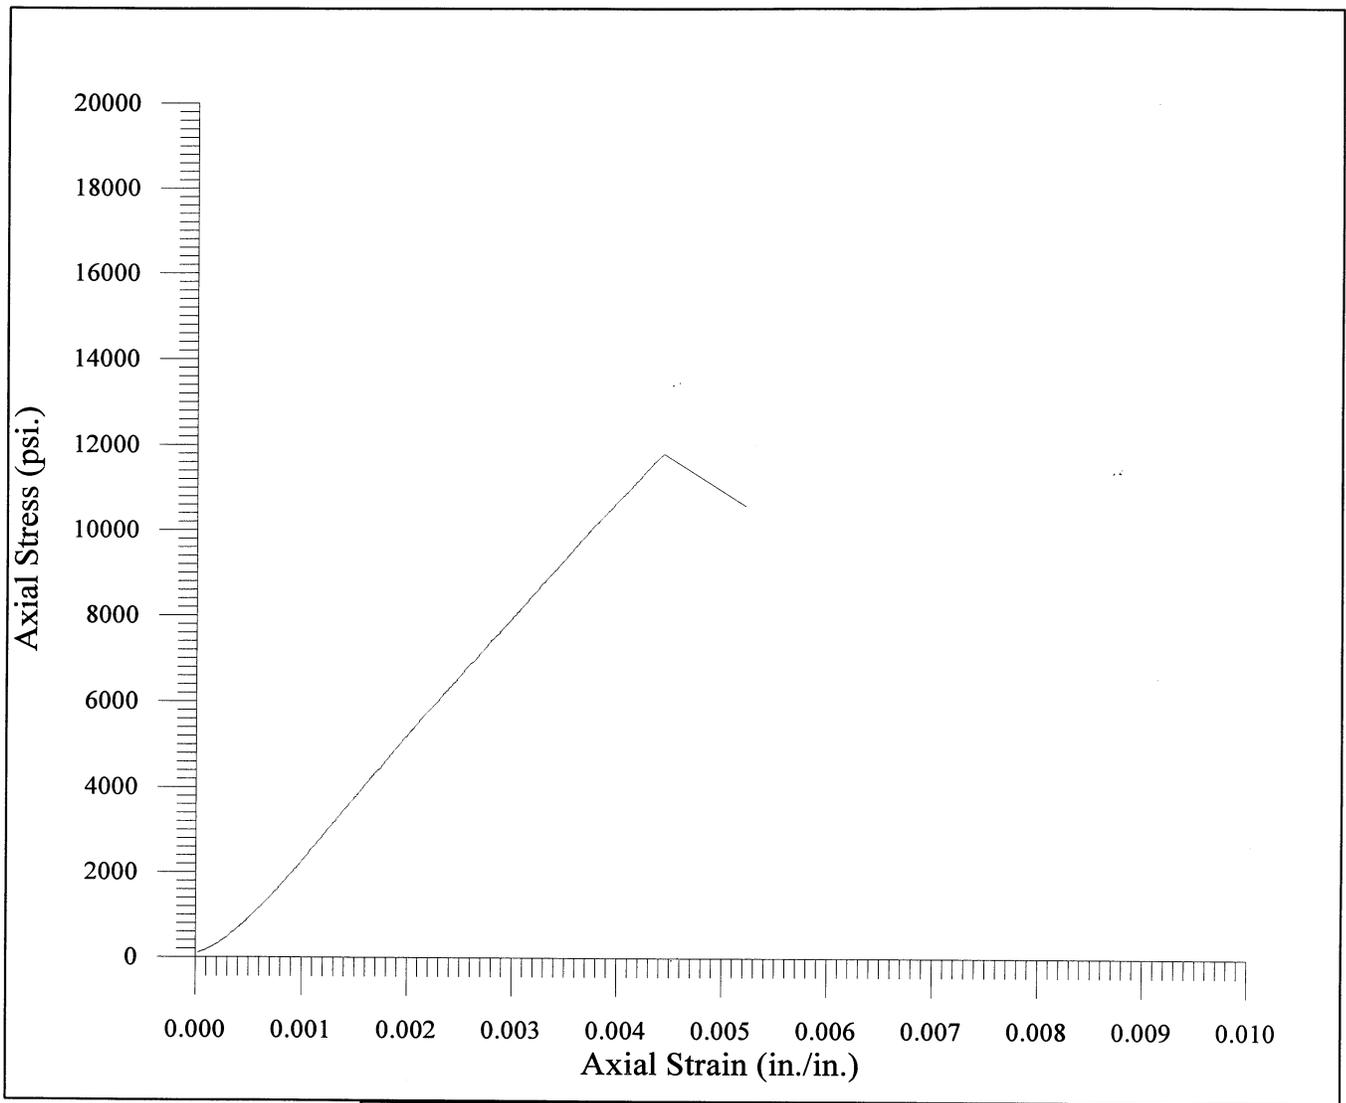
**UNCONFINED COMPRESSION TEST  
Axial Stress vs. Axial Strain**

<p><b>SAMPLE ID:</b> Boring : 98-21 Sample: 34a Depth: 122.5'</p> <p align="center"><b>DESCRIPTION</b></p> <p>Medium gray sandstone with a calcite healed hairline fracture about 32 degrees to the core axis.</p> <p><b>STRENGTH:</b> 11,791 psi</p>	<div style="text-align: center;">

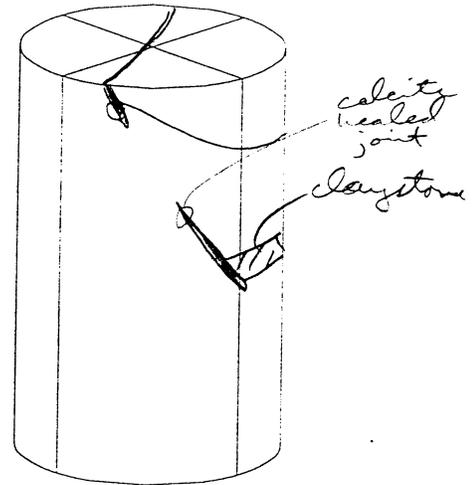
Comments: Failed by shear partially along healed joint, and by axial splitting.

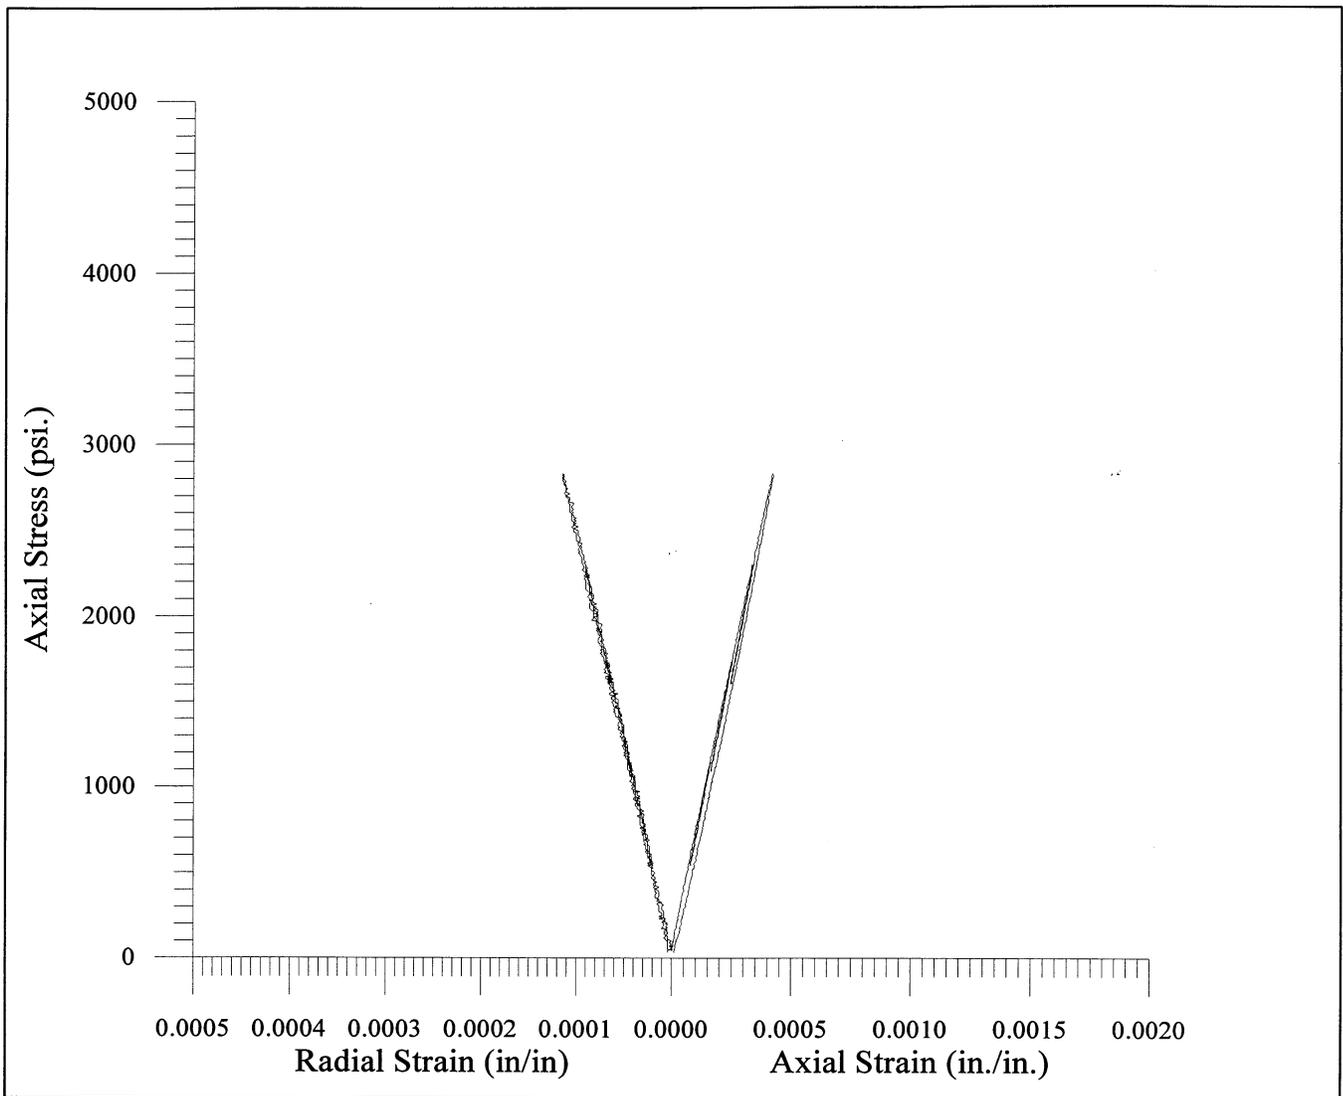
**ELASTIC MODULUS TEST**  
**Axial Stress vs. Axial & Radial Strain**

<p><b>SAMPLE ID:</b> Boring: 98-21  Sample: 35a  Depth: 130'</p> <p align="center"><b>DESCRIPTION</b></p> <p>Medium dark gray fine sandy siltstone to sandstone with a few claystone inclusions and one non-continuous calcite healed joint, about 24 degrees to the core axis.</p> <p><b>MODULUS:</b> 7,810,000 psi  <b>POISSON'S RATIO:</b> .32</p>	<p align="center"> <i>Geo</i>

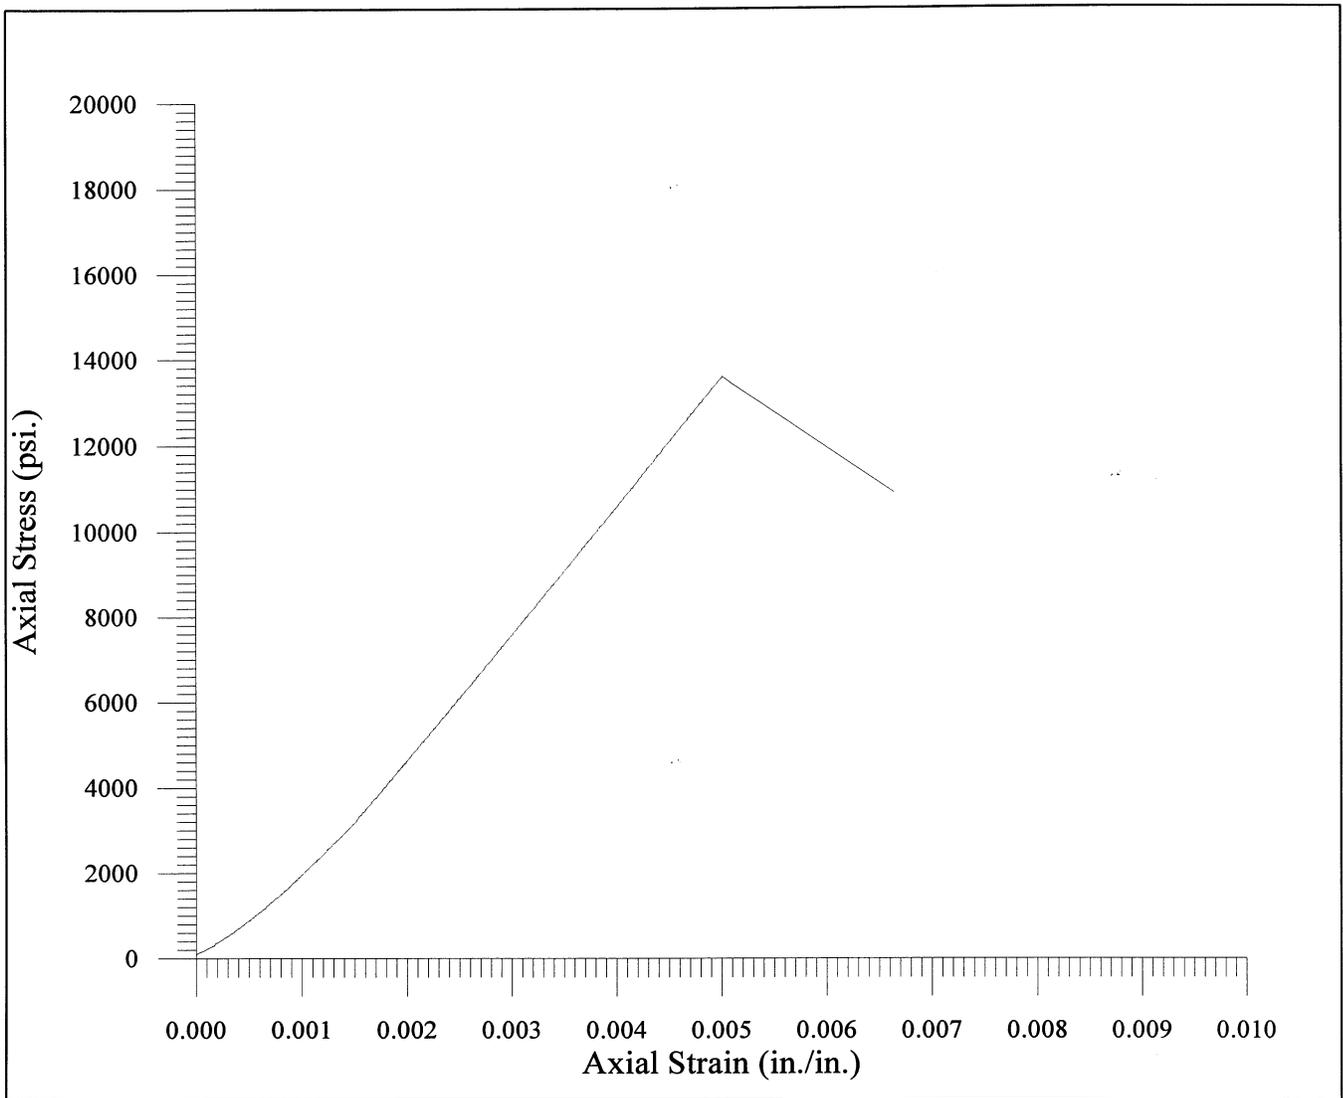
**UNCONFINED COMPRESSION TEST**  
**Axial Stress vs. Axial Strain**

<p><b>SAMPLE ID:</b> Boring : 98-21 Sample: 35a Depth: 130'</p> <p style="text-align: center;"><b>DESCRIPTION</b></p> <p>Medium dark gray fine sandy siltstone to sandstone with a few claystone inclusions and one non-continuous calcite healed joint, about 24 degrees to the core axis.</p> <p><b>STRENGTH:</b> 13,580 psi</p>	<div style="text-align: center;"> <p><i>Geo</i>

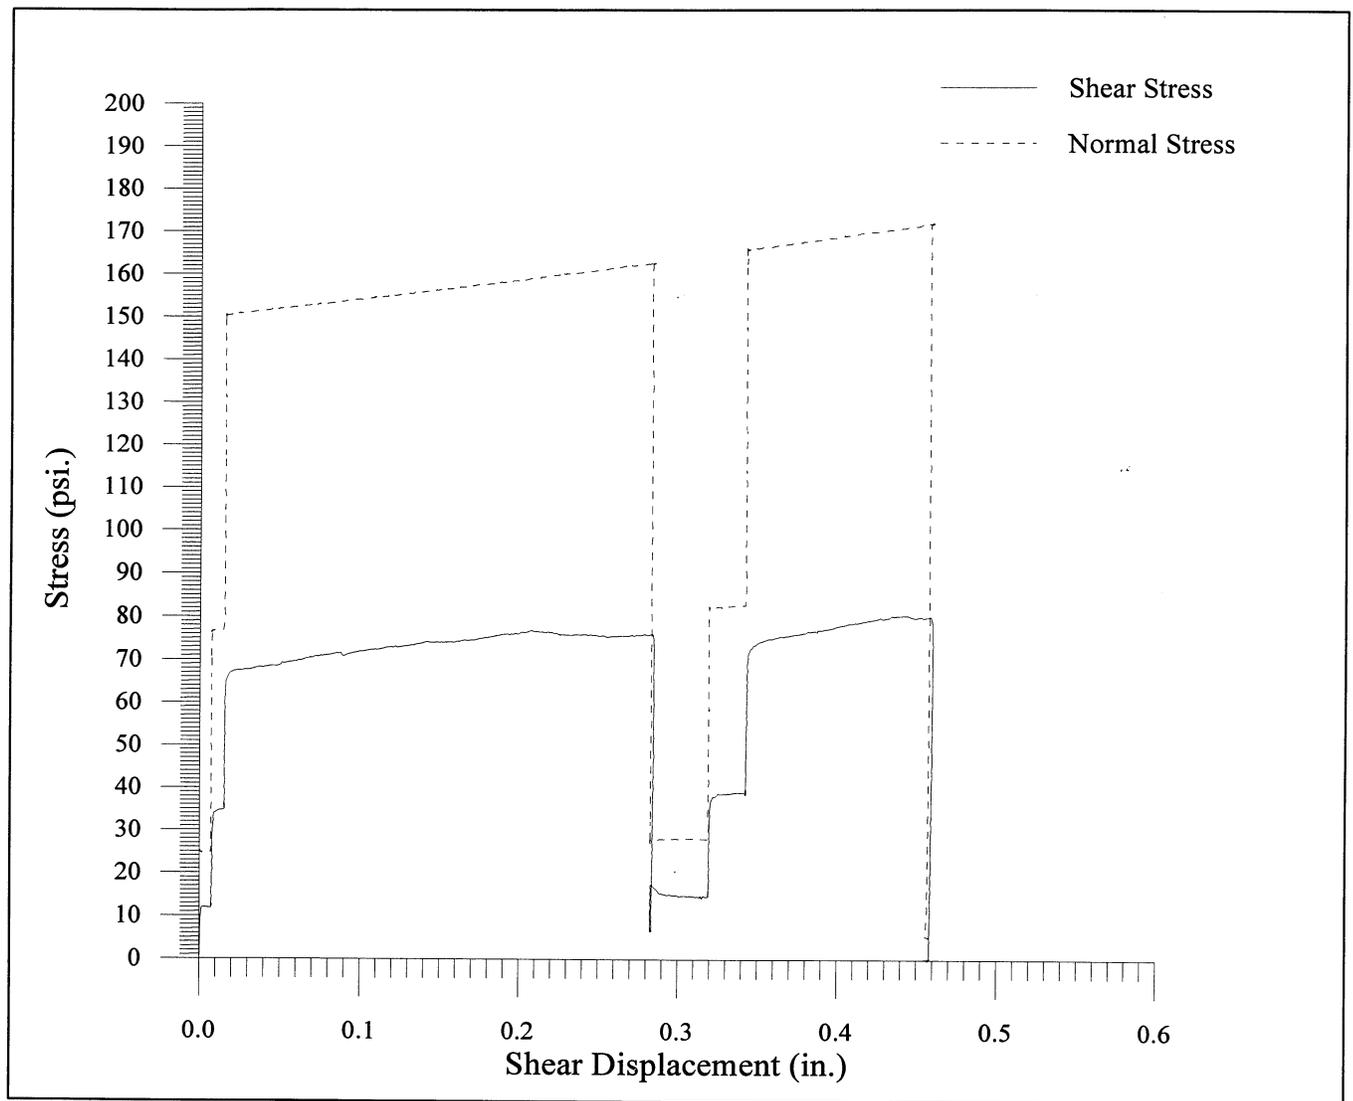
**DIRECT SHEAR TEST**  
**Shear and Normal Stress vs. Shear Displacement**

<b>SAMPLE ID:</b> Boring: 98-21 Sample: 20a Depth: 45'

Normal Stress	Shear Strength	Initial	25	12	77	35	151	67.5	Final	28	14	82	38.5	166.5	75	<b>Client:</b> Fugro West, Inc. 5855 Olivas Park Dr. Ventura, CA 93003	
	Normal Stress	Shear Strength																		
Initial	25	12																		
	77	35																		
	151	67.5																		
Final	28	14																		
	82	38.5																		
	166.5	75																		
		<b>Project:</b> San Francisco Oakland Bay Bridge East Span Replacement Project																		
		<b>Job Number:</b> 98-42-0053																		
		<b>Test Date:</b> October 28, 1998
