**SUBCONTRACTOR REPORTS  
FINAL GEOTECHNICAL  
SITE CHARACTERIZATION**

**SAN FRANCISCO-OAKLAND BAY BRIDGE  
EAST SPAN SEISMIC SAFETY PROJECT**

**VOLUME 2 OF 3  
(GeoTest Unlimited)**

Letter Report  
San Francisco Oakland Bay Bridge  
East Span Replacement Project  
Rock Testing Program

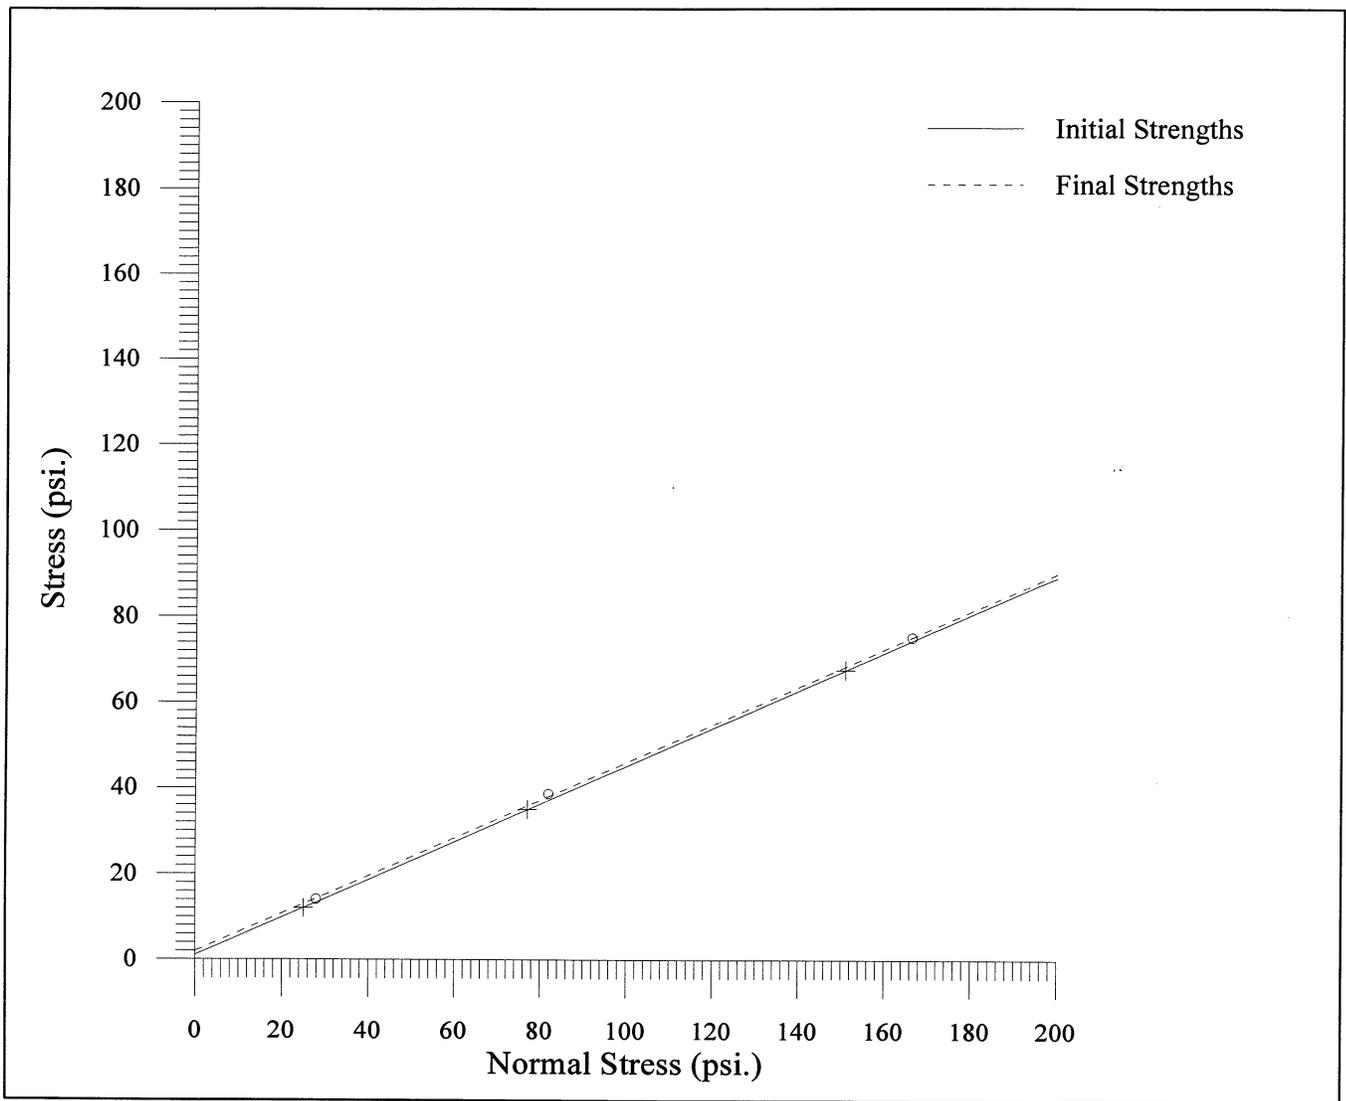
**DIRECT SHEAR TEST  
Failure Envelope**

<p><b>SAMPLE ID:</b> Boring: 98-21 Sample: 20a Depth: 45'</p> <p style="text-align: center;"><b>DESCRIPTION</b></p> <p>Planar bedding joint in dark gray claystone.</p>	<div style="text-align: center;">

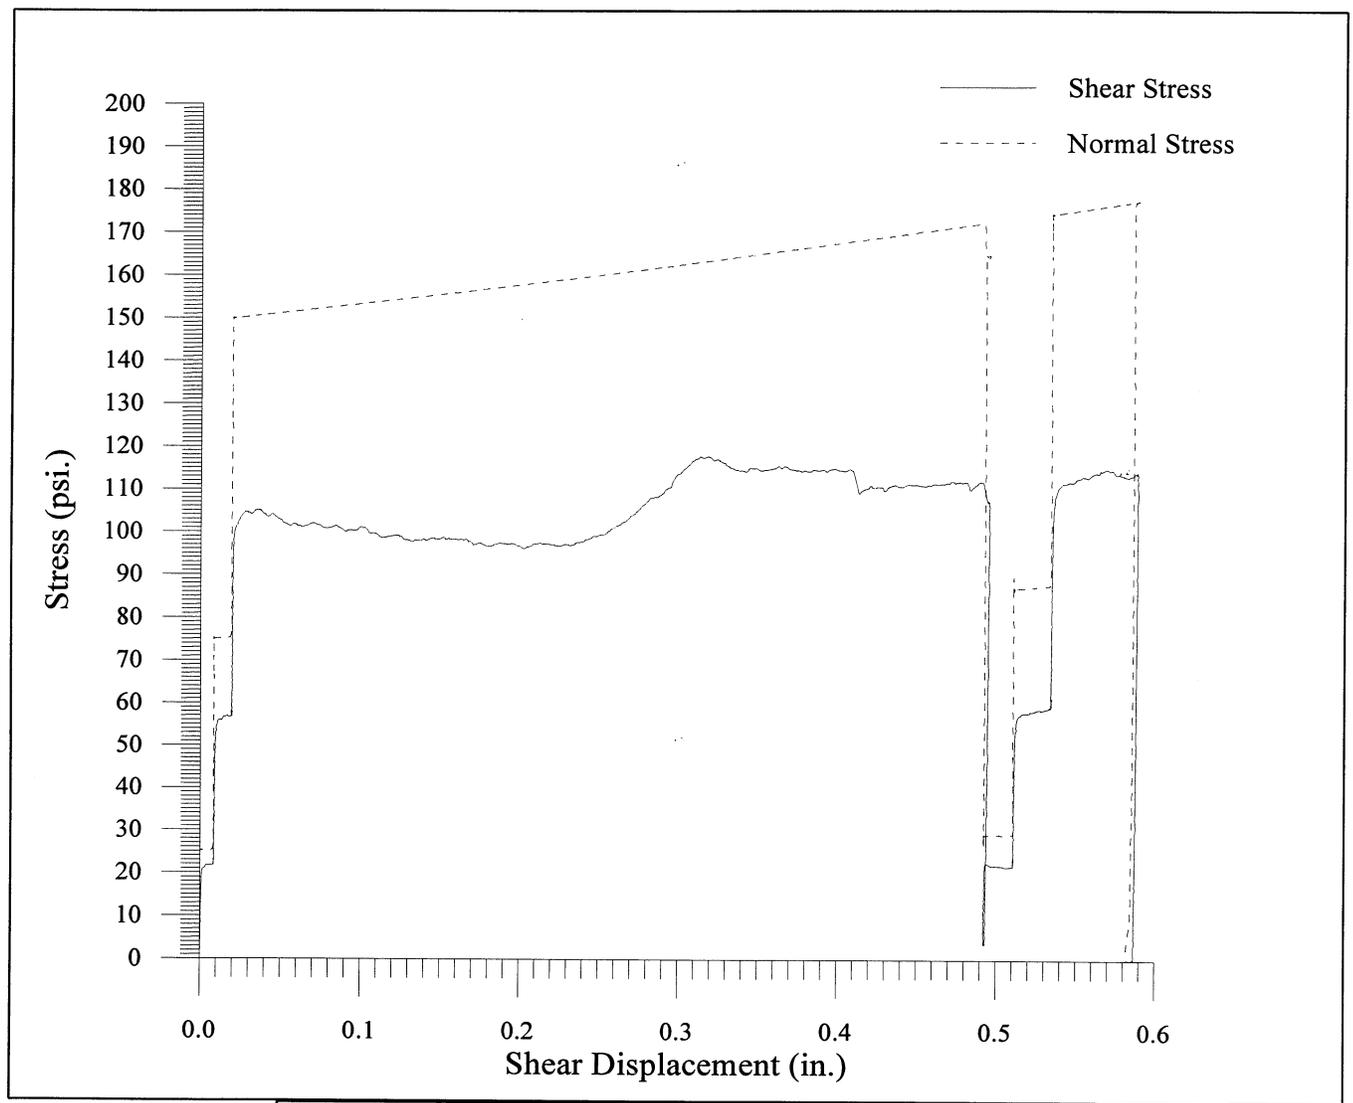
**DIRECT SHEAR TEST**  
**Shear and Normal Stress vs. Shear Displacement**

<p><b>SAMPLE ID:</b> Boring: 98-21          Sample: 31b          Depth: 98'</p> <p style="text-align: center;"><b>DESCRIPTION</b></p> <p>Planar parting between gray sandstone and dark gray fine sandy siltstone.</p>	<div style="text-align: center;">

Normal Stress	Shear Strength	Initial	25.5	22	75	57	151	105	Final	29.5	22	88	59	176	114	<p><b>Client:</b> Fugro West, Inc.          5855 Olivas Park Dr.          Ventura, CA 93003</p> <p><b>Project:</b> San Francisco Oakland Bay Bridge          East Span Replacement Project</p> <p><b>Job Number:</b> 98-42-0053</p>
	Normal Stress	Shear Strength																
Initial	25.5	22																
	75	57																
	151	105																
Final	29.5	22																
	88	59																
	176	114																
<p><b>Test Date:</b> October 29, 1998</p>

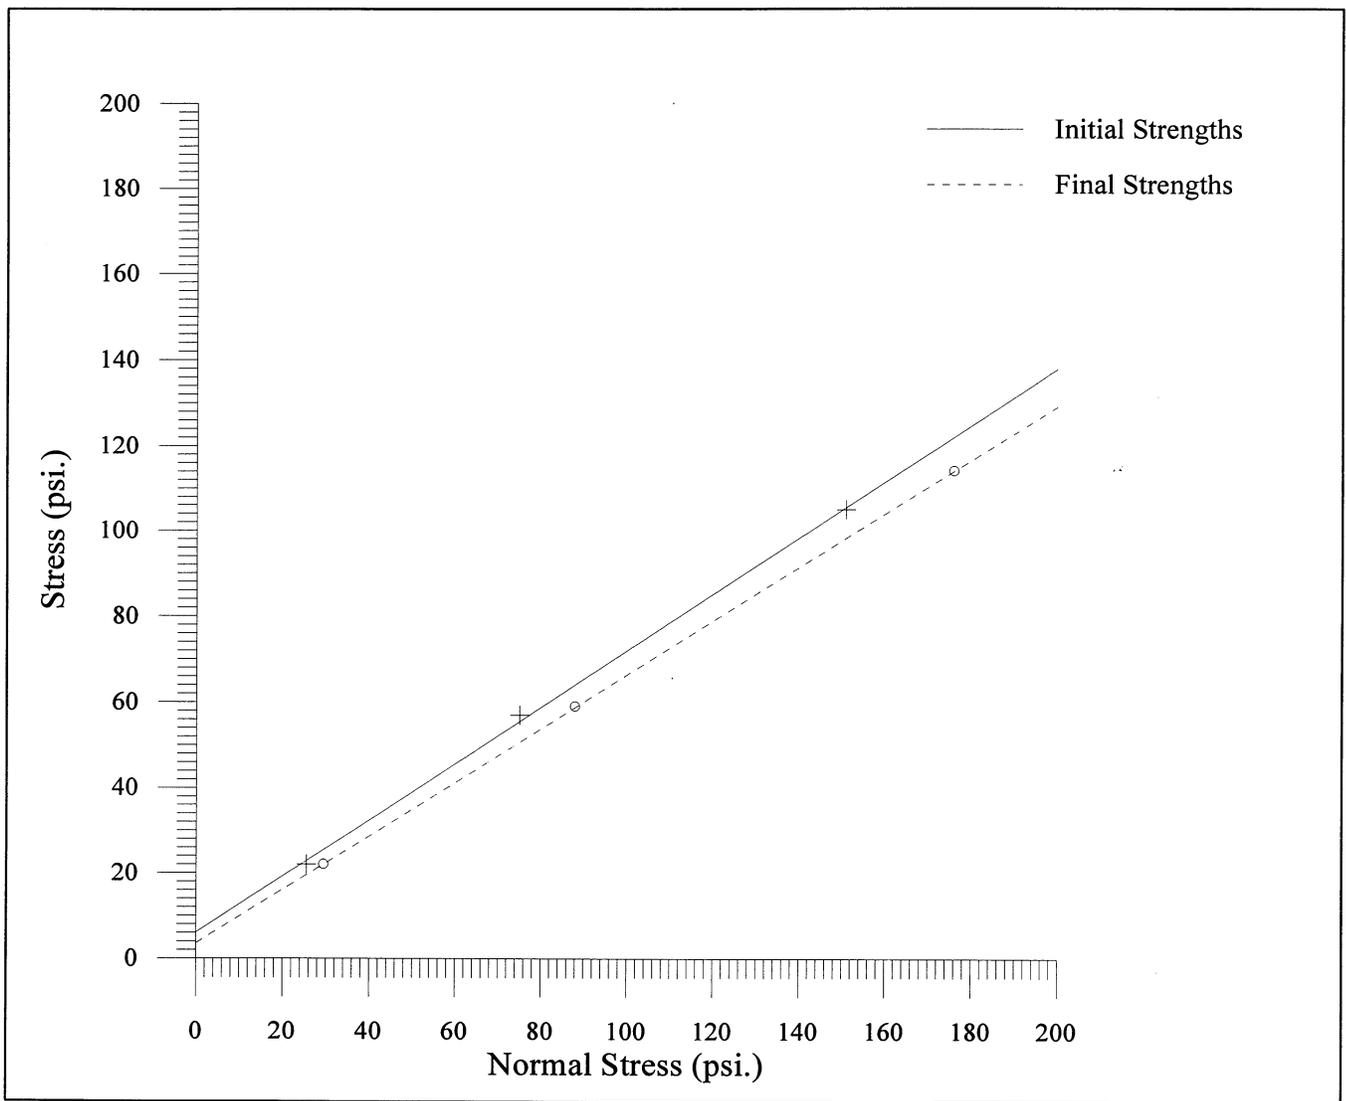
**DIRECT SHEAR TEST  
Failure Envelope**

<p><b>SAMPLE ID:</b> Boring: 98-21 Sample: 31b Depth: 98'</p> <p style="text-align: center;"><b>DESCRIPTION</b></p> <p>Planar parting between gray sandstone and dark gray fine sandy siltstone.</p>

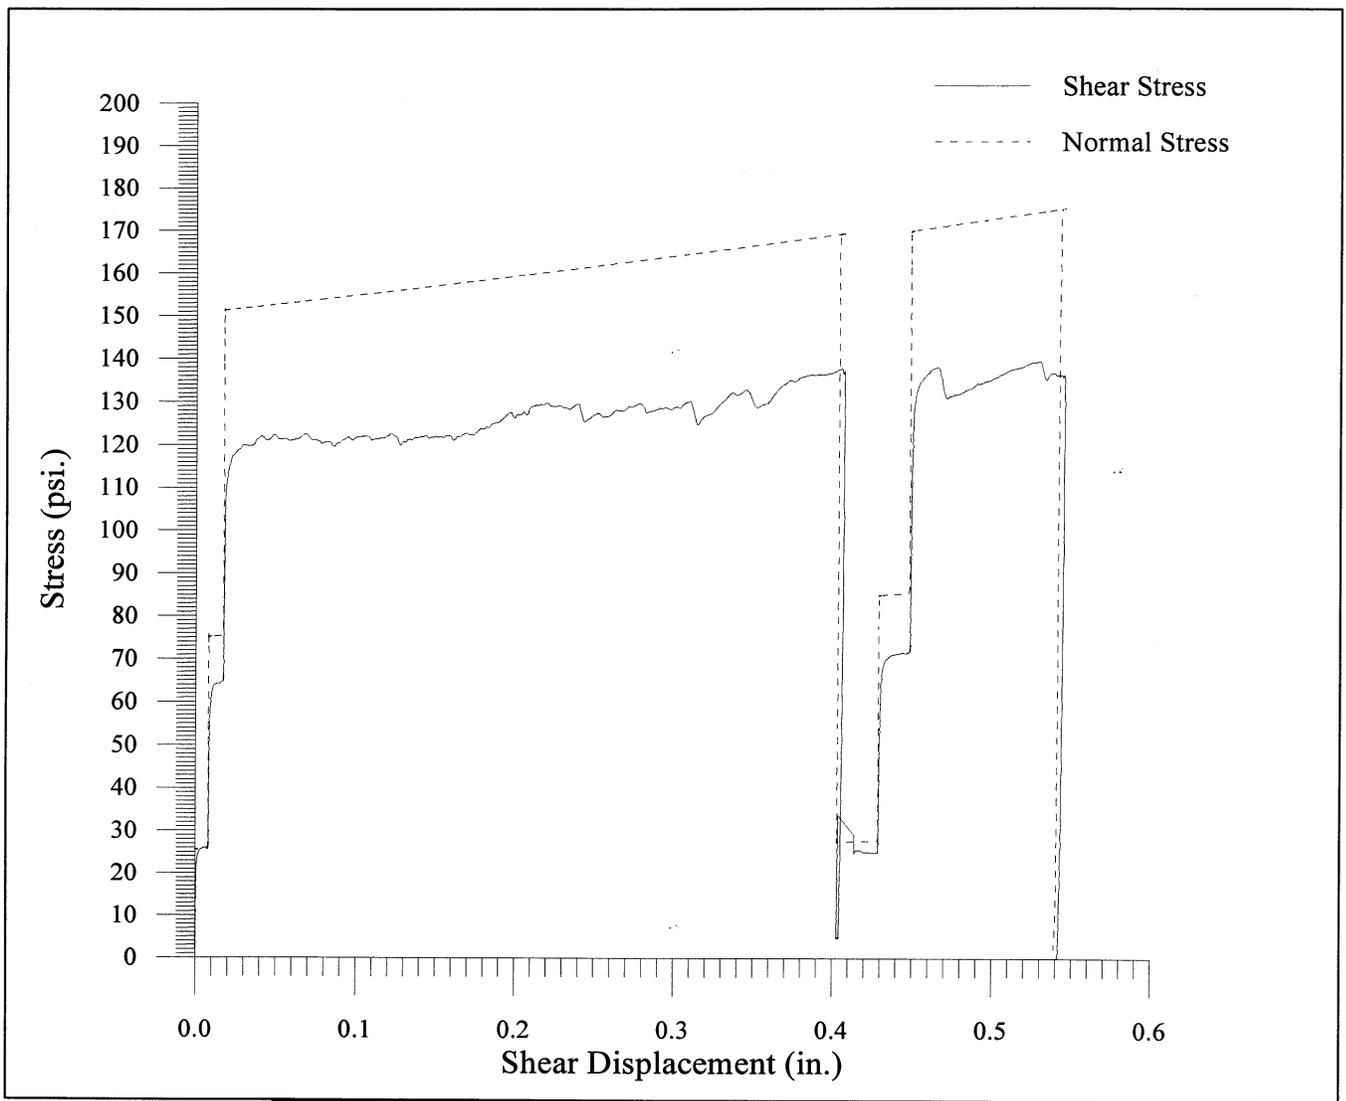
**DIRECT SHEAR TEST**  
**Shear and Normal Stress vs. Shear Displacement**

<p><b>SAMPLE ID:</b> Boring: 98-21          Sample: 34b          Depth: 123.5'</p> <p align="center"><b>DESCRIPTION</b></p> <p>Planar calcite coated joint in medium dark gray fine sandy siltstone.</p>		<p align="center"> <i>Geo</i>

Normal Stress	Shear Strength	Initial	25.5	25.5	75.5	64.5	153	121	Final	27.5	25.5	85.5	71.5	171	138	<p><b>Project:</b> San Francisco Oakland Bay Bridge          East Span Replacement Project</p> <p><b>Job Number:</b> 98-42-0053</p>	
	Normal Stress	Shear Strength																		
Initial	25.5	25.5																		
	75.5	64.5																		
	153	121																		
Final	27.5	25.5																		
	85.5	71.5																		
	171	138																		
		<p><b>Test Date:</b> October 29, 1998</p>

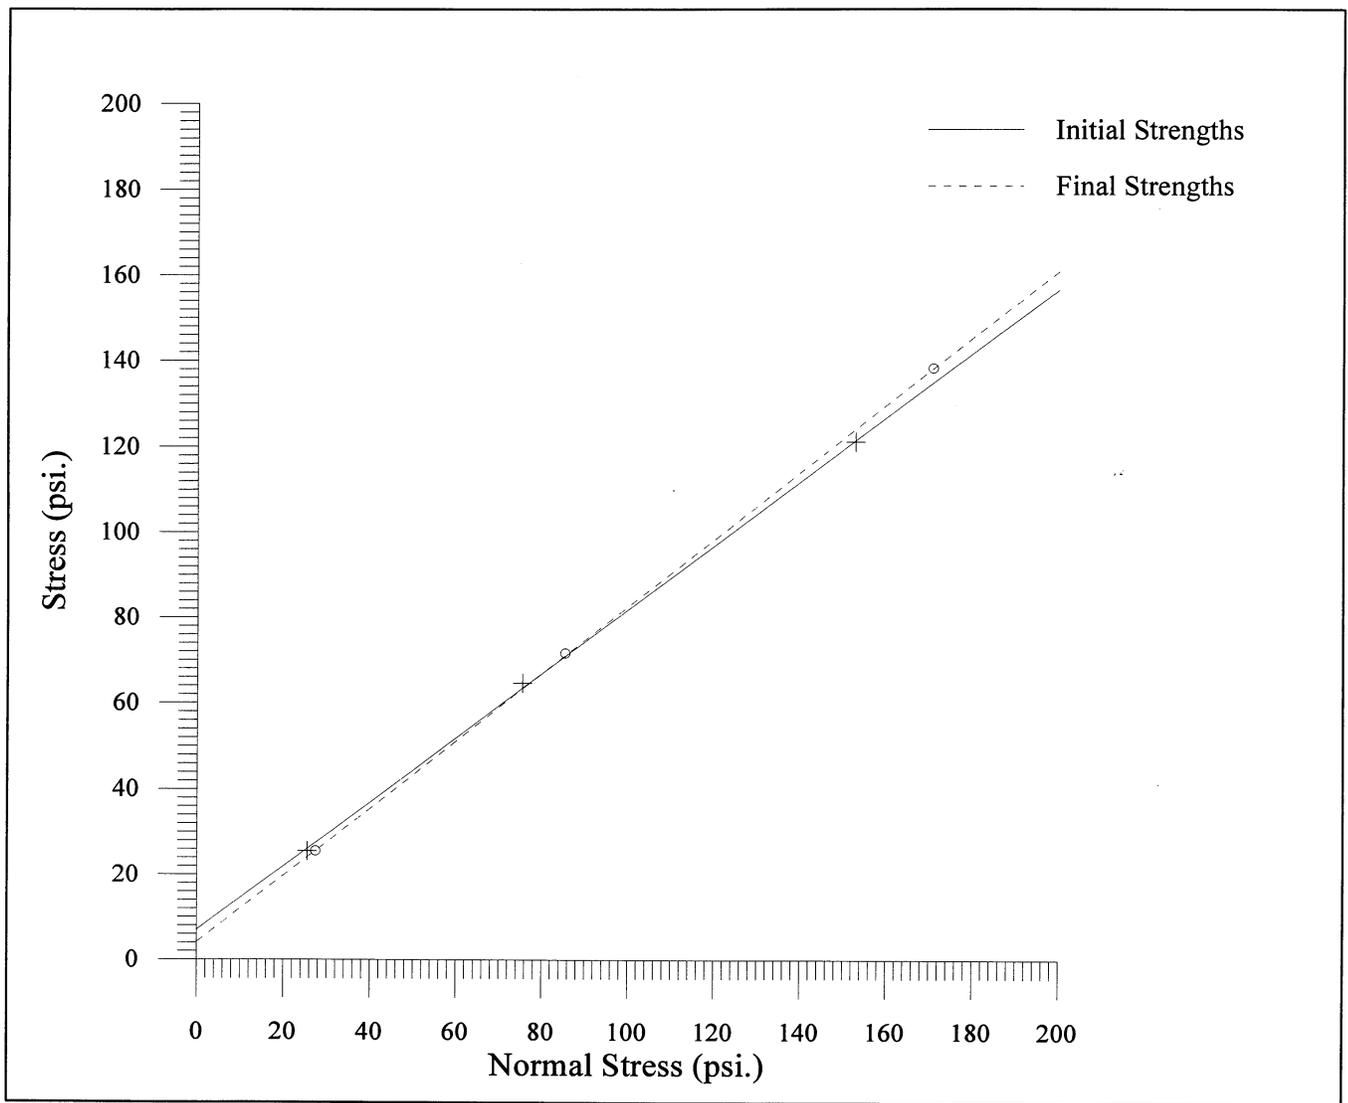
**DIRECT SHEAR TEST  
Failure Envelope**

<p><b>SAMPLE ID:</b> Boring: 98-21 Sample: 34b Depth: 123.5'</p> <p style="text-align: center;"><b>DESCRIPTION</b></p> <p>Planar calcite coated joint in medium dark gray fine sandy siltstone.</p>

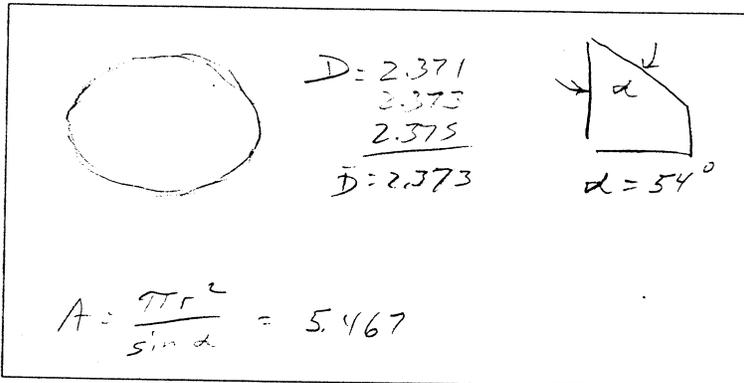
Sketch of Shear Surface

<b>SAMPLE ID:</b> Boring: 98-21 Sample: 36a Depth: 133'			 <b>800 Peralta Ave</b> <b>San Leandro, CA 94577</b>	
<b>DESCRIPTION</b> Planar bedding plane joint in dark gray claystone.				
	<u>Normal Stress</u>	<u>Shear Strength</u>	<b>Client:</b> Fugro West, Inc. 5855 Olivas Park Dr. Ventura, CA 93003	
Initial	25	20.5	<b>Project:</b> San Francisco Oakland Bay Bridge East Span Replacement Project	
	75.5	50.5		
	151	89.5		
Final	27.5	15	<b>Job Number:</b> 98-42-0053	
	82	41	<b>Test Date:</b> October 29, 1998	
	163	77

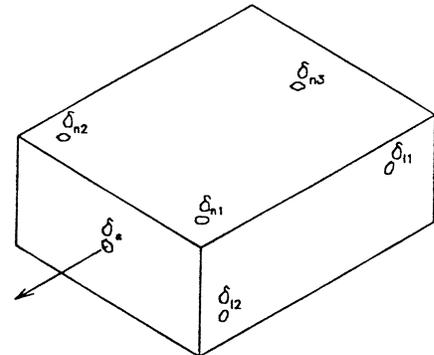
Location of LVDTs on top shear box

$\sigma_n$	<u>25</u>	<u>75</u>	<u>150</u>	psi
$F_n$	<u>137</u>	<u>411</u>	<u>822</u>	lb
$F_n - W_b$	<u>121</u>	<u>395</u>	<u>806</u>	lb

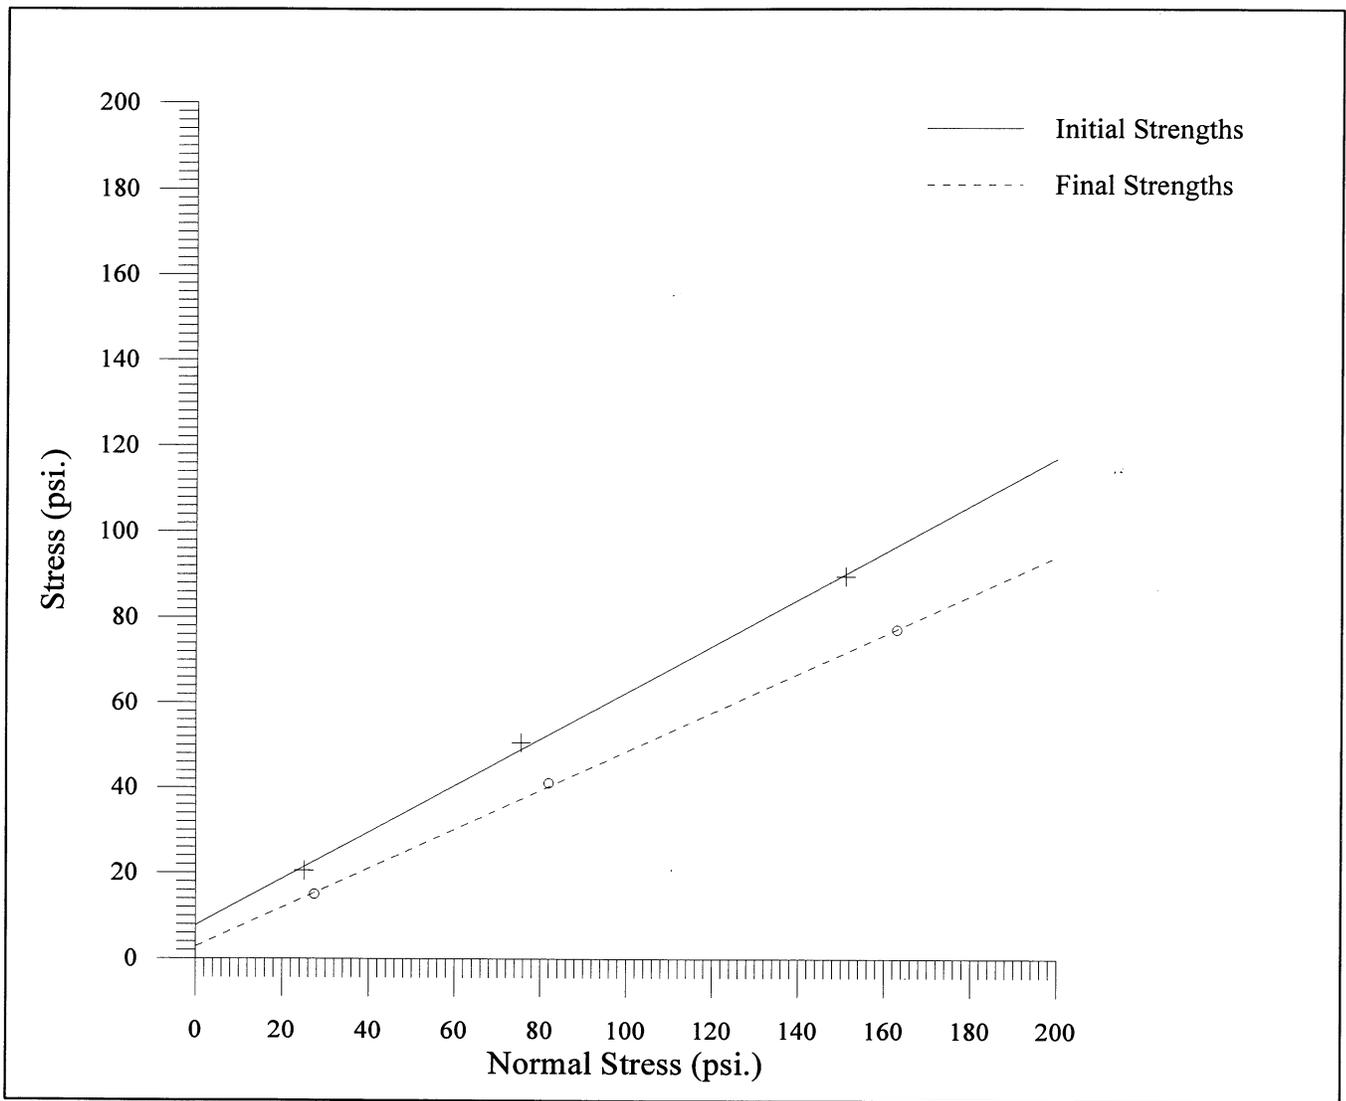
**DIRECT SHEAR TEST  
Failure Envelope**

<p><b>SAMPLE ID:</b> Boring: 98-21 Sample: 36a Depth: 133'</p> <p><b>DESCRIPTION</b> Planar bedding plane joint in dark gray claystone.</p>

<b>Test</b>  <b>Unlimited</b> 800 Peralta Ave  San Leandro, CA 94577 </p>
		Shear Intercept (psi)	Friction Angle (degrees)							
Initial	7.8	28.6								
Final	2.9	24.5								
<p><b>Client:</b> Fugro West, Inc. 5855 Olivas Park Dr. Ventura, CA 93003</p> <p><b>Project:</b> San Francisco Oakland Bay Bridge East Span Replacement Project</p> <p><b>Job Number:</b> 98-42-0053</p> <p><b>Test Date:</b> October 29, 1998</p>

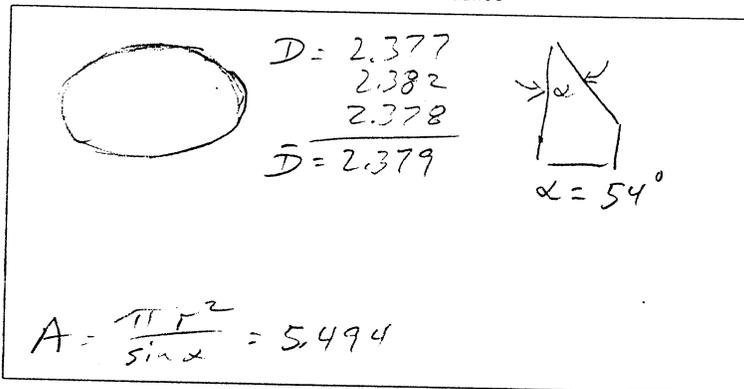
Sketch of Shear Surface

<p><b>SAMPLE ID:</b> Boring: 98-21  Sample: 36b  Depth: 135.5'</p> <p align="center"><b>DESCRIPTION</b></p> Planar bedding plane joint in a thin dark gray claystone bed.	<p align="center"><b>Geo</b>

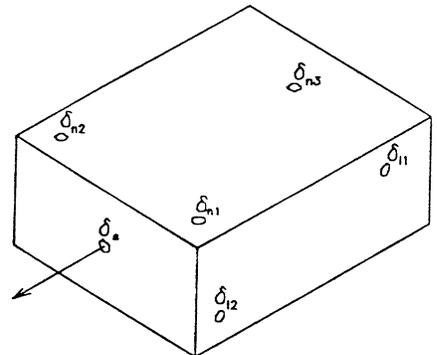
Location of LVDTs on top shear box

$\sigma_n$	<u>25</u>	<u>75</u>	<u>150</u>	psi
$F_n$	<u>137</u>	<u>411</u>	<u>822</u>	lb
$F_n - W_b$	<u>121</u>	<u>395</u>	<u>806</u>	lb

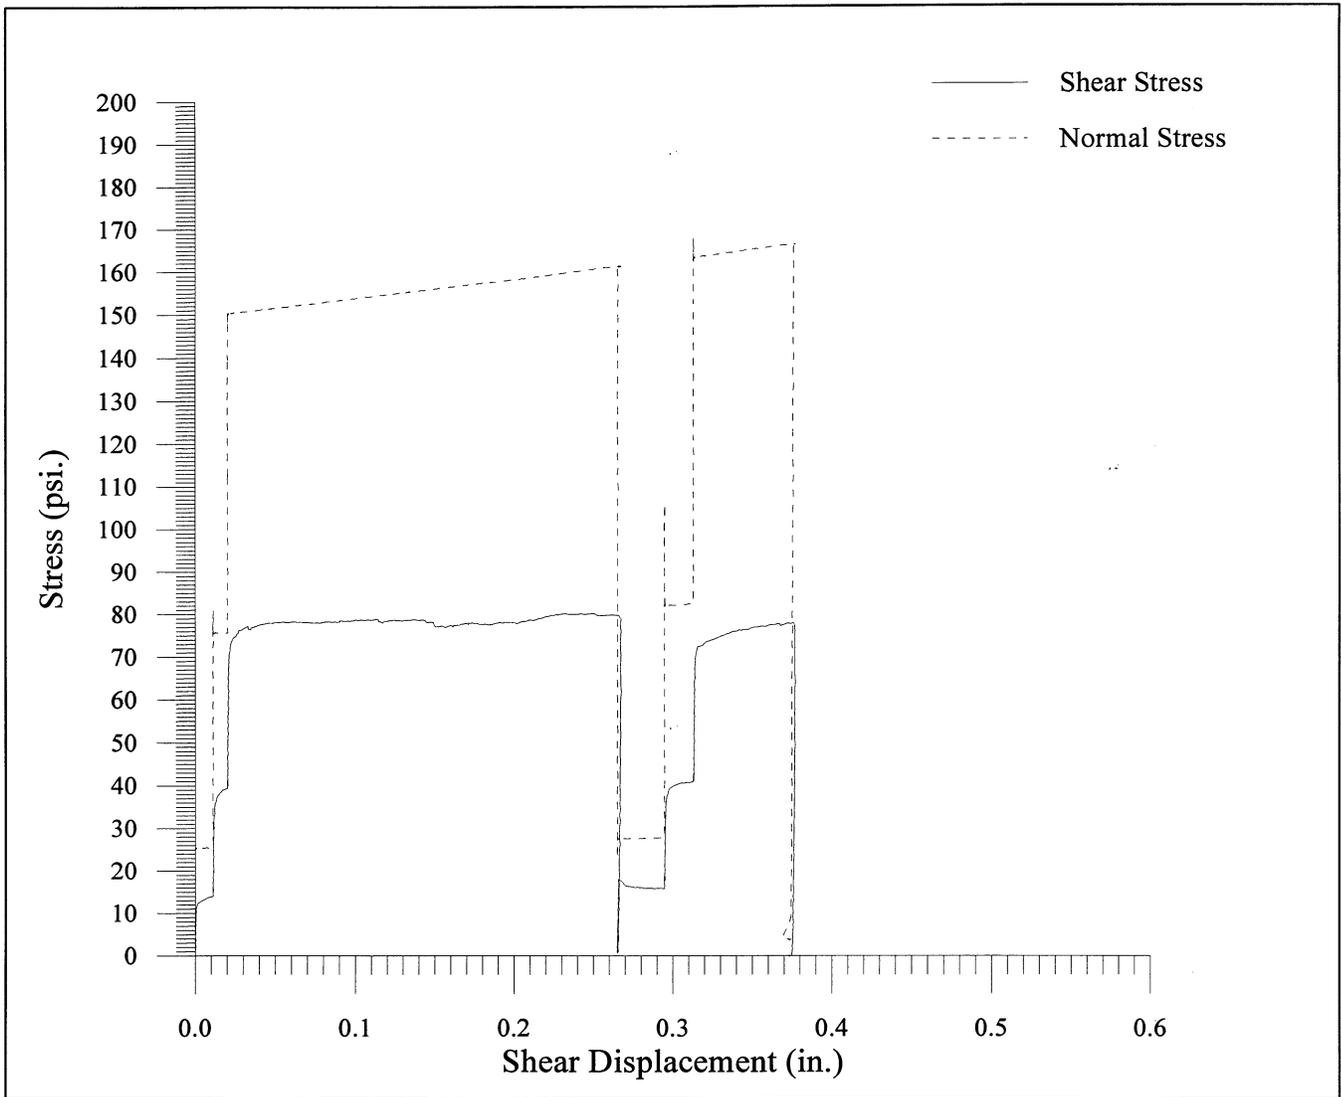
**DIRECT SHEAR TEST**  
**Shear and Normal Stress vs. Shear Displacement**

Normal Stress	Shear Strength	Initial	25.5	14	76	40	151	78	Final	27.5	16	82	41	166	77.5	
	Normal Stress	Shear Strength																	
Initial	25.5	14																	
	76	40																	
	151	78																	
Final	27.5	16																	
	82	41																	
	166	77.5

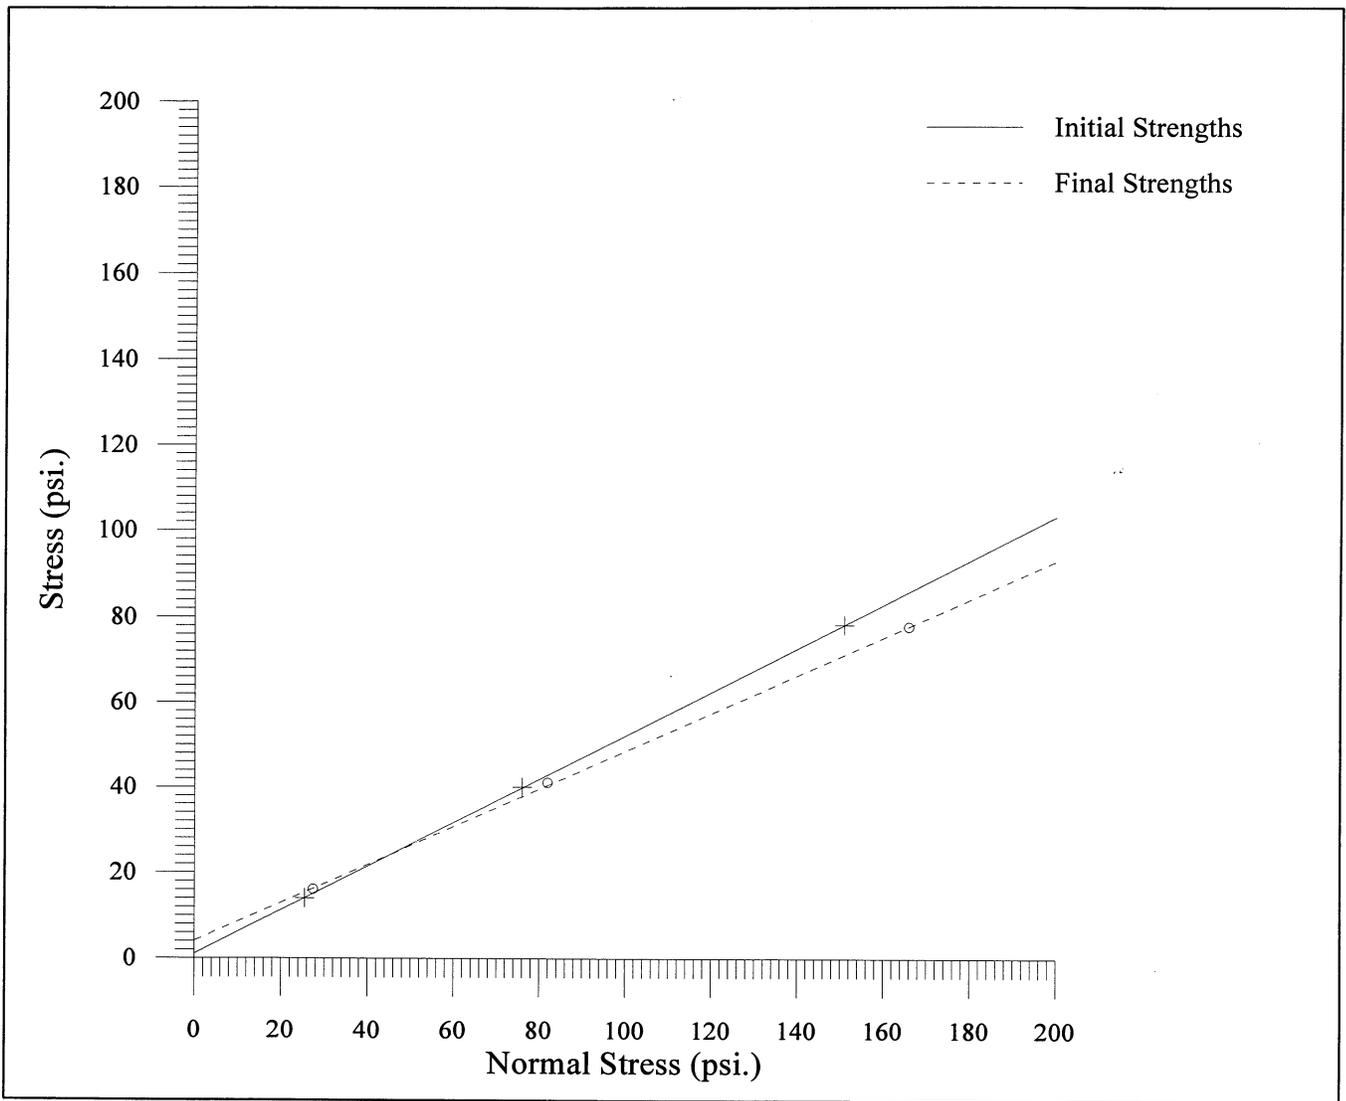
**DIRECT SHEAR TEST  
Failure Envelope**

<p><b>SAMPLE ID:</b> Boring: 98-21 Sample: 36b Depth: 135.5'</p> <p align="center"><b>DESCRIPTION</b></p> <p>Planar bedding plane joint in a thin dark gray claystone bed.</p>

<i>Test</i>  <b>Unlimited</b> 800 Peralta Ave  San Leandro, CA 94577 </p>
		Shear Intercept (psi)	Friction Angle (degrees)							
Initial	1.1	27.0								
Final	4.1	23.9								
<p><b>Client:</b> Fugro West, Inc. 5855 Olivas Park Dr. Ventura, CA 93003</p> <p><b>Project:</b> San Francisco Oakland Bay Bridge East Span Replacement Project</p> <p><b>Job Number:</b> 98-42-0053</p> <p><b>Test Date:</b> October 29, 1998</p>

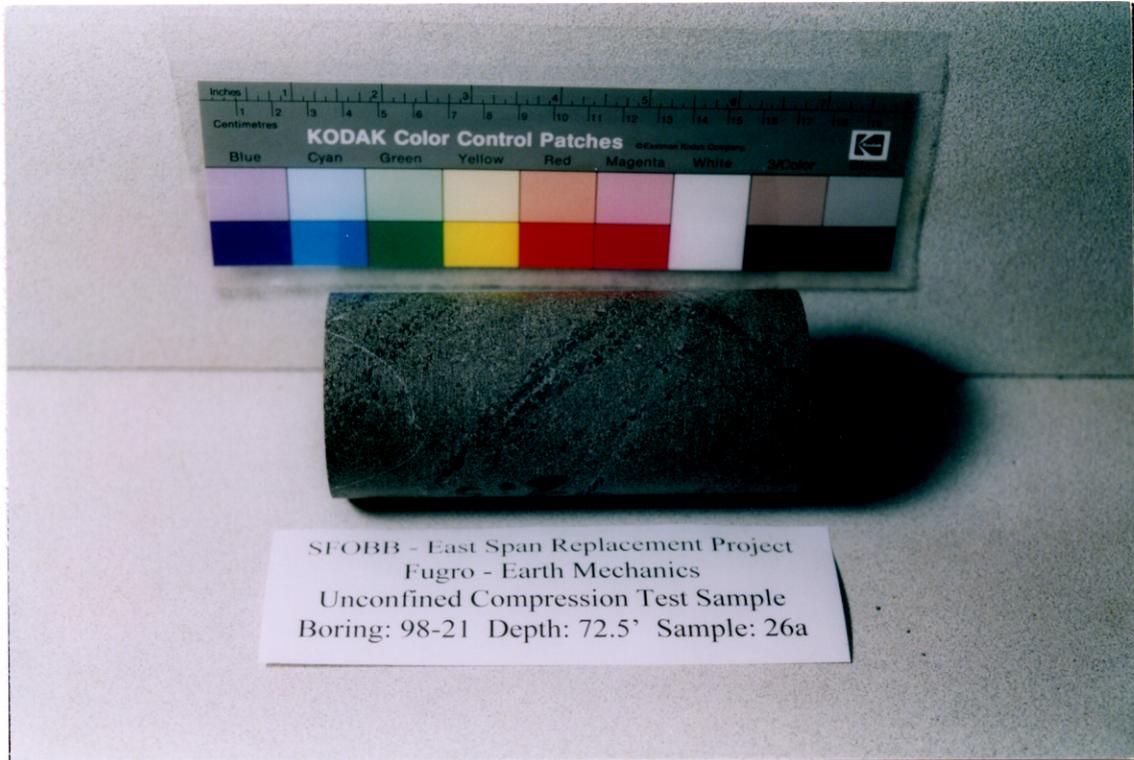
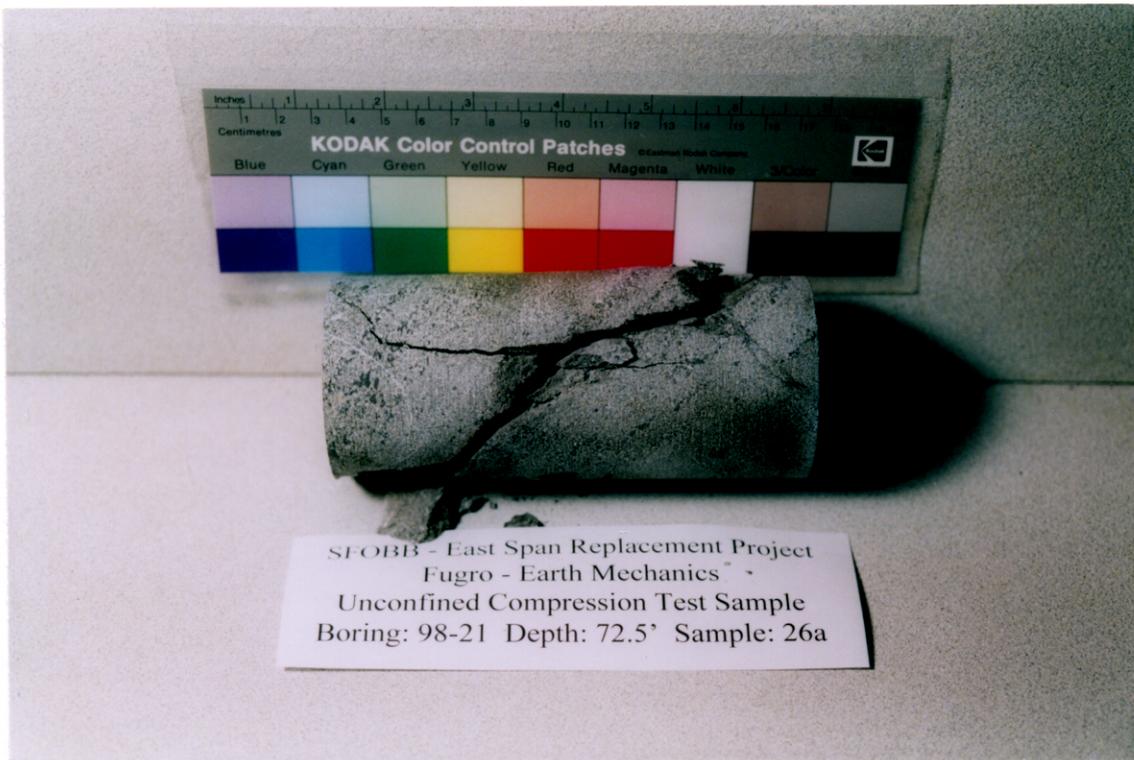
SFOBB - East Span Replacement Project  
Fugro - Earth Mechanics  
Unconfined Compression Test Sample  
Boring: 98-21 Depth: 72.5' Sample: 26a

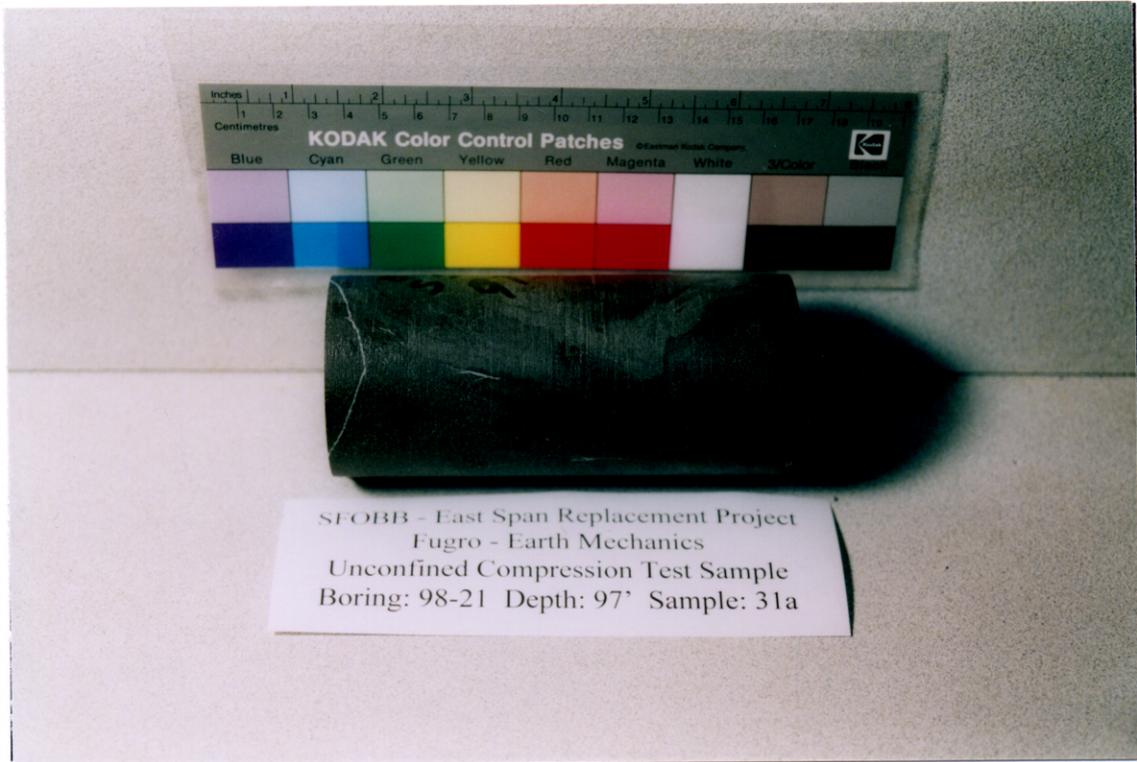
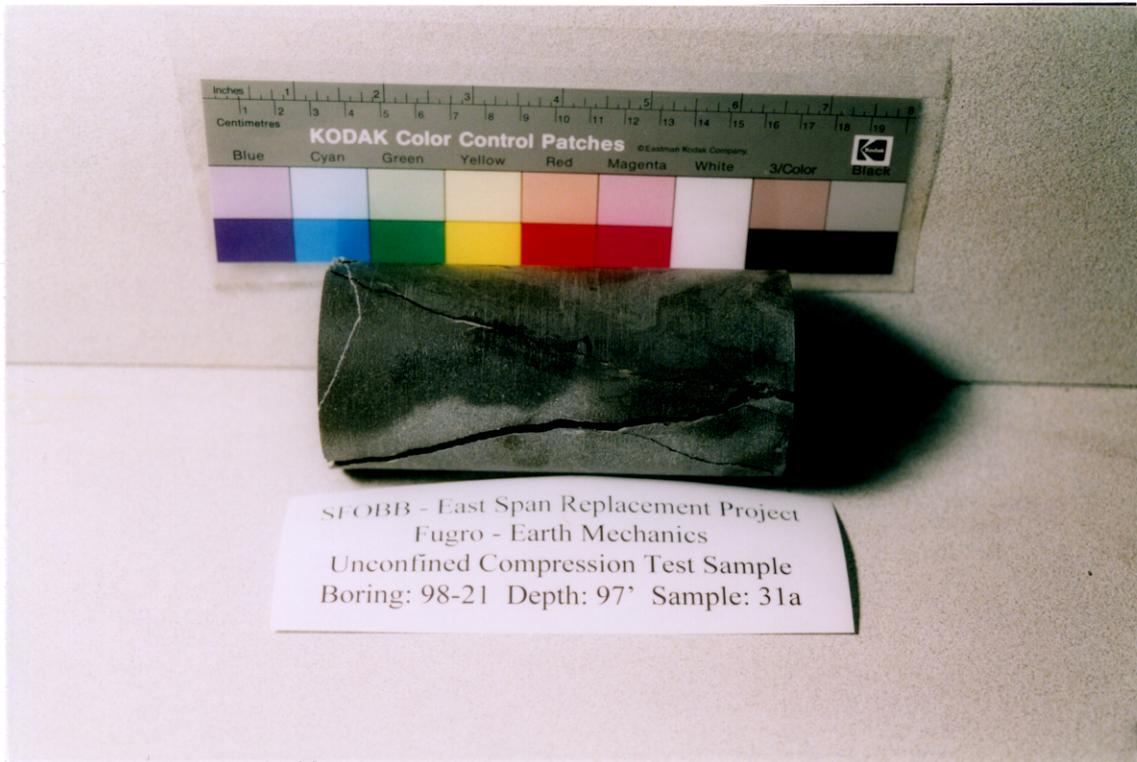
SFOBB - East Span Replacement Project  
Fugro - Earth Mechanics  
Unconfined Compression Test Sample  
Boring: 98-21 Depth: 97' Sample: 31a

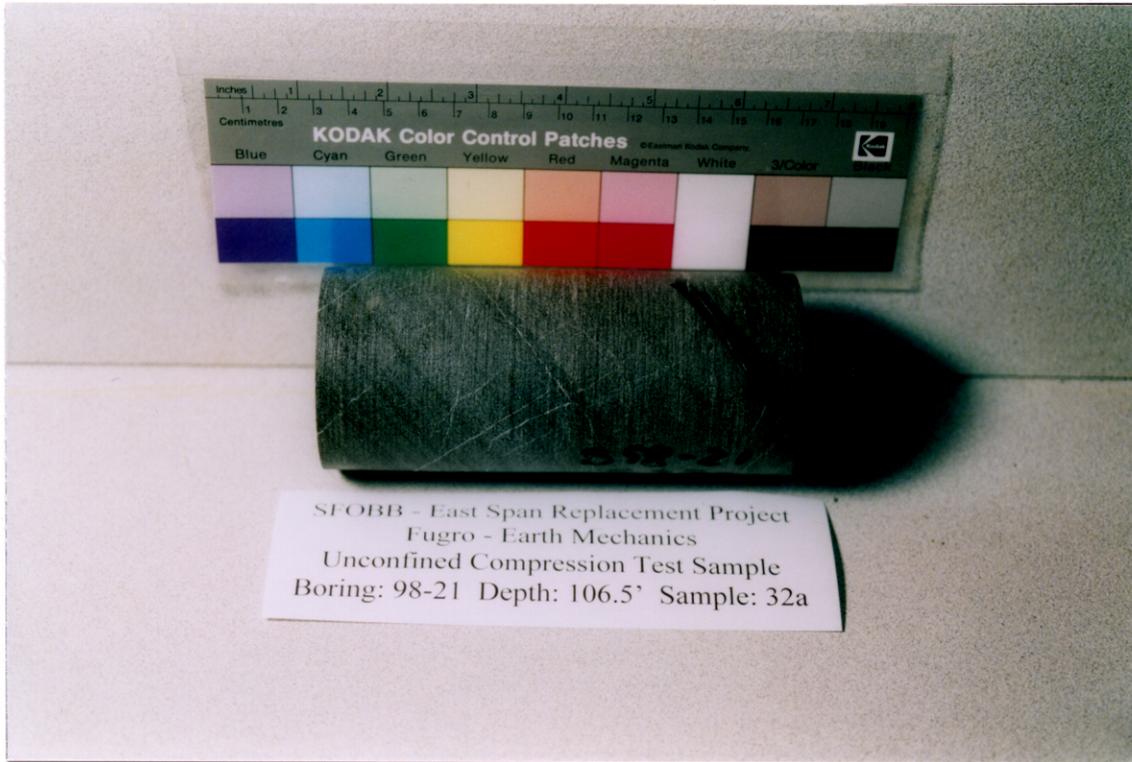
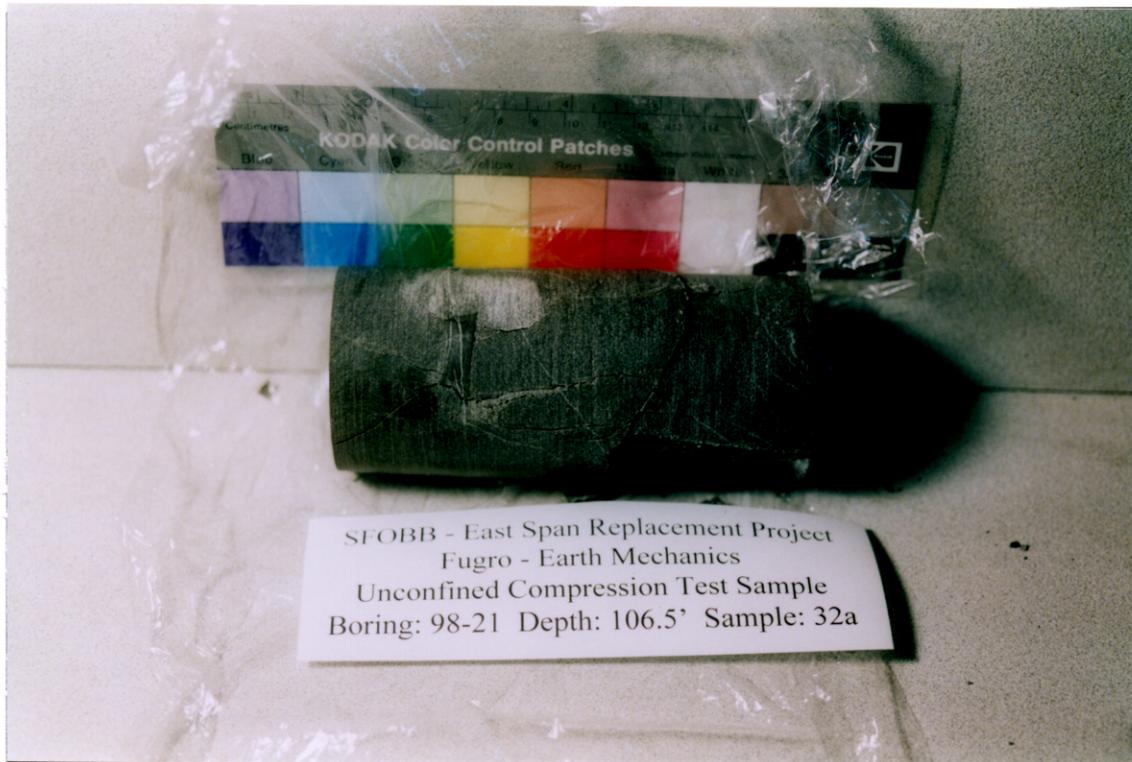
SFOBB - East Span Replacement Project  
Fugro - Earth Mechanics  
Unconfined Compression Test Sample  
Boring: 98-21 Depth: 106.5' Sample: 32a

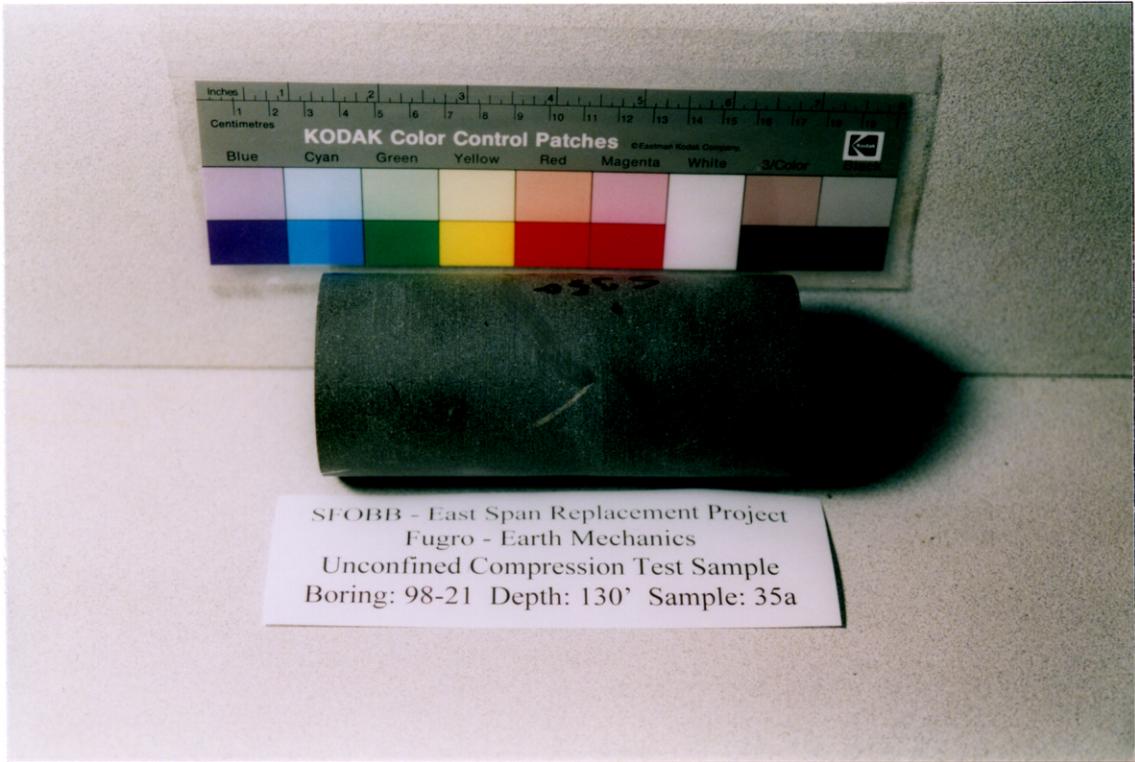
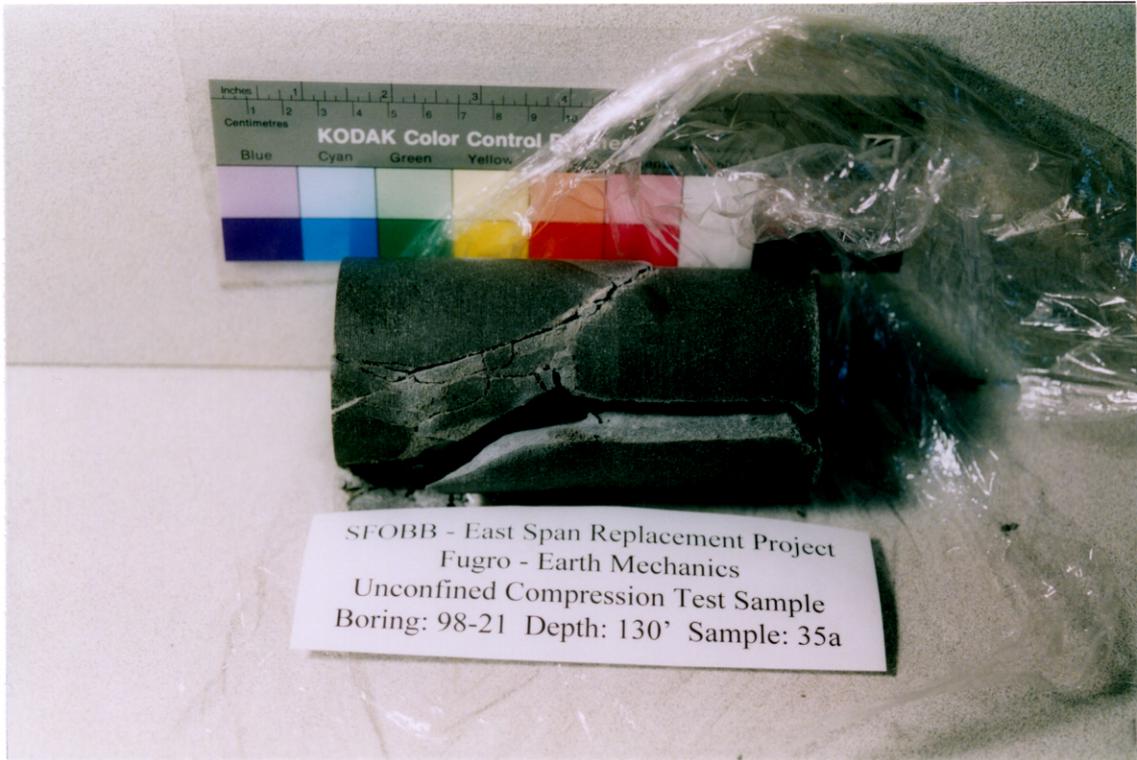
SFOBB - East Span Replacement Project  
Fugro - Earth Mechanics  
Unconfined Compression Test Sample  
Boring: 98-21 Depth: 130' Sample: 35a

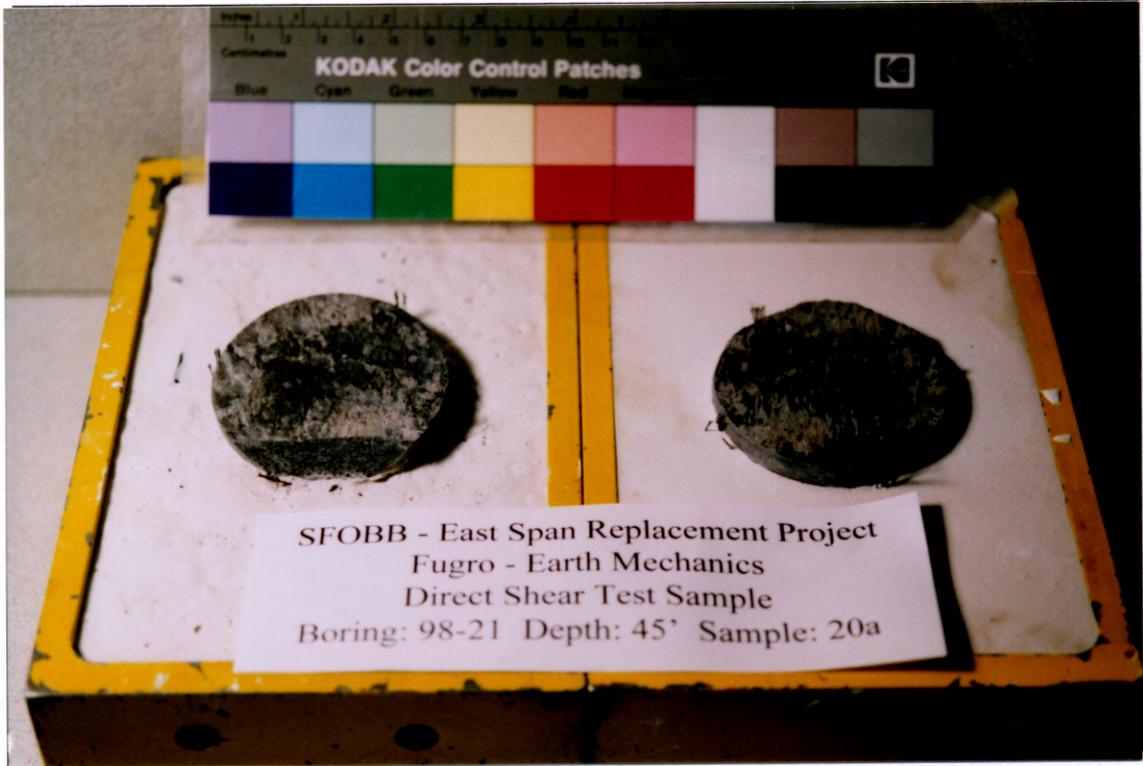
SFOBB - East Span Replacement Project  
Fugro - Earth Mechanics  
Direct Shear Test Sample  
Boring: 98-21 Depth: 45' Sample: 20a

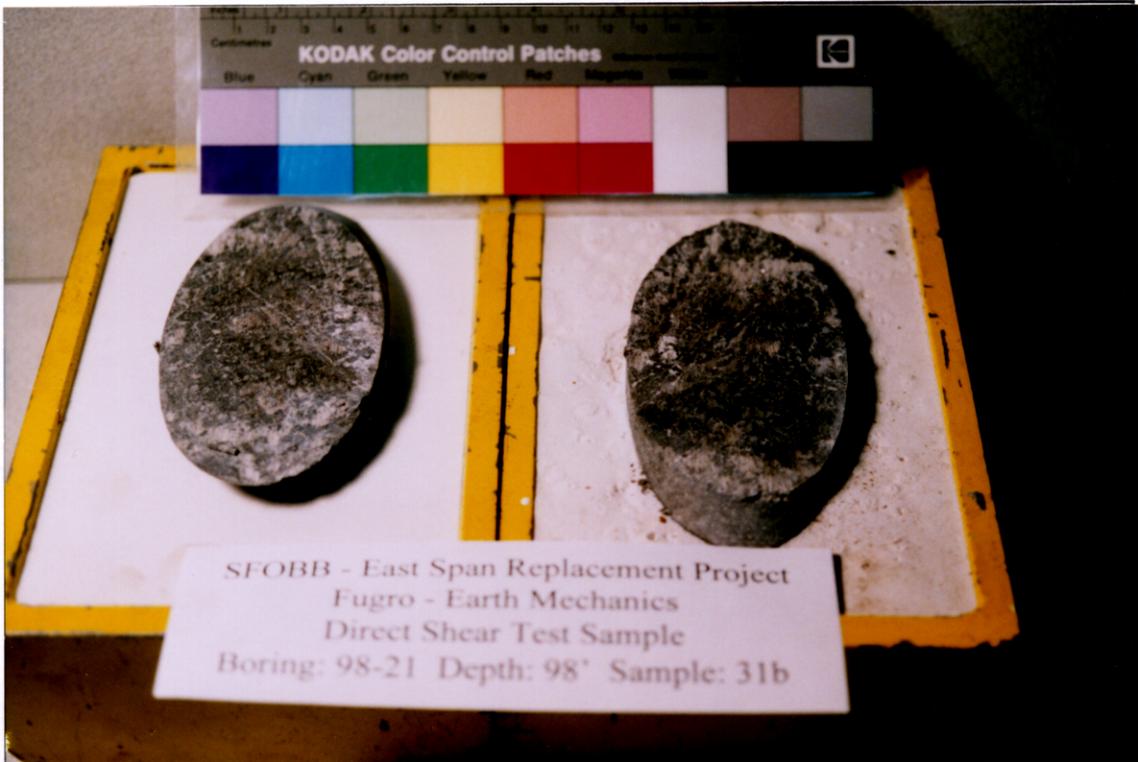
SFOBB - East Span Replacement Project  
Fugro - Earth Mechanics  
Direct Shear Test Sample  
Boring: 98-21 Depth: 98' Sample: 31b
