**SUBCONTRACTOR REPORTS  
FINAL GEOTECHNICAL  
SITE CHARACTERIZATION**

**SAN FRANCISCO-OAKLAND BAY BRIDGE  
EAST SPAN SEISMIC SAFETY PROJECT**

**VOLUME 2 OF 3  
(GeoTest Unlimited)**

Letter Report  
San Francisco Oakland Bay Bridge  
East Span Replacement Project  
Rock Testing Program

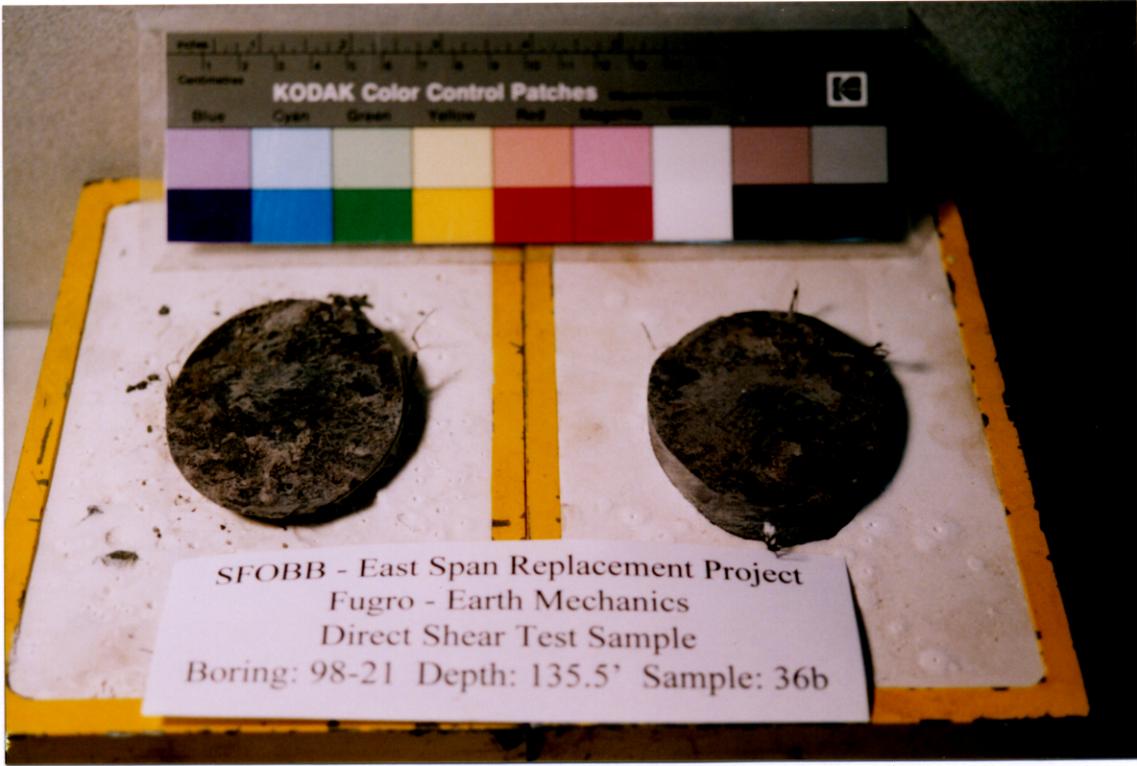
SFOBB - East Span Replacement Project  
Fugro - Earth Mechanics  
Direct Shear Test Sample  
Boring: 98-21 Depth: 135.5' Sample: 36b

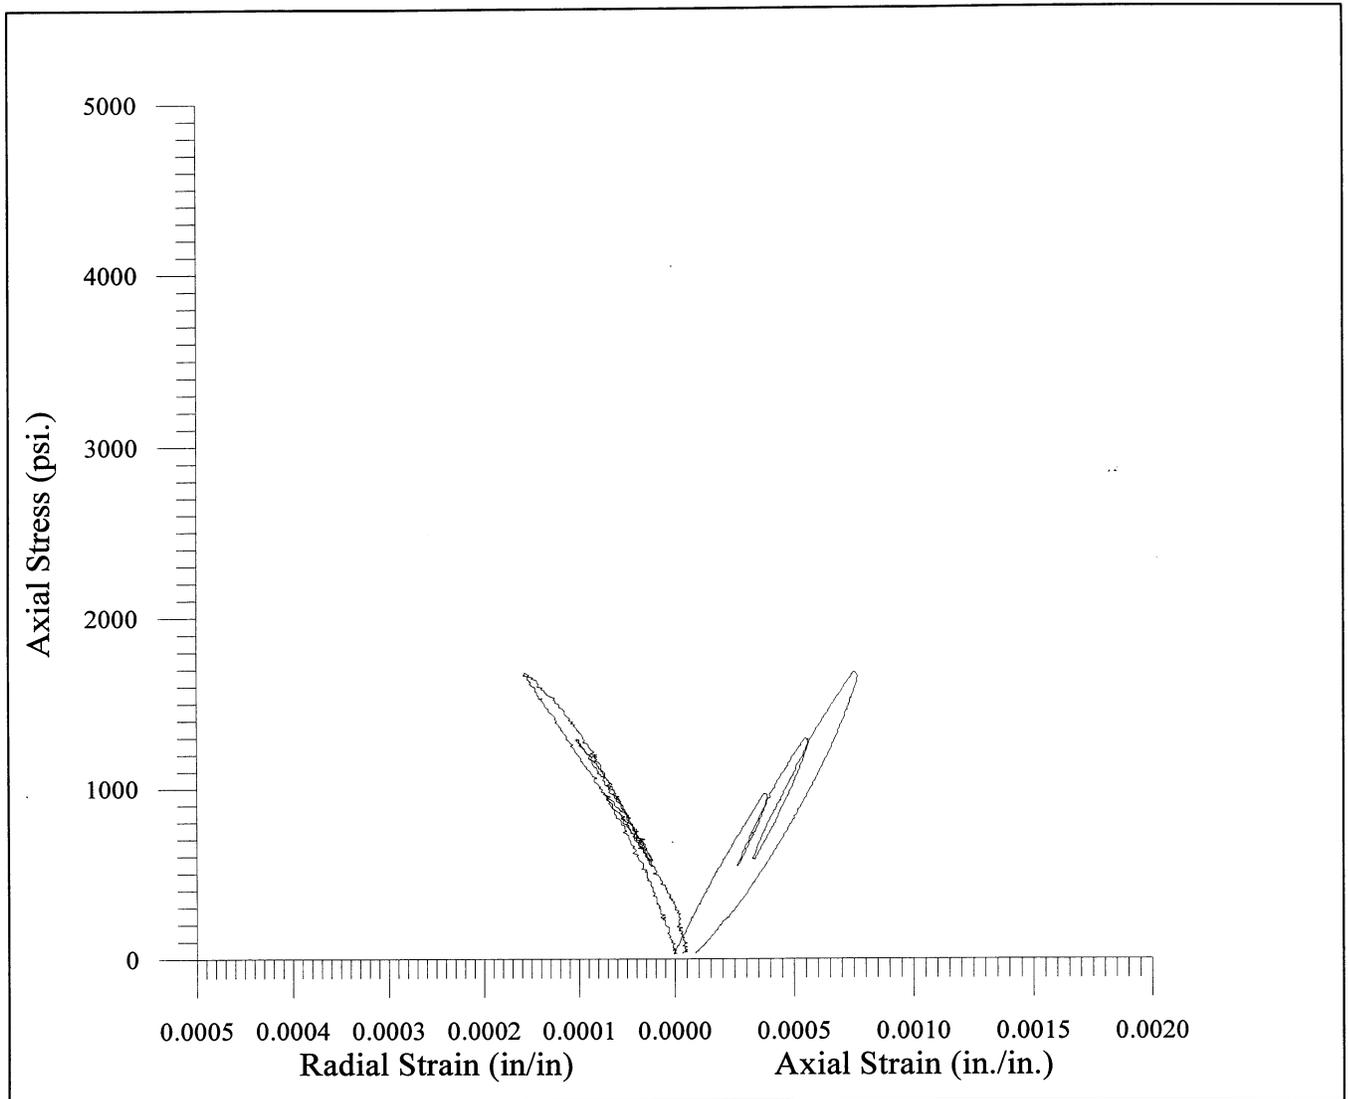
**ELASTIC MODULUS TEST**  
**Axial Stress vs. Axial & Radial Strain**

<p><b>SAMPLE ID:</b> Boring: 98-22  Sample: 16a  Depth: 35'</p> <p align="center"><b>DESCRIPTION</b></p> <p>Tan weathered massive sandstone.</p> <p><b>MODULUS:</b> 2,780,000 psi  <b>POISSON'S RATIO:</b> .31</p>	<p align="center"> <i>Geo</i>

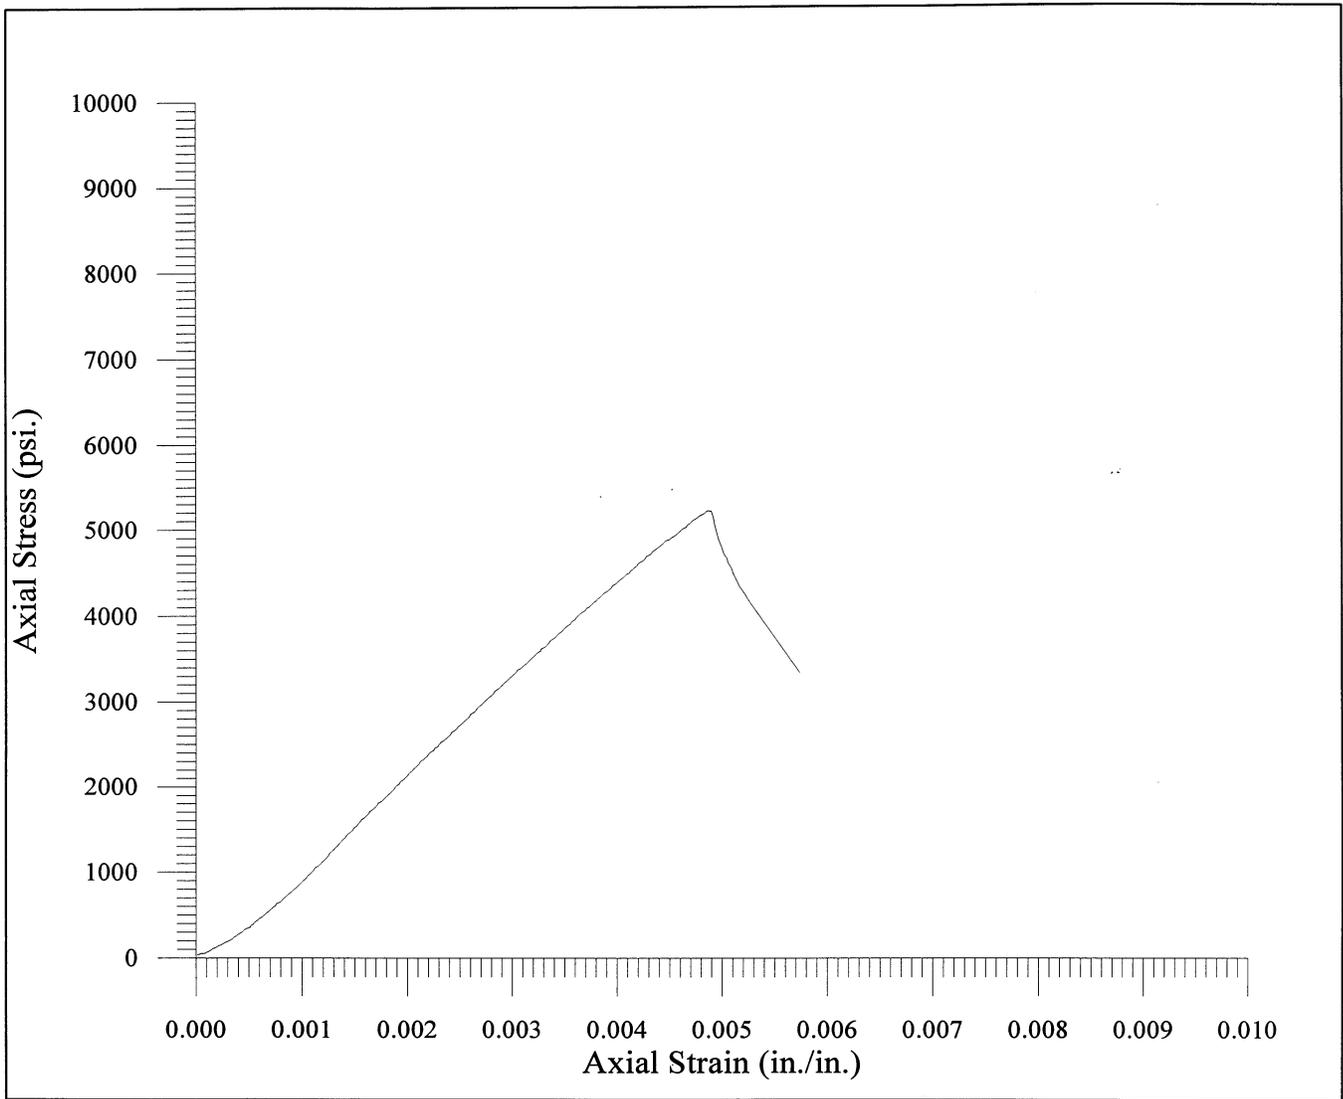
**UNCONFINED COMPRESSION TEST**  
**Axial Stress vs. Axial Strain**

<p><b>SAMPLE ID:</b> Boring : 98-22 Sample: 16a Depth: 35'</p> <p style="text-align: center;"><b>DESCRIPTION</b></p> <p style="text-align: center;">Tan weathered massive sandstone.</p> <p><b>STRENGTH:</b> 5217 psi</p>	<div style="text-align: center;">

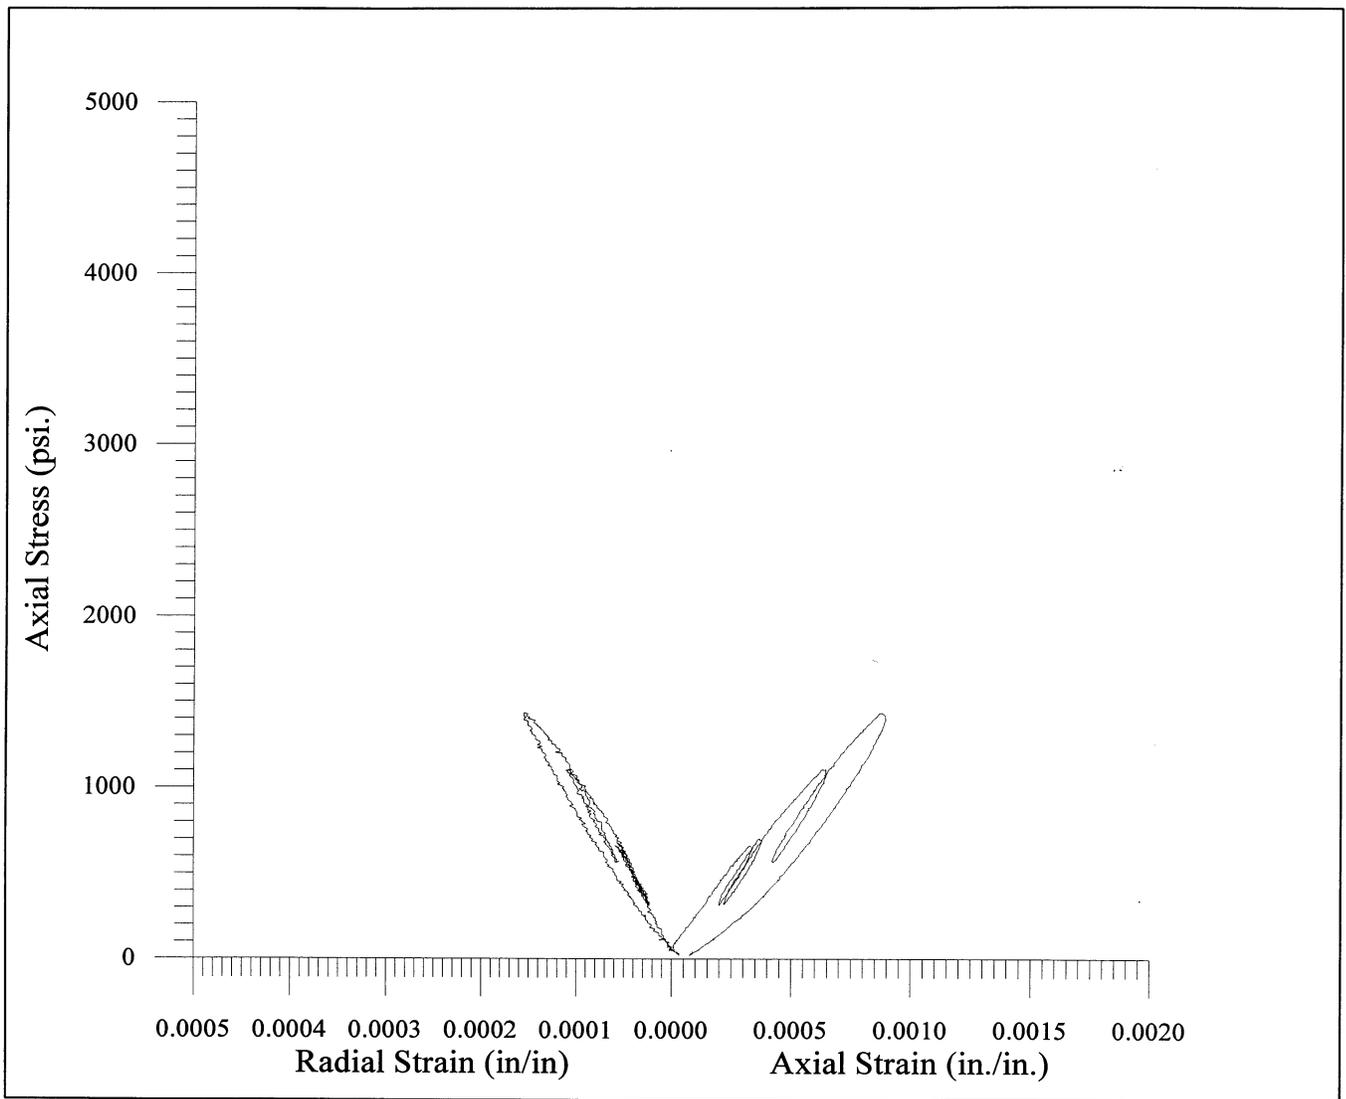
**ELASTIC MODULUS TEST**  
**Axial Stress vs. Axial & Radial Strain**

<p><b>SAMPLE ID:</b> Boring: 98-22          Sample: 17a          Depth: 38.5'</p>	<p align="center"> <i>Geo</i>

<i>U</i>  <i>Test</i>  <b>Unlimited</b> 800 Peralta Ave          San Leandro, CA 94577       </p>
<p align="center"><b>DESCRIPTION</b></p> <p>Olive gray sandy siltstone with a few yellowish tan fine sandstone inclusions and a few partially healed fractures.</p> <p><b>MODULUS:</b> 2,240,000 psi  <b>POISSON'S RATIO:</b> .20</p>	
<p><b>Test Date:</b> October 18, 1998</p>

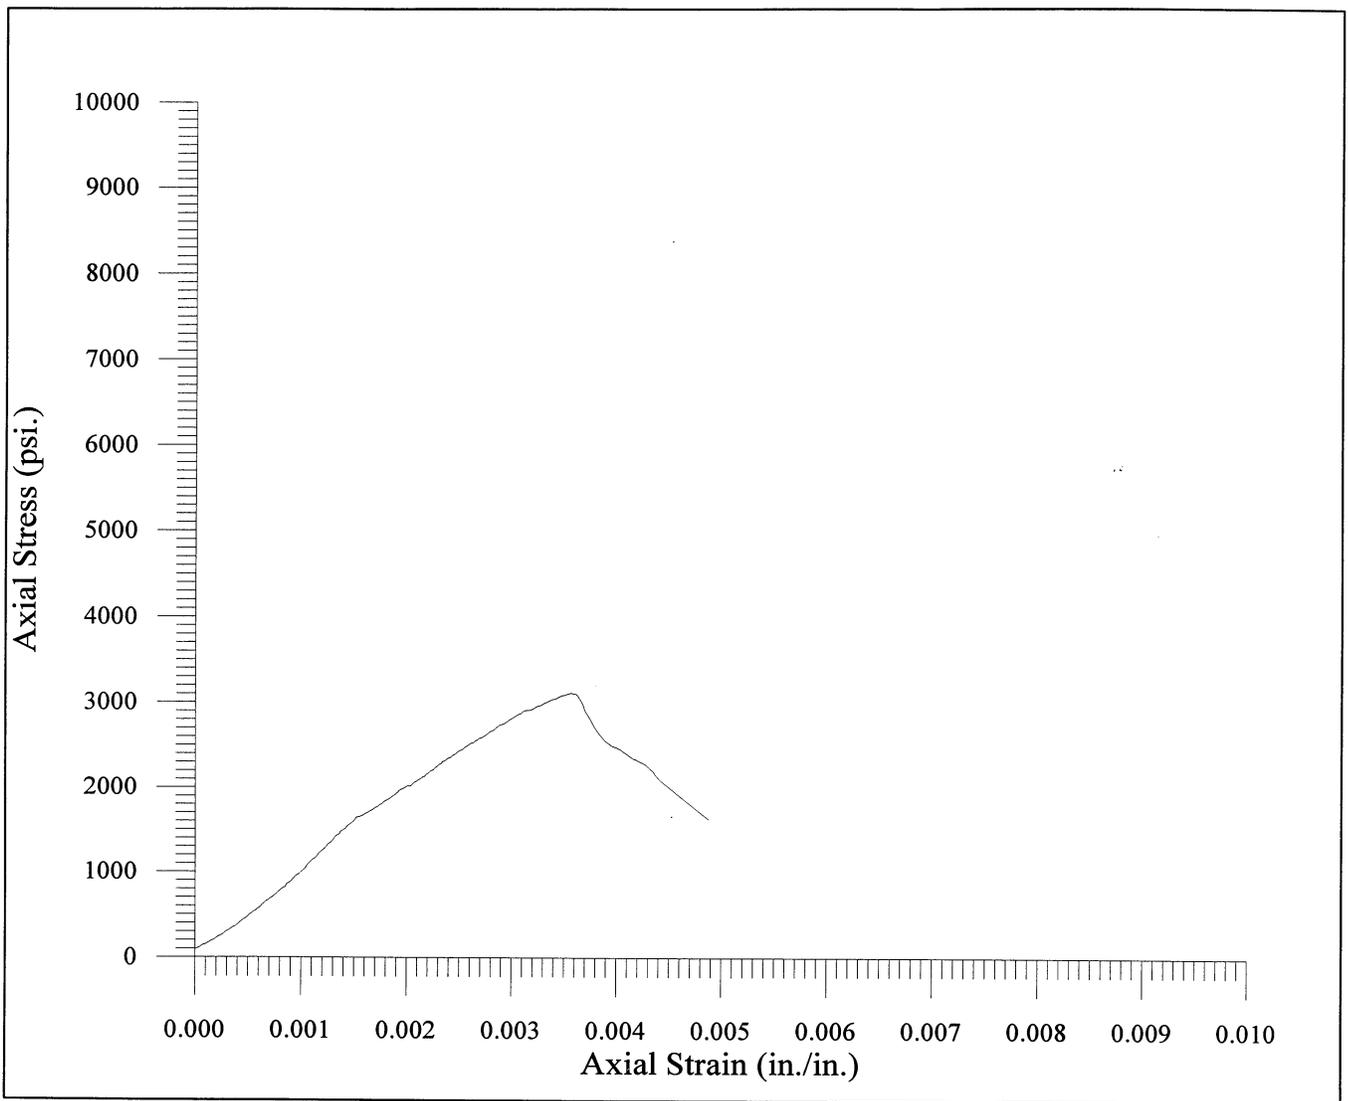
**UNCONFINED COMPRESSION TEST**  
**Axial Stress vs. Axial Strain**

**SAMPLE ID:** Boring : 98-22  
 Sample: 17a  
 Depth: 38.5'

Olive gray sandy siltstone with a few yellowish tan fine sandstone inclusions and a few partially healed fractures.

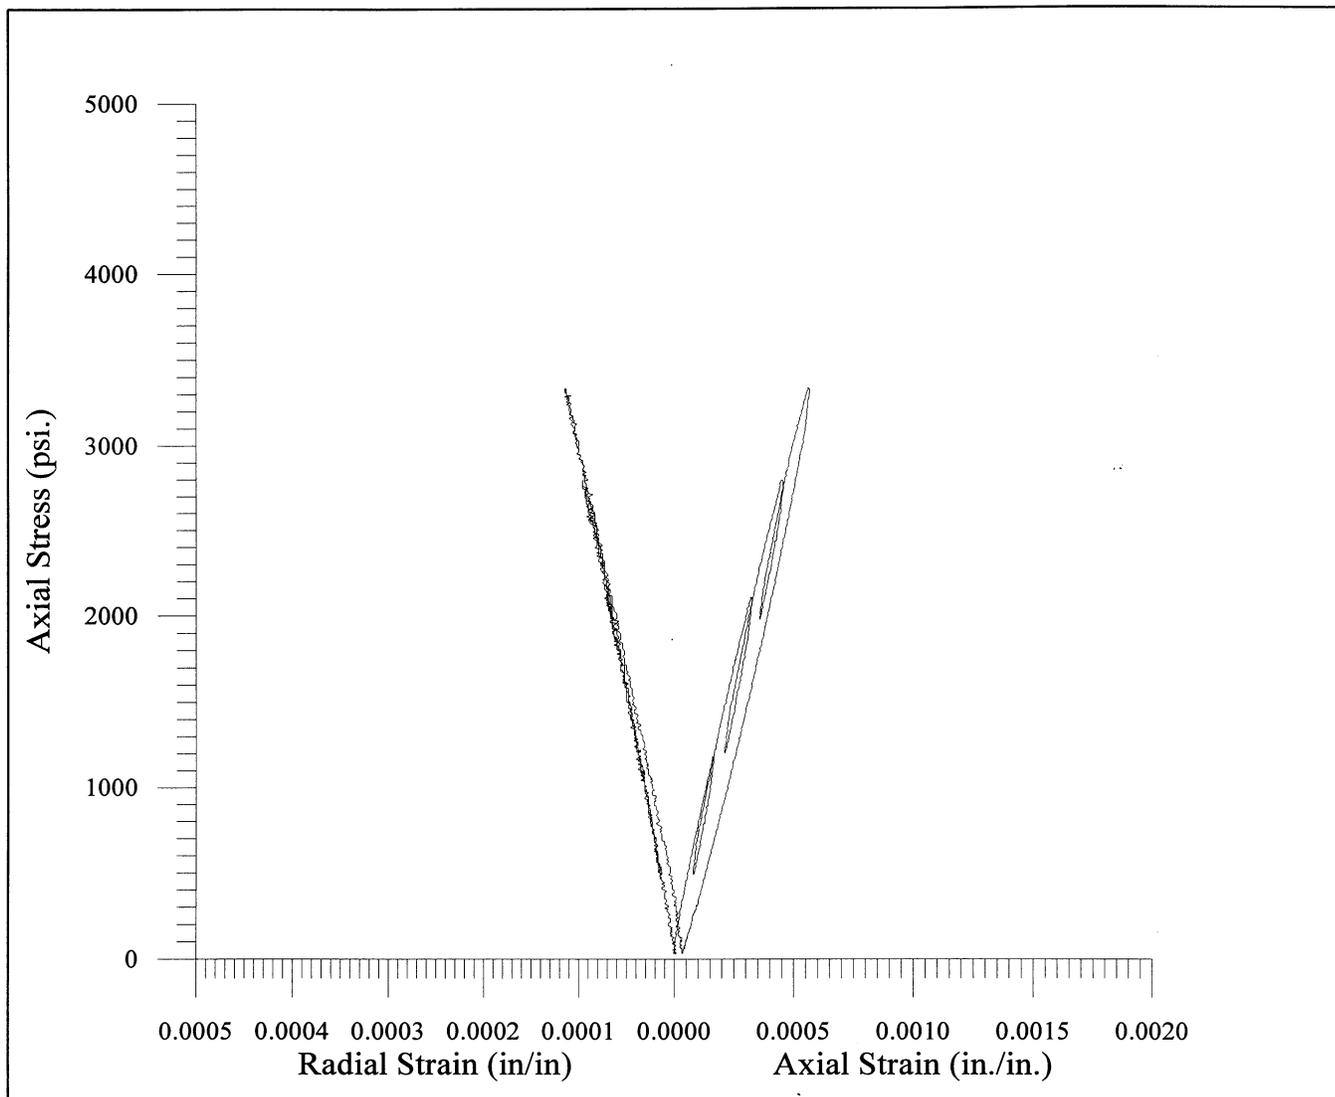
**ELASTIC MODULUS TEST**  
**Axial Stress vs. Axial & Radial Strain**

<p><b>SAMPLE ID:</b> Boring: 98-22  Sample: 18a  Depth: 48'</p> <p style="text-align: center;"><b>DESCRIPTION</b></p> <p>Medium gray sandstone with calcite healed fractures 0, 32, and 53 degrees to the core axis.</p> <p><b>MODULUS:</b> 7,580,000 psi  <b>POISSON'S RATIO:</b> .25</p>	<div style="text-align: center;">

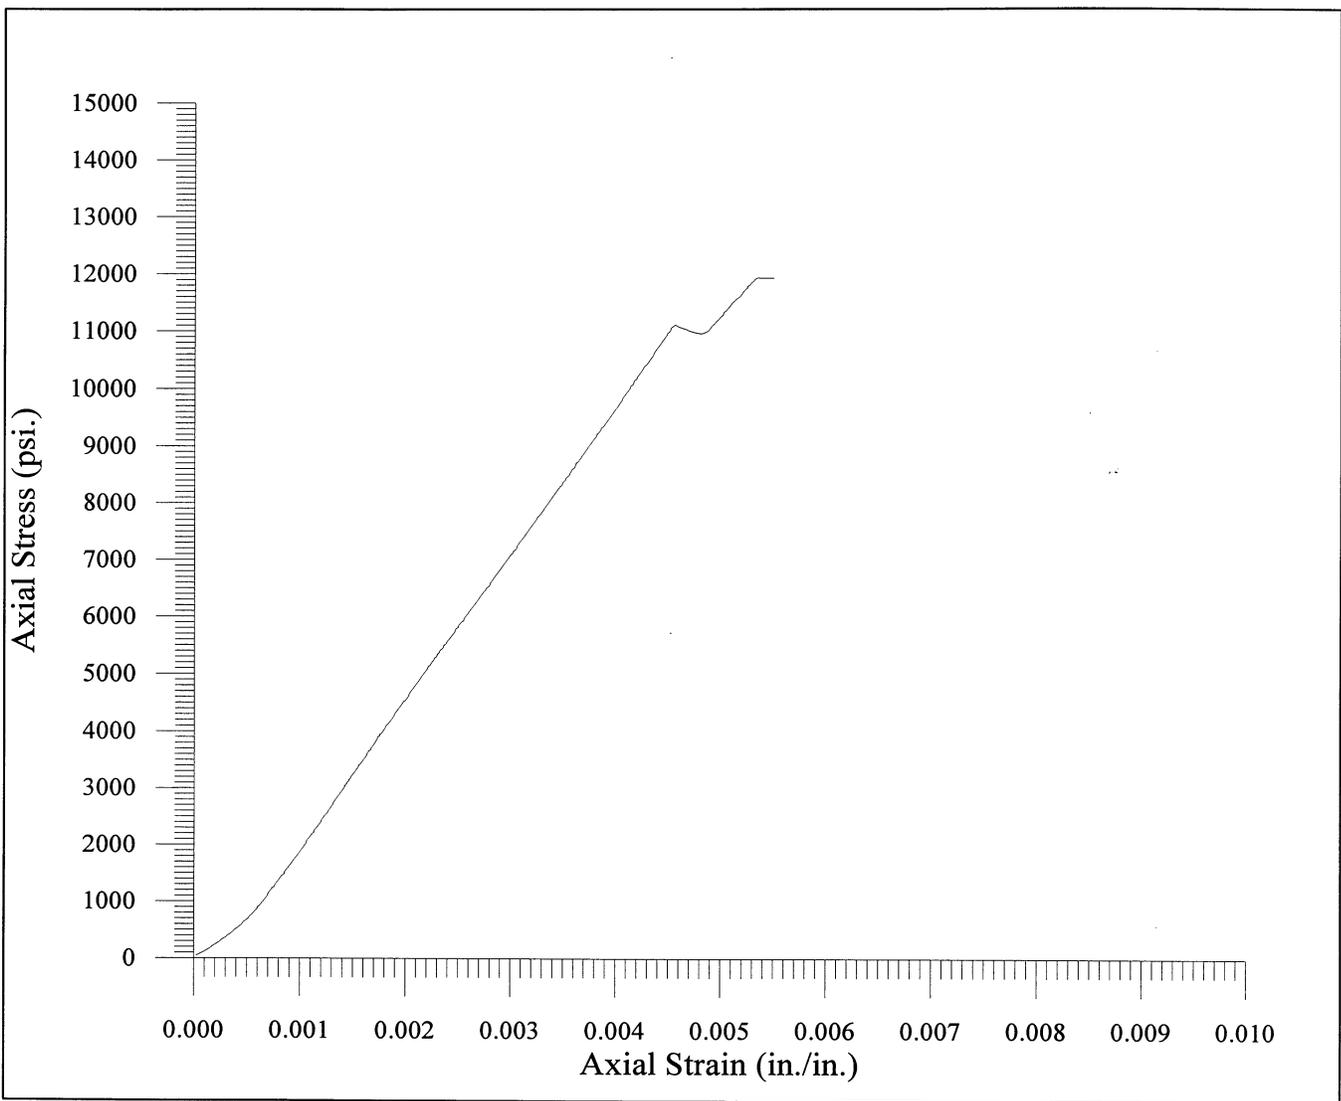
**UNCONFINED COMPRESSION TEST**  
**Axial Stress vs. Axial Strain**

<p><b>SAMPLE ID:</b> Boring : 98-22          Sample: 18a          Depth: 48'</p>	<p align="center"> <i>Geo</i>

<i>Test</i>  <b>Unlimited</b> 800 Peralta Ave          San Leandro, CA 94577       </p>
<p align="center"><b>DESCRIPTION</b></p> <p>Medium gray sandstone with calcite healed fractures 0, 32, and 53 degrees to the core axis.</p> <p><b>STRENGTH:</b> 11,934 psi</p>	<p><b>Client:</b> Fugro West, Inc.          5855 Olivas Park Dr.          Ventura, CA 93003</p> <p><b>Project:</b> San Francisco Oakland Bay Bridge          East Span Replacement Project</p> <p><b>Job Number:</b> 98-42-0053</p>
	<p><b>Test Date:</b> October 19, 1998</p>

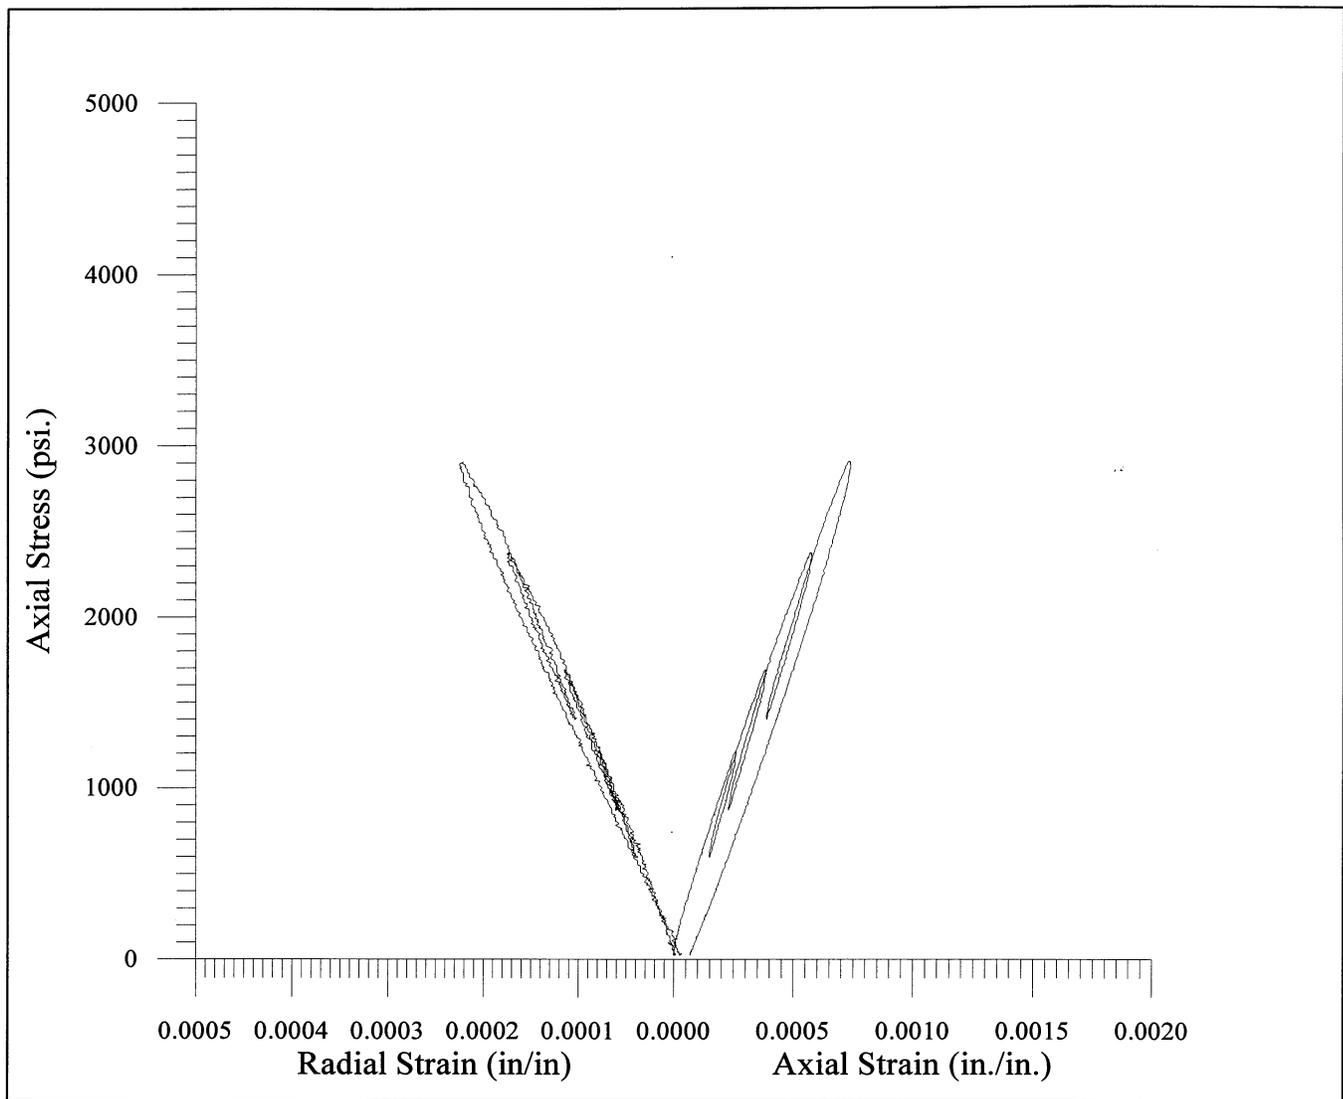
**ELASTIC MODULUS TEST**  
**Axial Stress vs. Axial & Radial Strain**

<p><b>SAMPLE ID:</b> Boring: 98-22  Sample: 20a  Depth: 59'</p> <p><b>DESCRIPTION</b>  Medium gray massive sandy siltstone with a few small claystone inclusions.</p> <p><b>MODULUS:</b> 4,900,000 psi  <b>POISSON'S RATIO:</b> .34</p>	<p align="center"> <i>Geo</i>

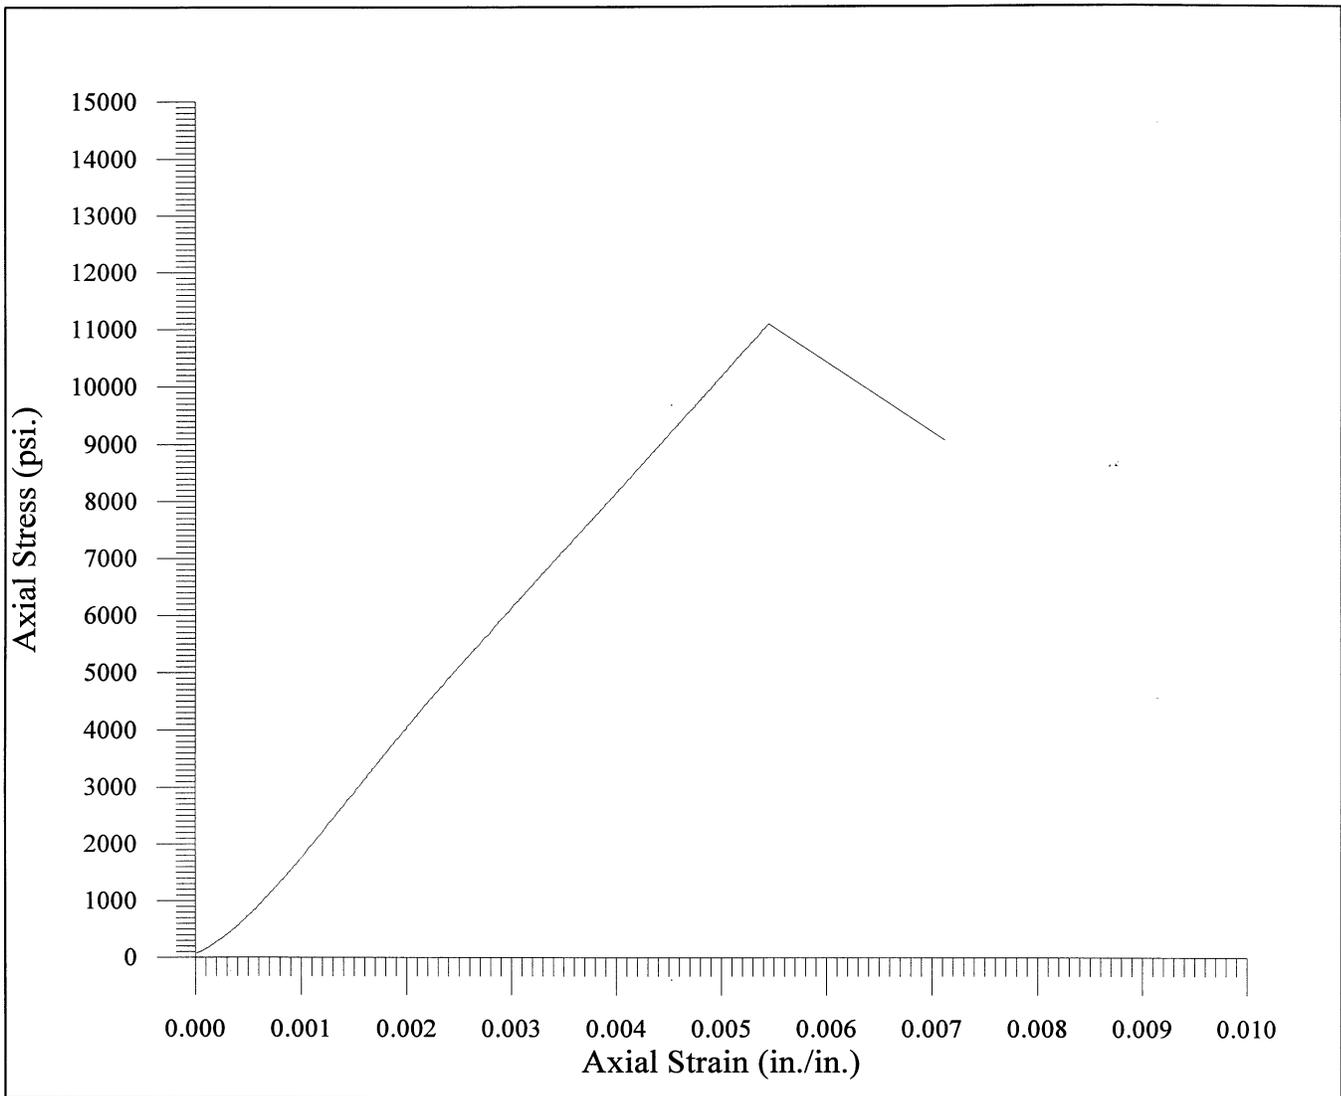
**UNCONFINED COMPRESSION TEST**  
**Axial Stress vs. Axial Strain**

<p><b>SAMPLE ID:</b> Boring : 98-22 Sample: 20a Depth: 59'</p> <p style="text-align: center;"><b>DESCRIPTION</b></p> <p>Medium gray massive sandy siltstone with a few small claystone inclusions.</p> <p><b>STRENGTH:</b> 11,087 psi</p>	<div style="text-align: center;">

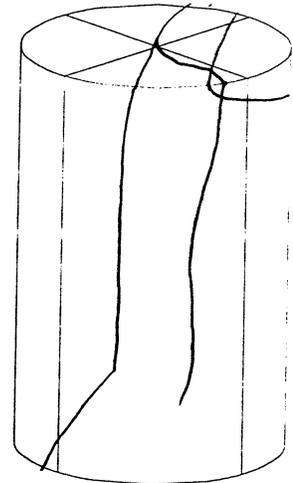
Sample Description: medium gray sandstone with a few calcite healed (partially) axial fractures

Comments: Failed by shear on existing joint

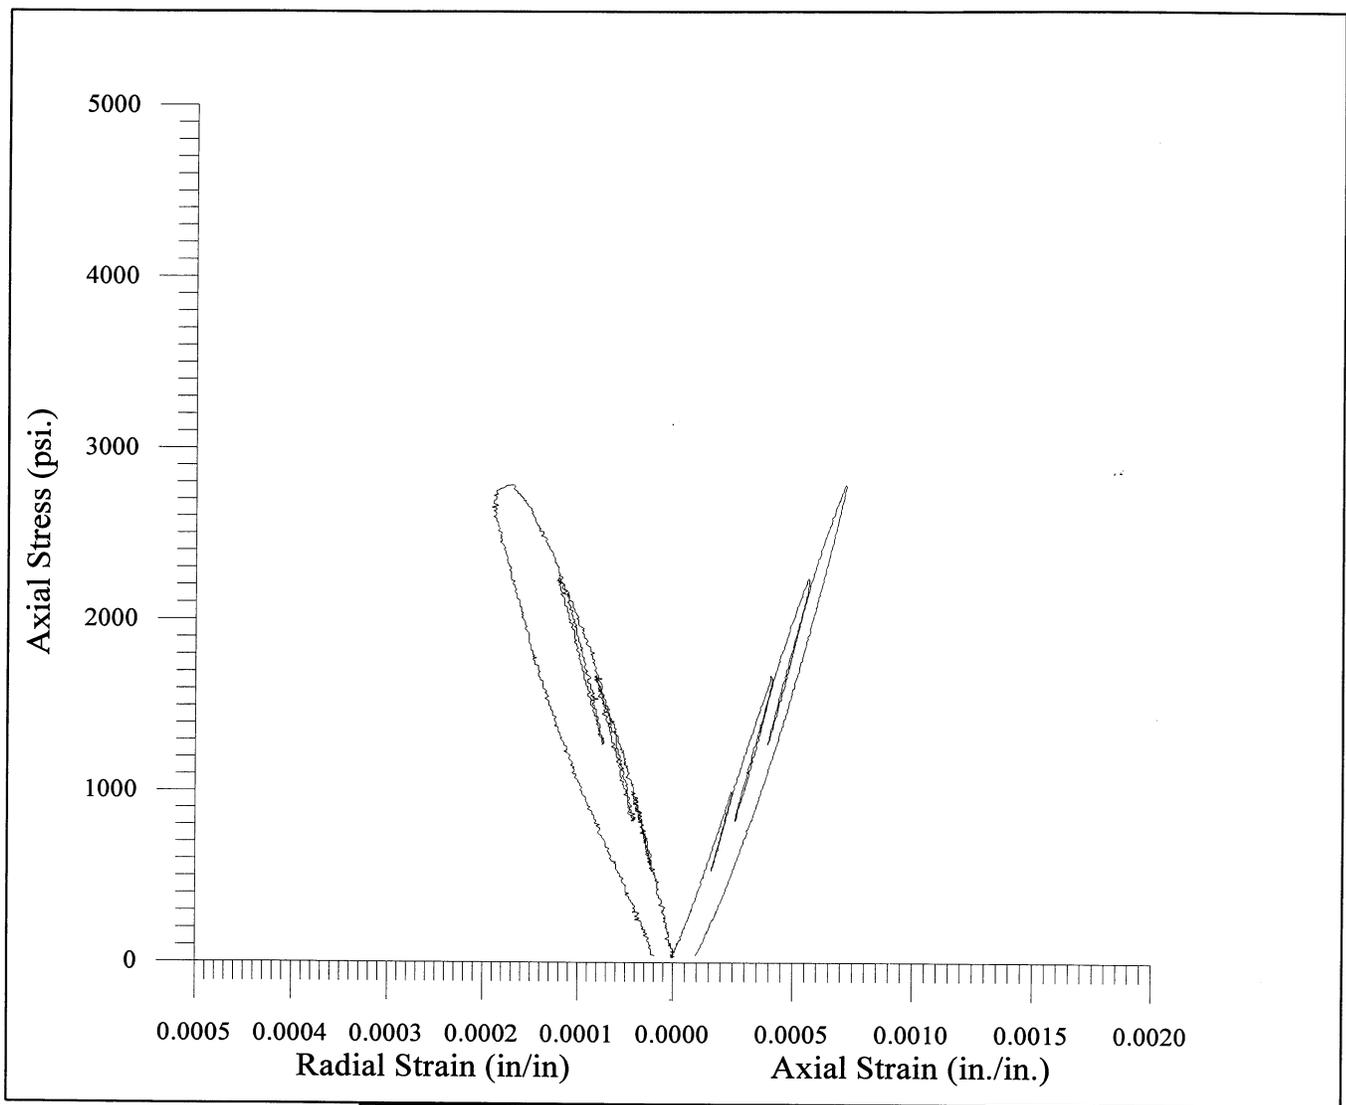
**ELASTIC MODULUS TEST**  
**Axial Stress vs. Axial & Radial Strain**

**SAMPLE ID:** Boring: 98-22  
 Sample: 21a  
 Depth: 70'

**DESCRIPTION**  
 Medium gray sandstone with a few axial fractures partially healed with calcite.

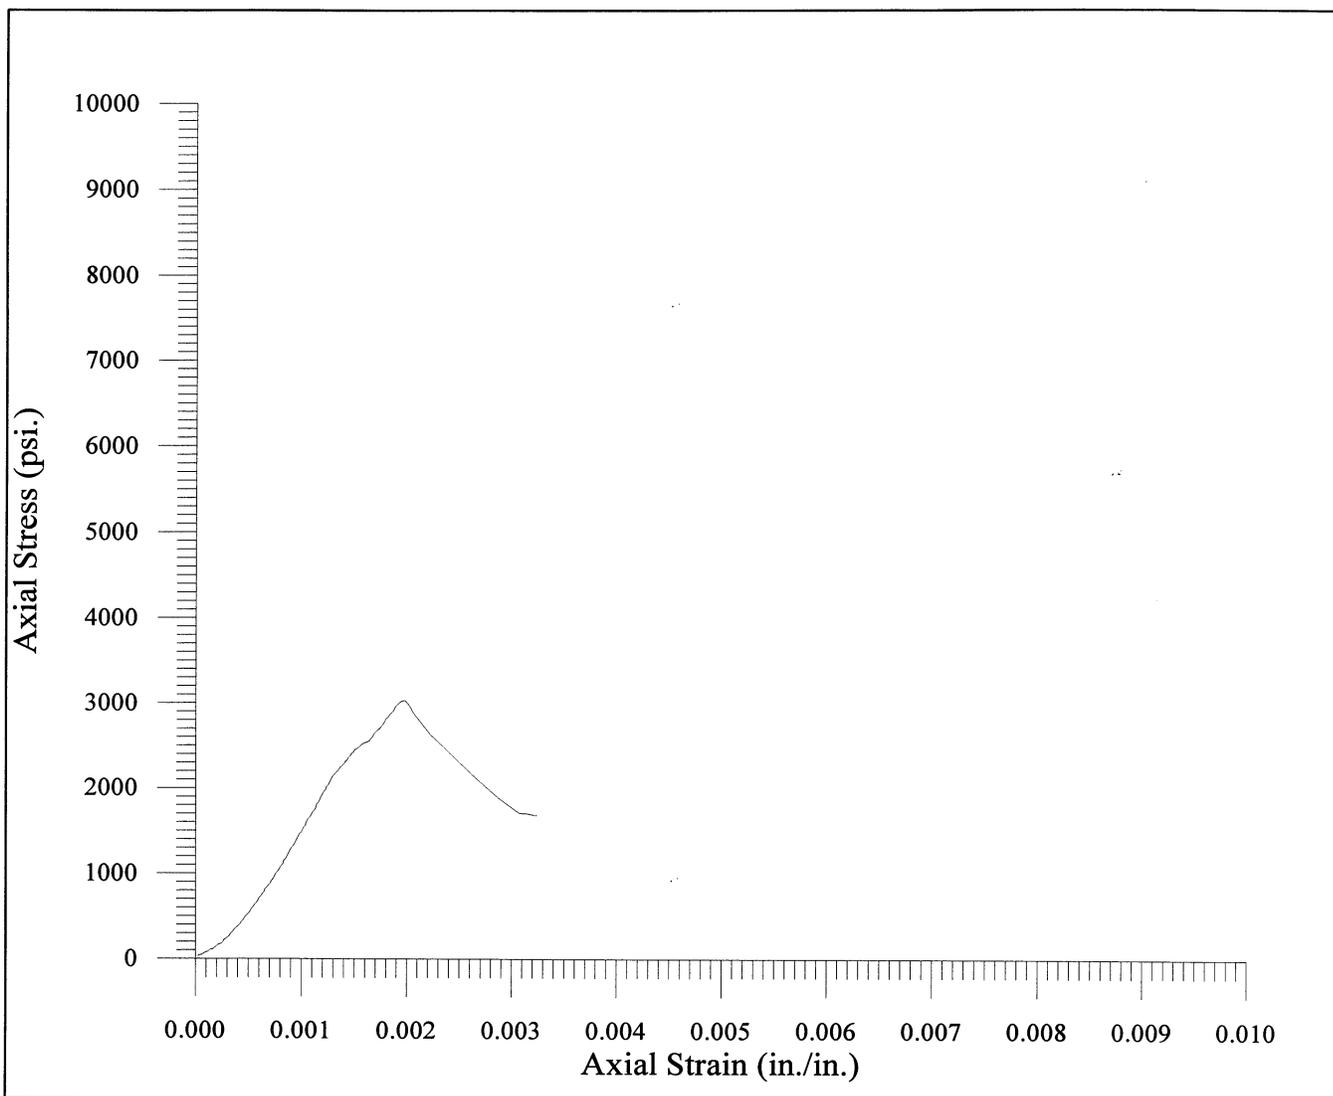
**UNCONFINED COMPRESSION TEST**  
**Axial Stress vs. Axial Strain**

<p><b>SAMPLE ID:</b> Boring : 98-22          Sample: 21a          Depth: 70'</p> <p align="center"><b>DESCRIPTION</b></p> <p align="center">Medium gray sandstone with a few axial fractures partially healed with calcite.</p> <p><b>STRENGTH:</b> 3030 psi</p>	<p align="center"> <i>Geo</i>

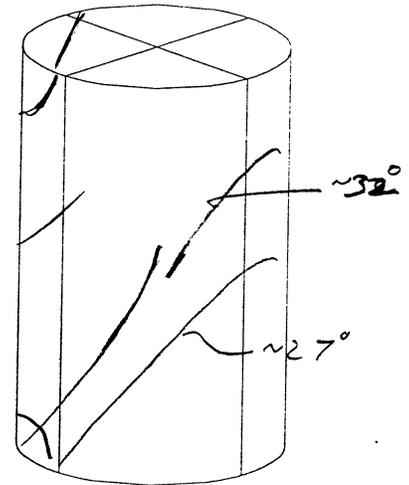
Sample Description: medium gray sandstone with a few diagonal calcite healed fractures

Comments: SZ1a, SZ1a (b) & SZ1a (c) were tested to investigate the sample variation in a very flat length. These samples were immediately adjacent to each other.

Failed by axial splitting.

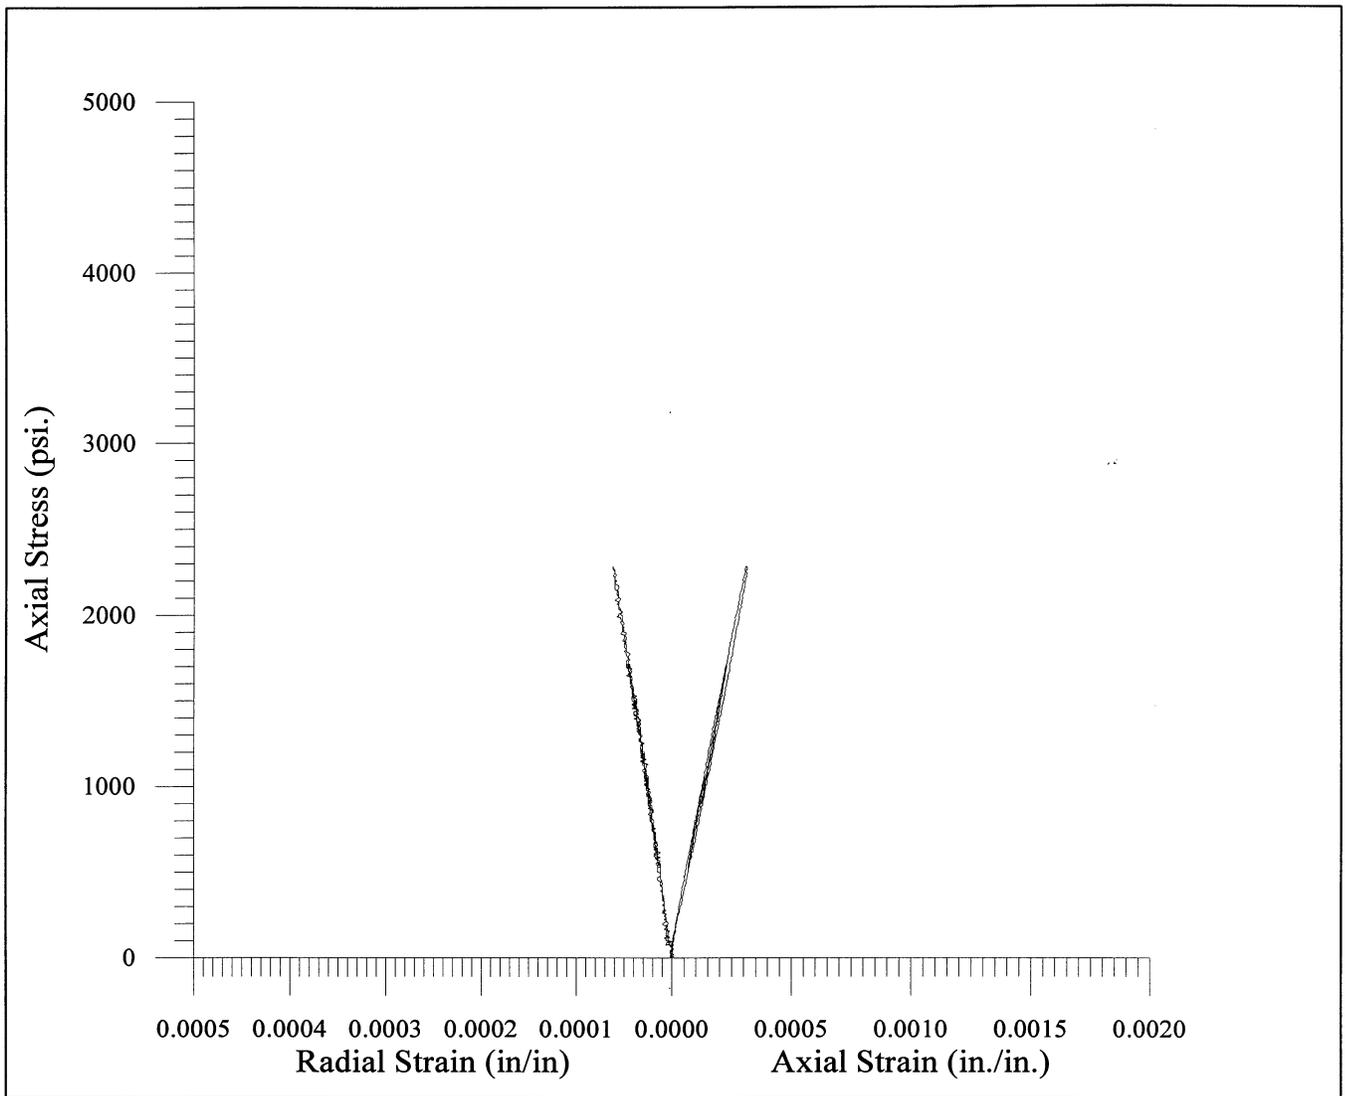
**ELASTIC MODULUS TEST**  
**Axial Stress vs. Axial & Radial Strain**

<p><b>SAMPLE ID:</b> Boring: 98-22  Sample: 21a(b)  Depth: 70.5'</p> <p style="text-align: center;"><b>DESCRIPTION</b></p> <p>Medium gray sandstone with a few calcite healed fractures, 27 and 32 degrees to the core axis.</p> <p><b>MODULUS:</b> 7,690,000 psi  <b>POISSON'S RATIO:</b> .21</p>	<div style="text-align: center;">

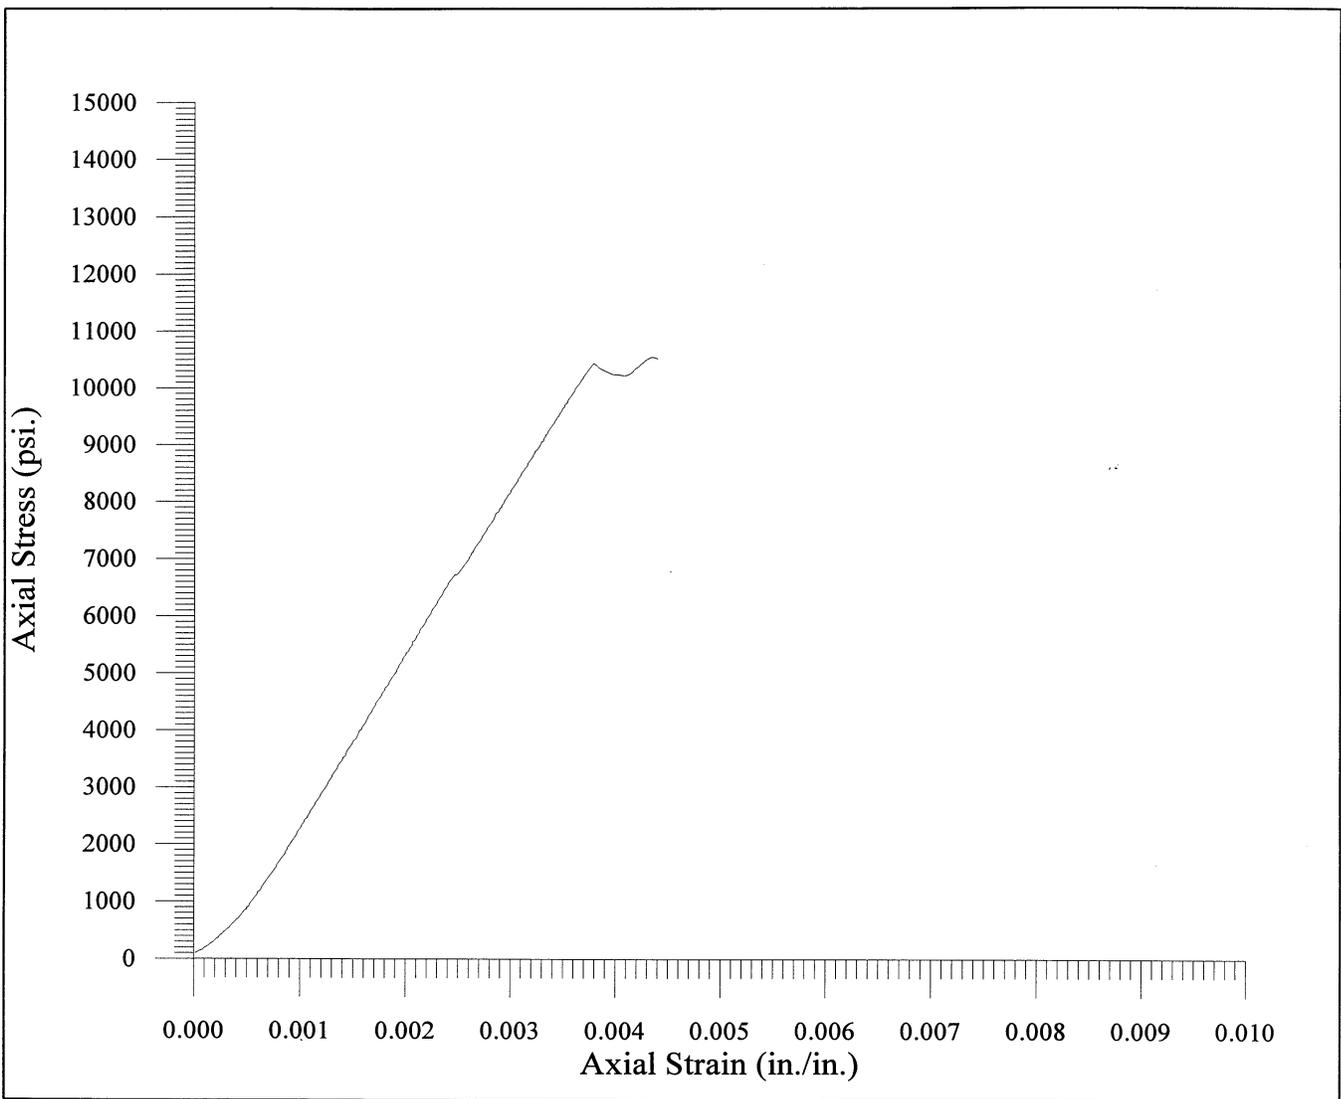
**UNCONFINED COMPRESSION TEST**  
**Axial Stress vs. Axial Strain**

**SAMPLE ID:** Boring : 98-22  
 Sample: 21a (b)  
 Depth: 70.5'

Medium gray sandstone with a few calcite healed fractures, 27 and 32 degrees to the core axis.

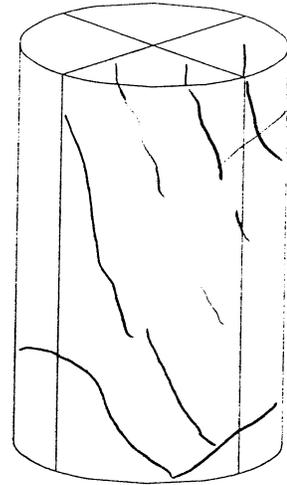
Sample Description: medium gray sandstone with many calcite healed hairline fractures, ~20° to the core axis

Comments: Failed by splitting / shear along healed fractures.

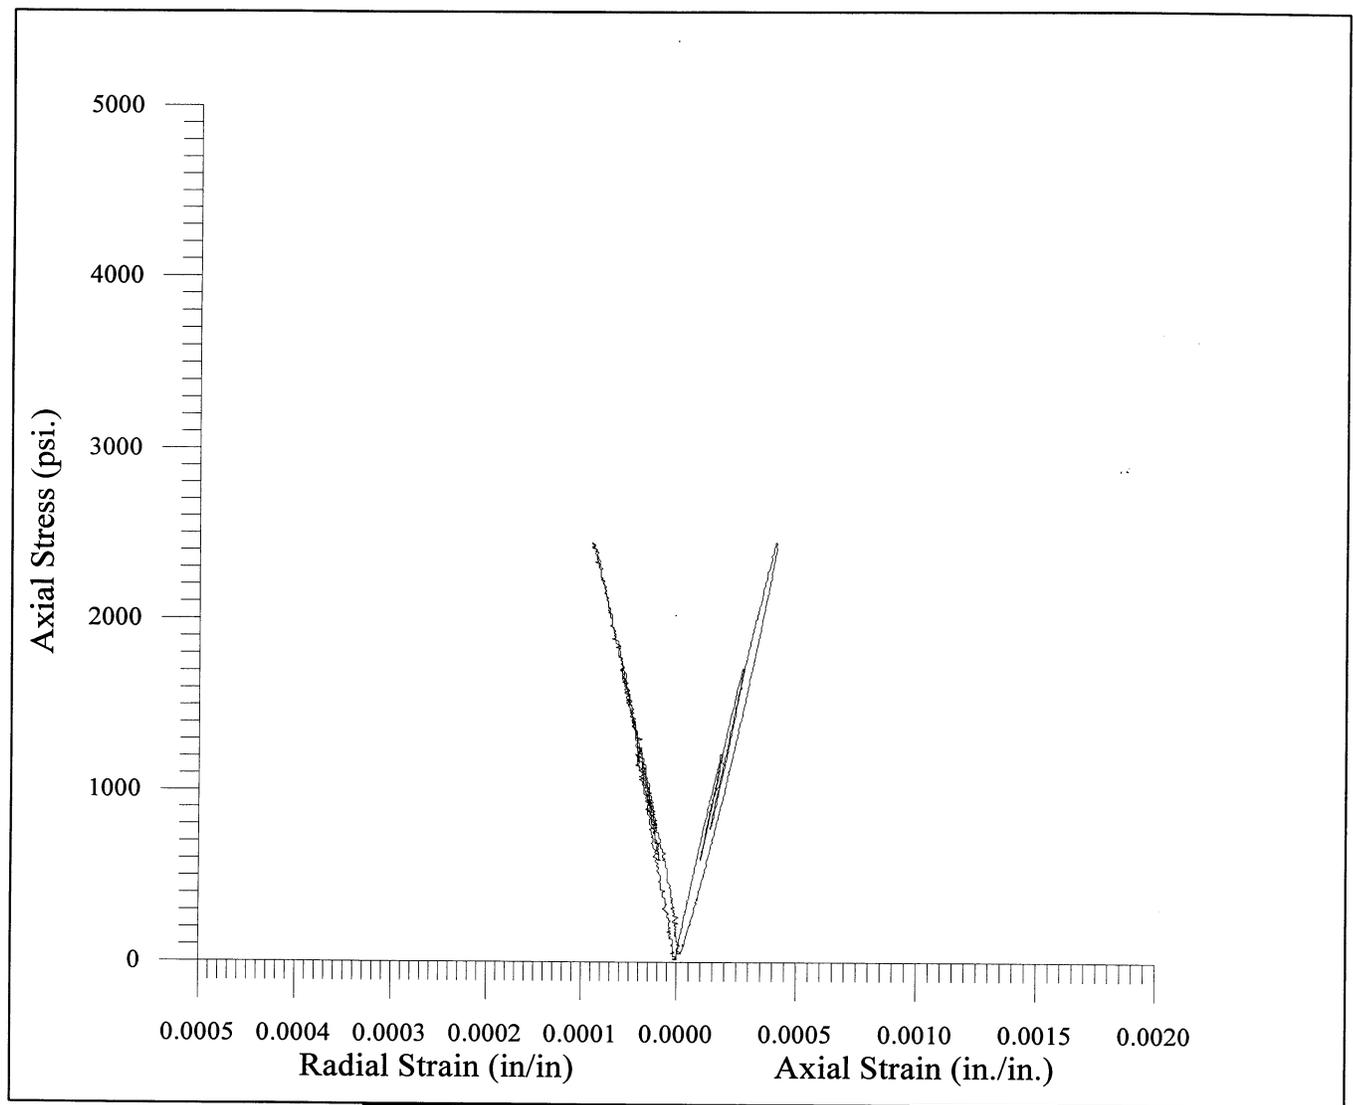
**ELASTIC MODULUS TEST**  
**Axial Stress vs. Axial & Radial Strain**

**SAMPLE ID:** Boring: 98-22  
 Sample: 21a(c)  
 Depth: 71'

**DESCRIPTION**  
 Medium gray sandstone with a few calcite healed hairline fractures, about 20 degrees to the core axis.
