**SUBCONTRACTOR REPORTS  
FINAL GEOTECHNICAL  
SITE CHARACTERIZATION**

**SAN FRANCISCO-OAKLAND BAY BRIDGE  
EAST SPAN SEISMIC SAFETY PROJECT**

**VOLUME 2 OF 3  
(GeoTest Unlimited)**

Letter Report  
San Francisco Oakland Bay Bridge  
East Span Replacement Project  
Rock Testing Program

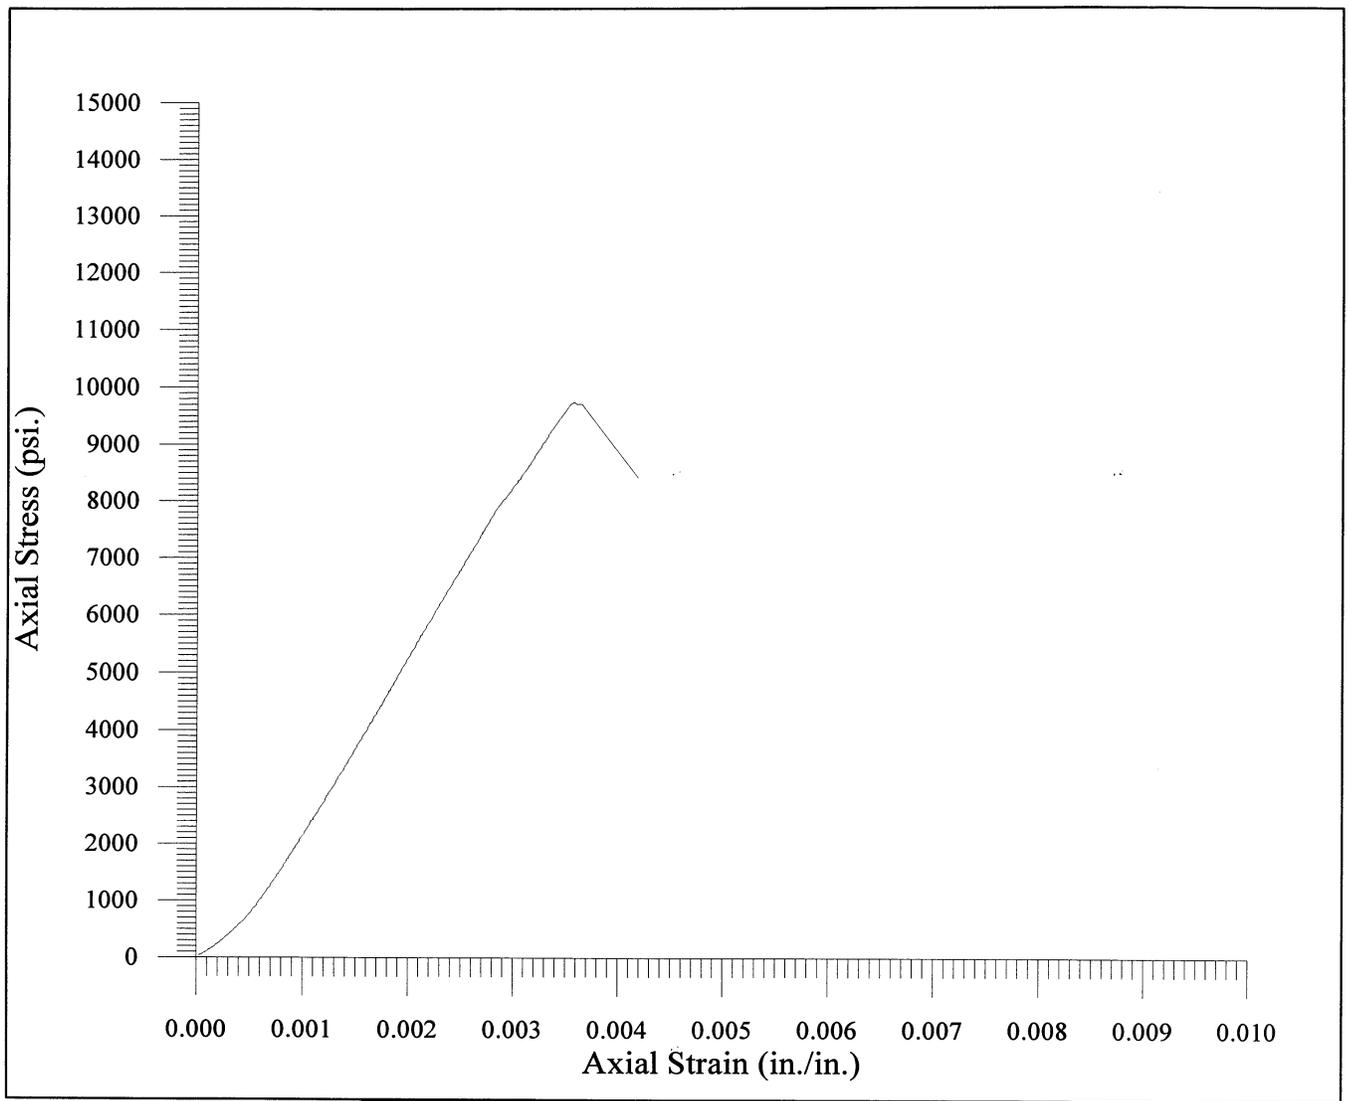
**UNCONFINED COMPRESSION TEST**  
**Axial Stress vs. Axial Strain**

<p><b>SAMPLE ID:</b> Boring : 98-22          Sample: 21a (c)          Depth: 71'</p> <p align="center"><b>DESCRIPTION</b></p> <p>Medium gray sandstone with a few calcite healed hairline fractures, about 20 degrees to the core axis.</p> <p><b>STRENGTH:</b> 9746 psi</p>	<p align="center"> <i>Geo</i>

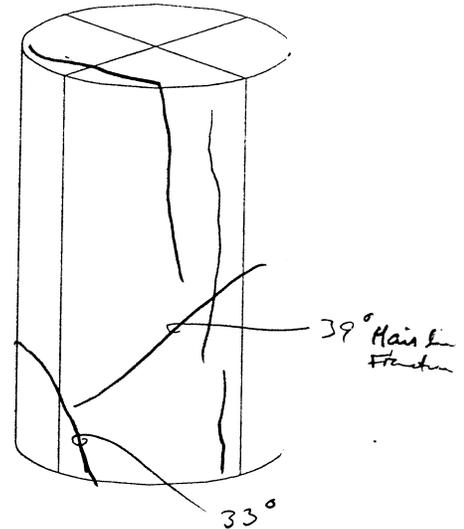
Sample Description: medium gray sandstone with a few calcite healed joints and transverse fractures. with a few small claystone inclusions.

Avg. diameter: 2.402 Avg. length: 5.251  
 Sample area: 4.531 l/d ratio: 2.19  
 Sample volume(in<sup>3</sup>): 23.795  
 Sample weight (g): 1057.4g  
 Density: 44.44g/in<sup>3</sup> = 169.3pcf (1 g/in<sup>3</sup>=3.8095lb/ft<sup>3</sup>)  
 Gauge length: 2.000 in

Comments: Failed by shear - along calcite healed joint - 37° Fracture.

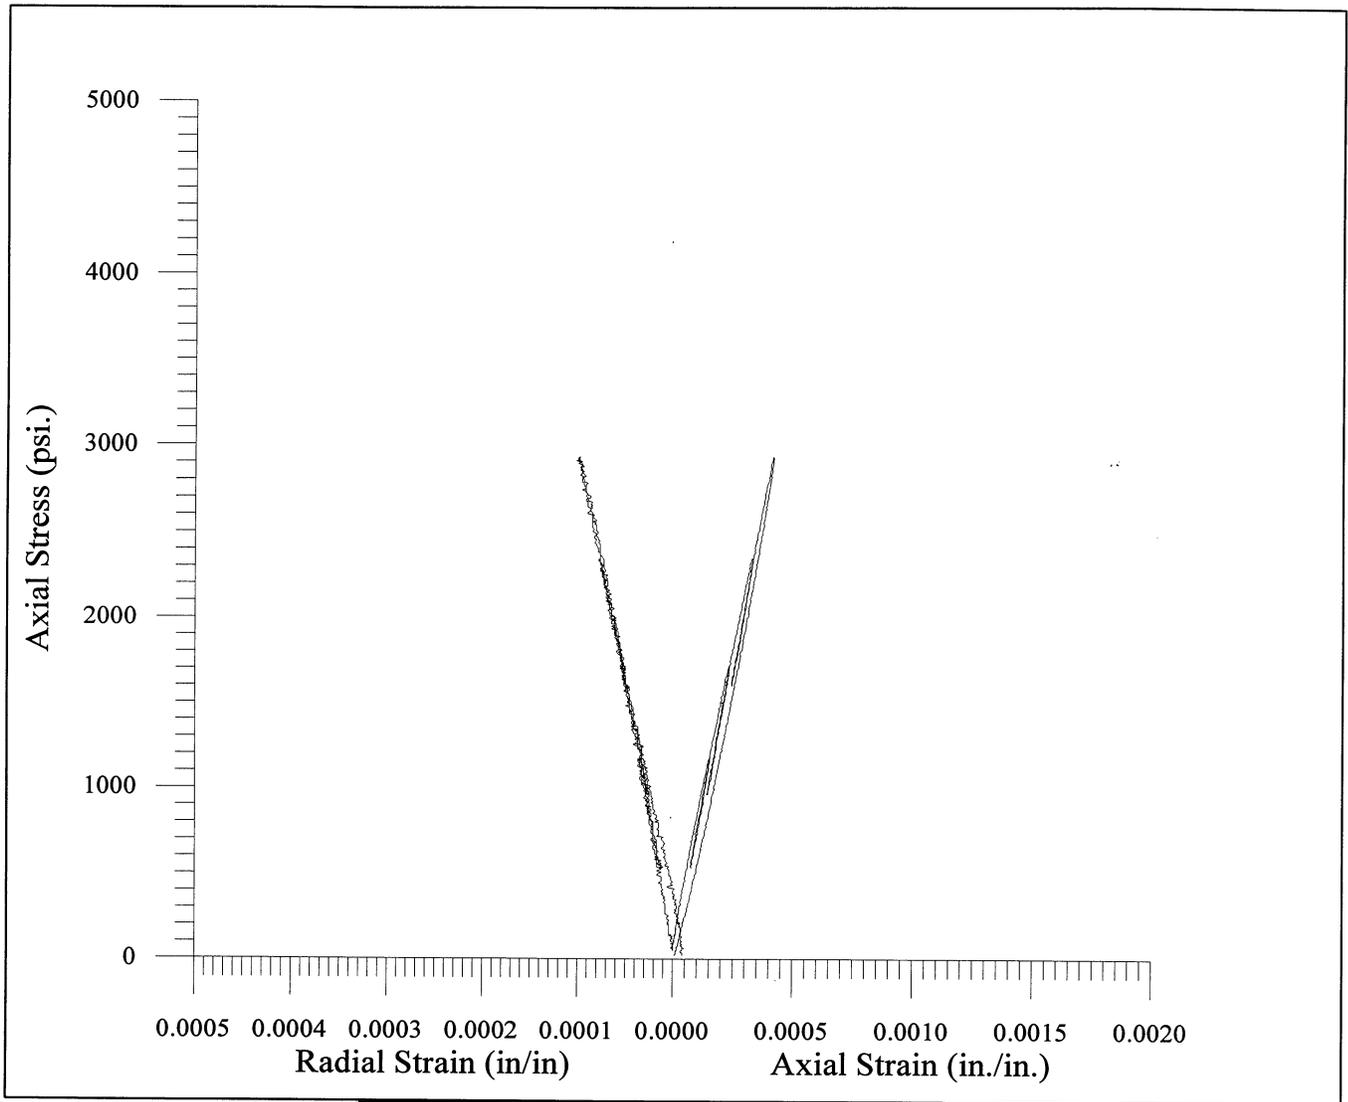
**ELASTIC MODULUS TEST**  
**Axial Stress vs. Axial & Radial Strain**

<p><b>SAMPLE ID:</b> Boring: 98-22  Sample: 25a  Depth: 85'</p> <p align="center"><b>DESCRIPTION</b></p> <p>Medium gray sandstone with a few calcite healed joints and hairline fractures, 33 and 39 degrees to the core axis, with a few small claystone inclusions.</p> <p><b>MODULUS:</b> 8,330,000 psi  <b>POISSON'S RATIO:</b> .29</p>	<p align="center"> <i>Geo</i>

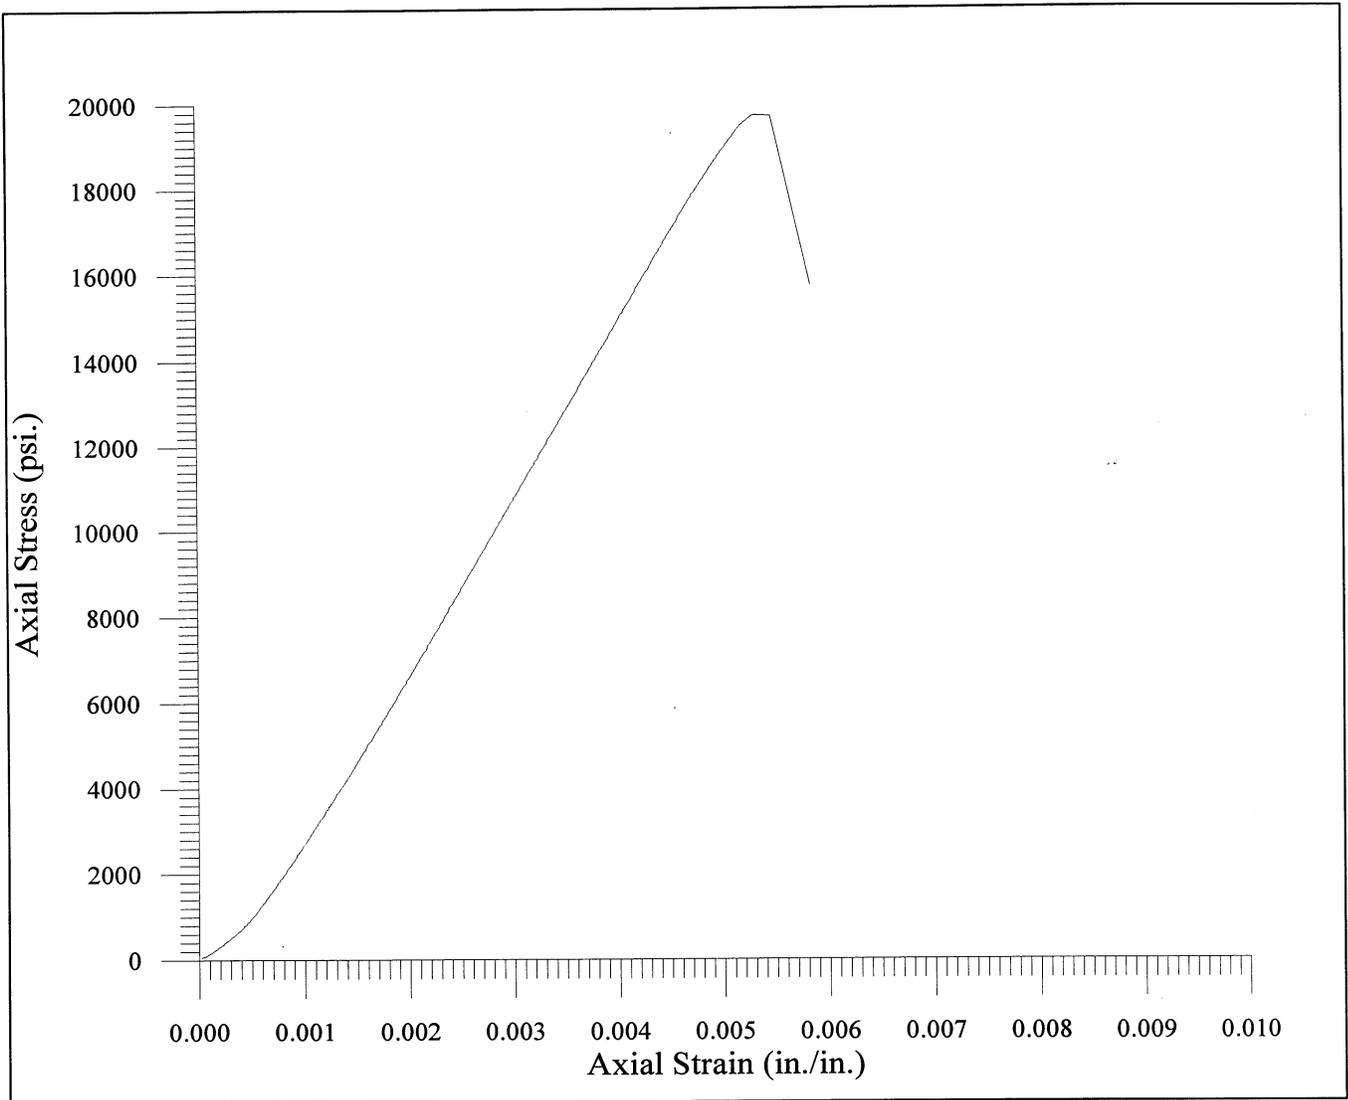
**UNCONFINED COMPRESSION TEST**  
**Axial Stress vs. Axial Strain**

<p><b>SAMPLE ID:</b> Boring : 98-22          Sample: 25a          Depth: 85'</p> <p align="center"><b>DESCRIPTION</b></p> <p>Medium gray sandstone with a few calcite healed joints and hairline fractures, 33 and 39 degrees to the core axis, with a few small claystone inclusions.</p> <p><b>STRENGTH:</b> 19,710 psi</p>	<p><i>Geo</i>

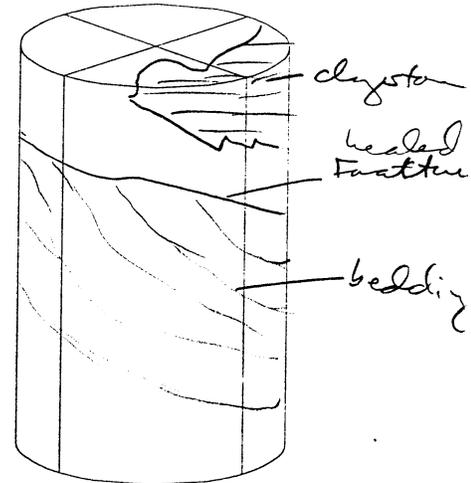
Sample Description: Finely interbedded medium gray sandstone and claystone ~60° to core axis with claystone on one e. and a calcite healed fracture (73° to axis)

Comments: 2<sup>nd</sup> test at gauge across healed fracture @ top

Failed by diagonal & axial splitting.

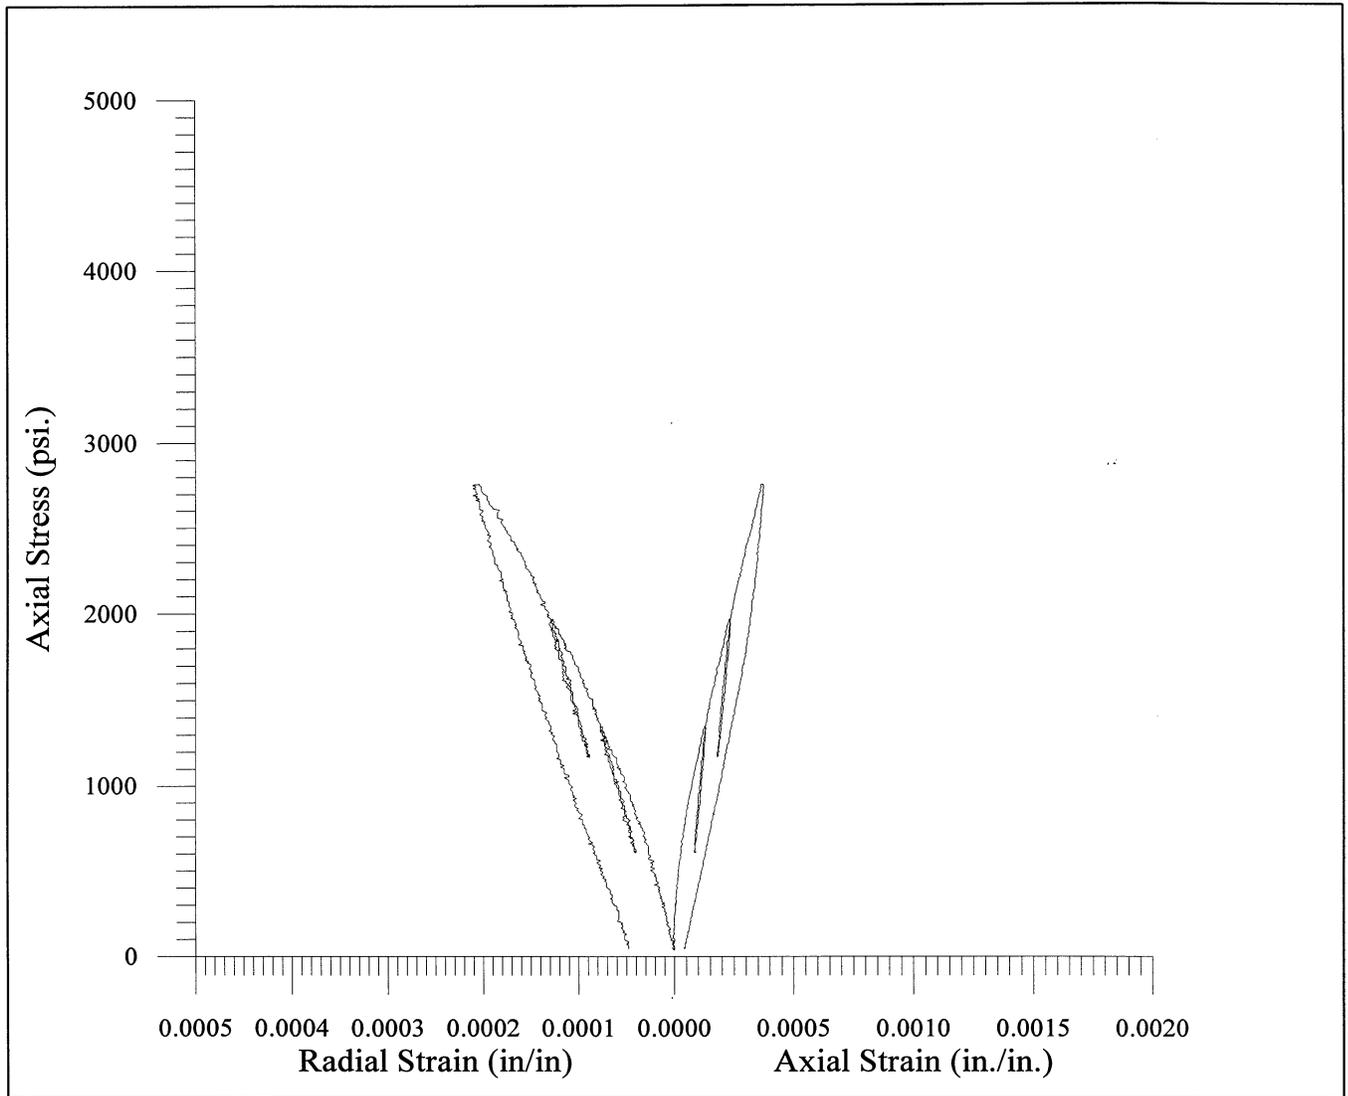
**ELASTIC MODULUS TEST**  
**Axial Stress vs. Axial & Radial Strain**

<p><b>SAMPLE ID:</b> Boring: 98-22  Sample: 27a  Depth: 98.5'</p>	<p style="text-align: center;"><i>Geo</i>

<i>Test</i>  <b>Unlimited</b> 800 Peralta Ave  San Leandro, CA 94577</p>
<p style="text-align: center;"><b>DESCRIPTION</b></p> <p>Finely interbedded medium gray sandstone and claystone, bedding about 60 degrees to the core axis, with claystone on one end and a calcite healed fracture about 37 degrees to the core axis.</p> <p><b>MODULUS:</b> NA (15,630,000 psi)</p> <p><b>POISSON'S RATIO:</b> NA (.77)</p>	
	<p><b>Test Date:</b> October 18, 1998</p>

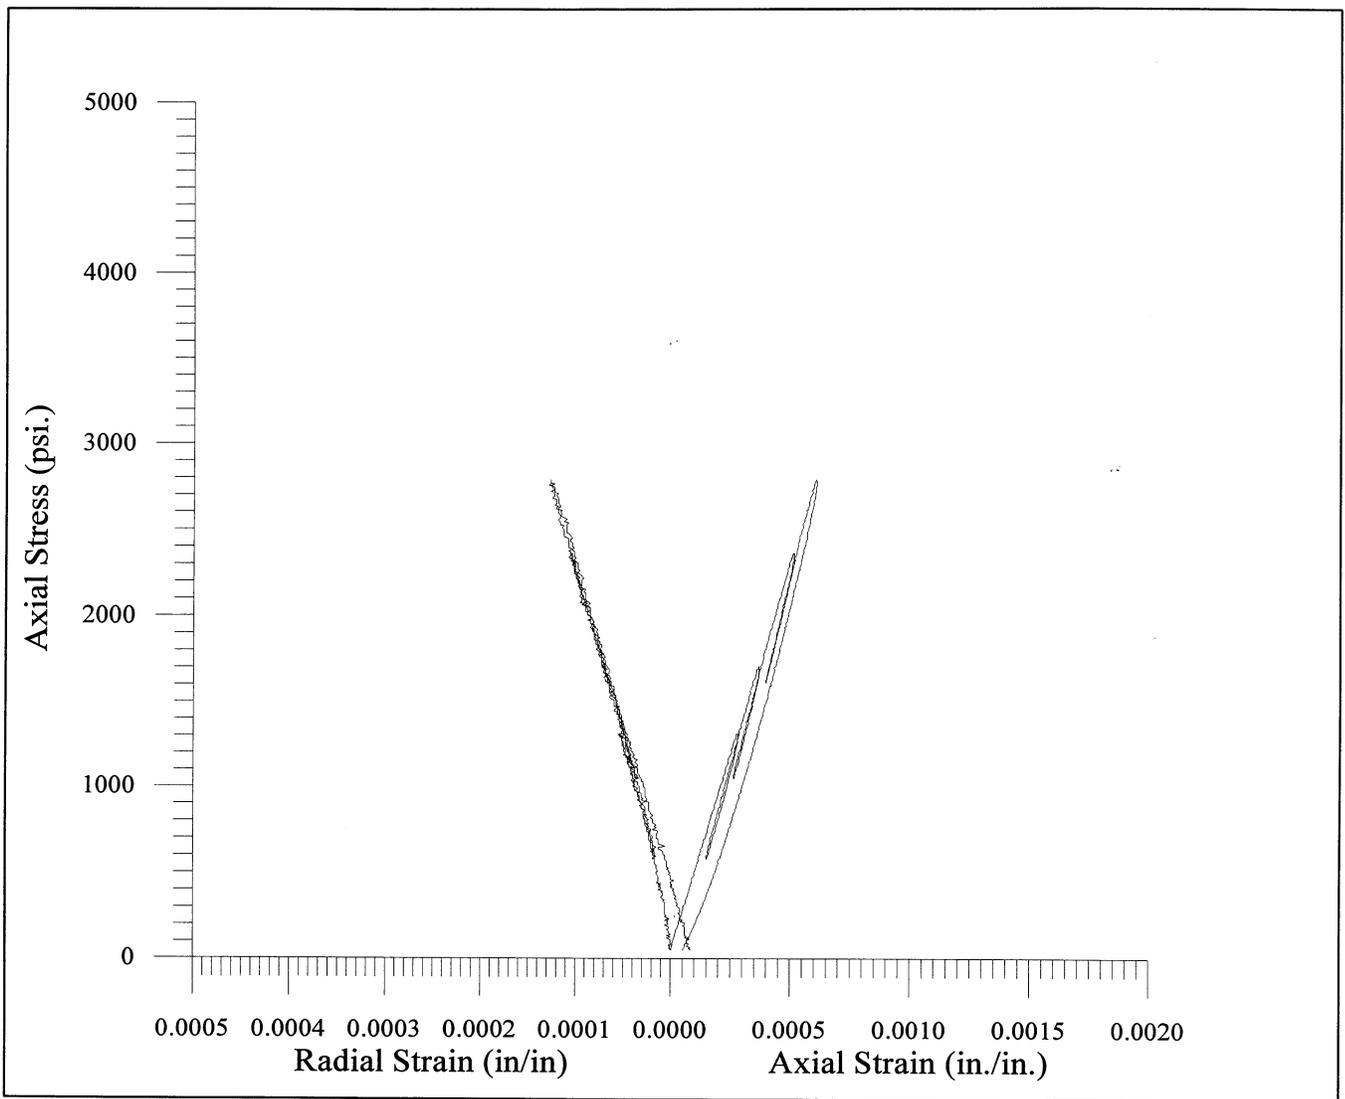
**ELASTIC MODULUS TEST**  
**Axial Stress vs. Axial & Radial Strain**

**SAMPLE ID:** Boring: 98-22  
 Sample: 27a (Retest)  
 Depth: 98.5'

**DESCRIPTION**  
 Finely interbedded medium gray sandstone and claystone, bedding about 60 degrees to the core axis, with claystone on one end and a calcite healed fracture about 37 degrees to the core axis.

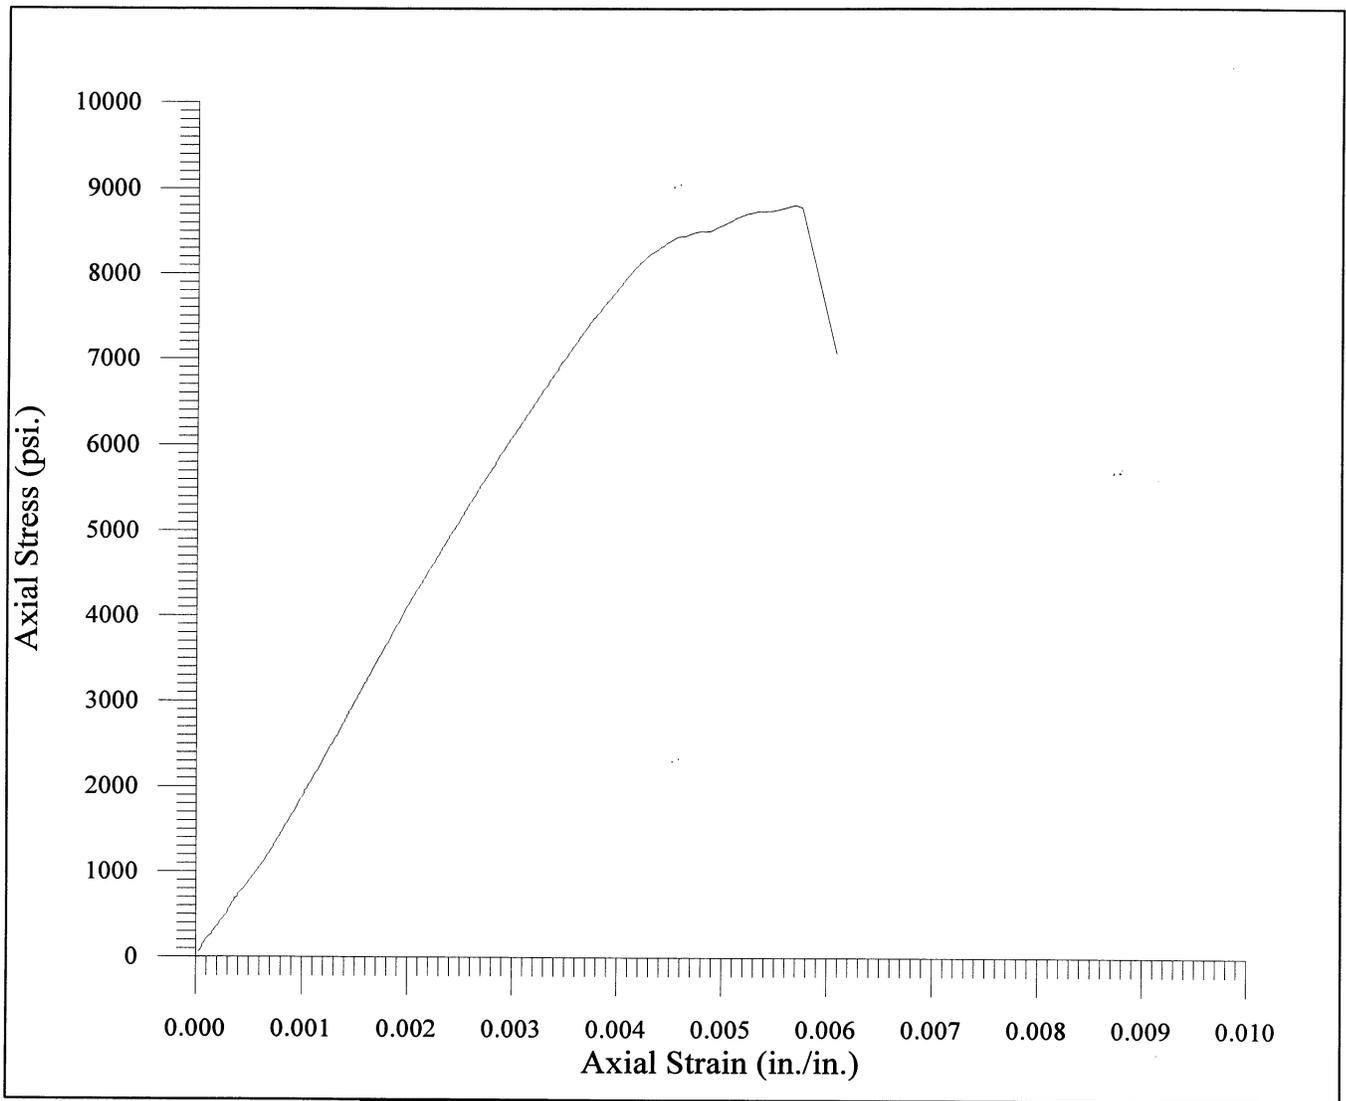
**UNCONFINED COMPRESSION TEST  
Axial Stress vs. Axial Strain**

<p><b>SAMPLE ID:</b> Boring : 98-22 Sample: 27a Depth: 98.5'</p> <p align="center"><b>DESCRIPTION</b></p> <p>Finely interbedded medium gray sandstone and claystone, bedding about 60 degrees to the core axis, with claystone on one end and a calcite healed fracture about 37 degrees to the core axis.</p> <p><b>STRENGTH:</b> 8799 psi</p>	<div style="text-align: center;"> <p><i>Geo</i>

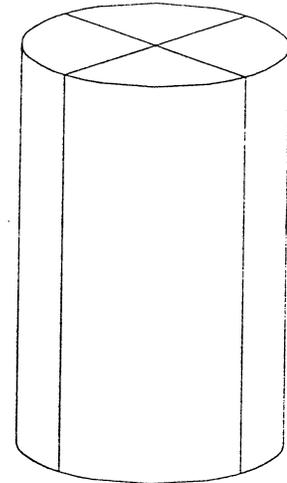
Sample Description: medium gray massive sandstone with one calcite healed hairline fracture 45° to core axis

Comments: explosive failure - splitting & shear on calcite healed fracture.

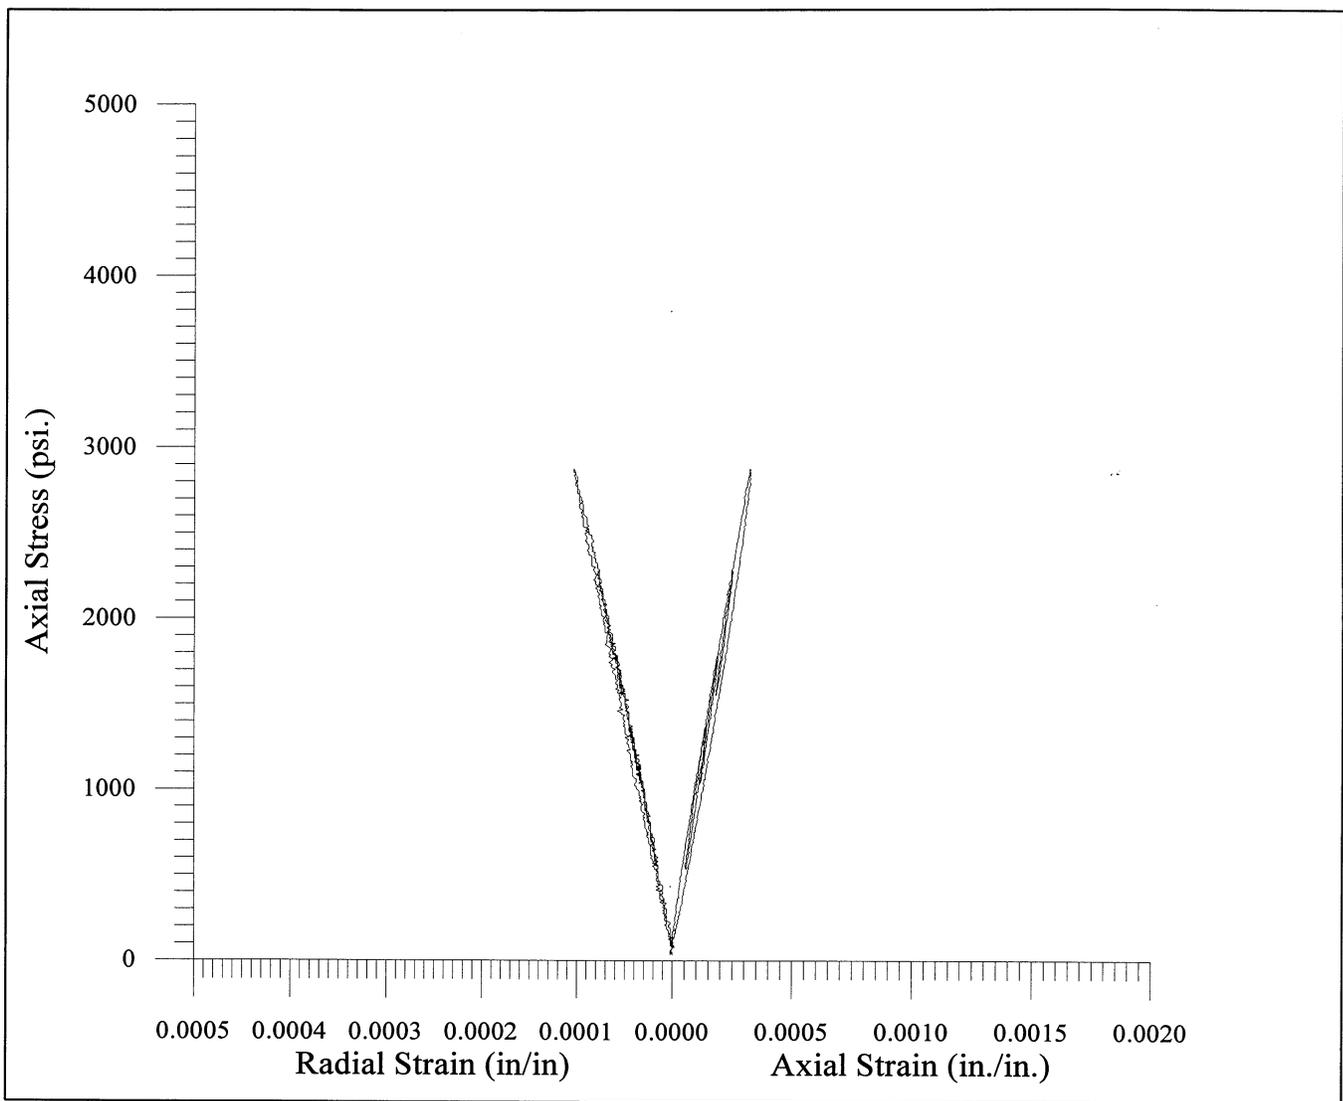
**ELASTIC MODULUS TEST**  
**Axial Stress vs. Axial & Radial Strain**

<p><b>SAMPLE ID:</b> Boring: 98-22  Sample: 29a  Depth: 112'</p> <p><b>DESCRIPTION</b>  Medium gray massive sandstone with one calcite healed hairline fracture about 45 degrees to the core axis.</p> <p><b>MODULUS:</b> 10,000,000 psi  <b>POISSON'S RATIO:</b> .38</p>	<p align="center"> <i>Geo</i>

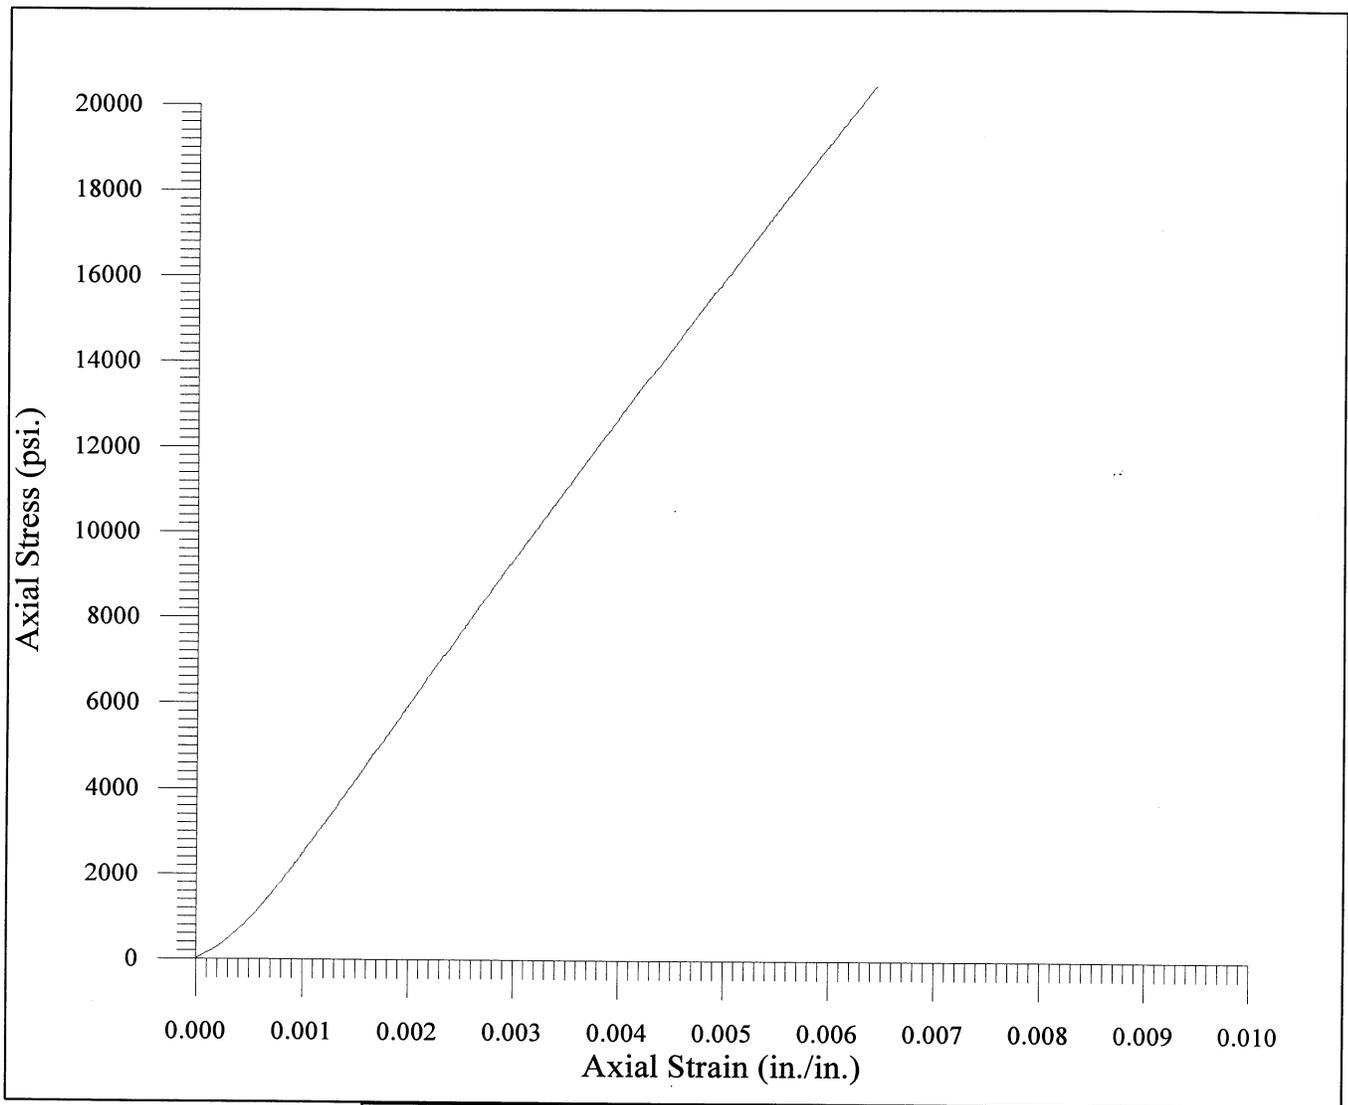
**UNCONFINED COMPRESSION TEST**  
**Axial Stress vs. Axial Strain**

**SAMPLE ID:** Boring : 98-22  
 Sample: 29a  
 Depth: 112'

Medium gray massive sandstone with one calcite healed hairline fracture about 45 degrees to the core axis.

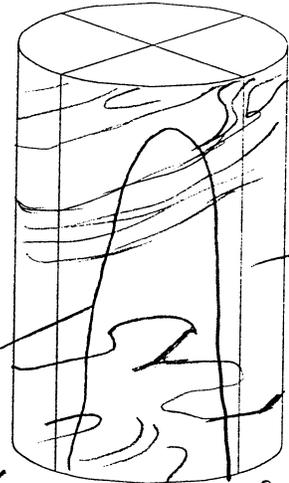
Sample Description: Dark gray claystone interbedded with sandy siltstone. Many hairline fractures parallel bedding (60° to core axis) and one axial calcite healed fracture.

Comments: Failed by splitting, and shear along bedding planes

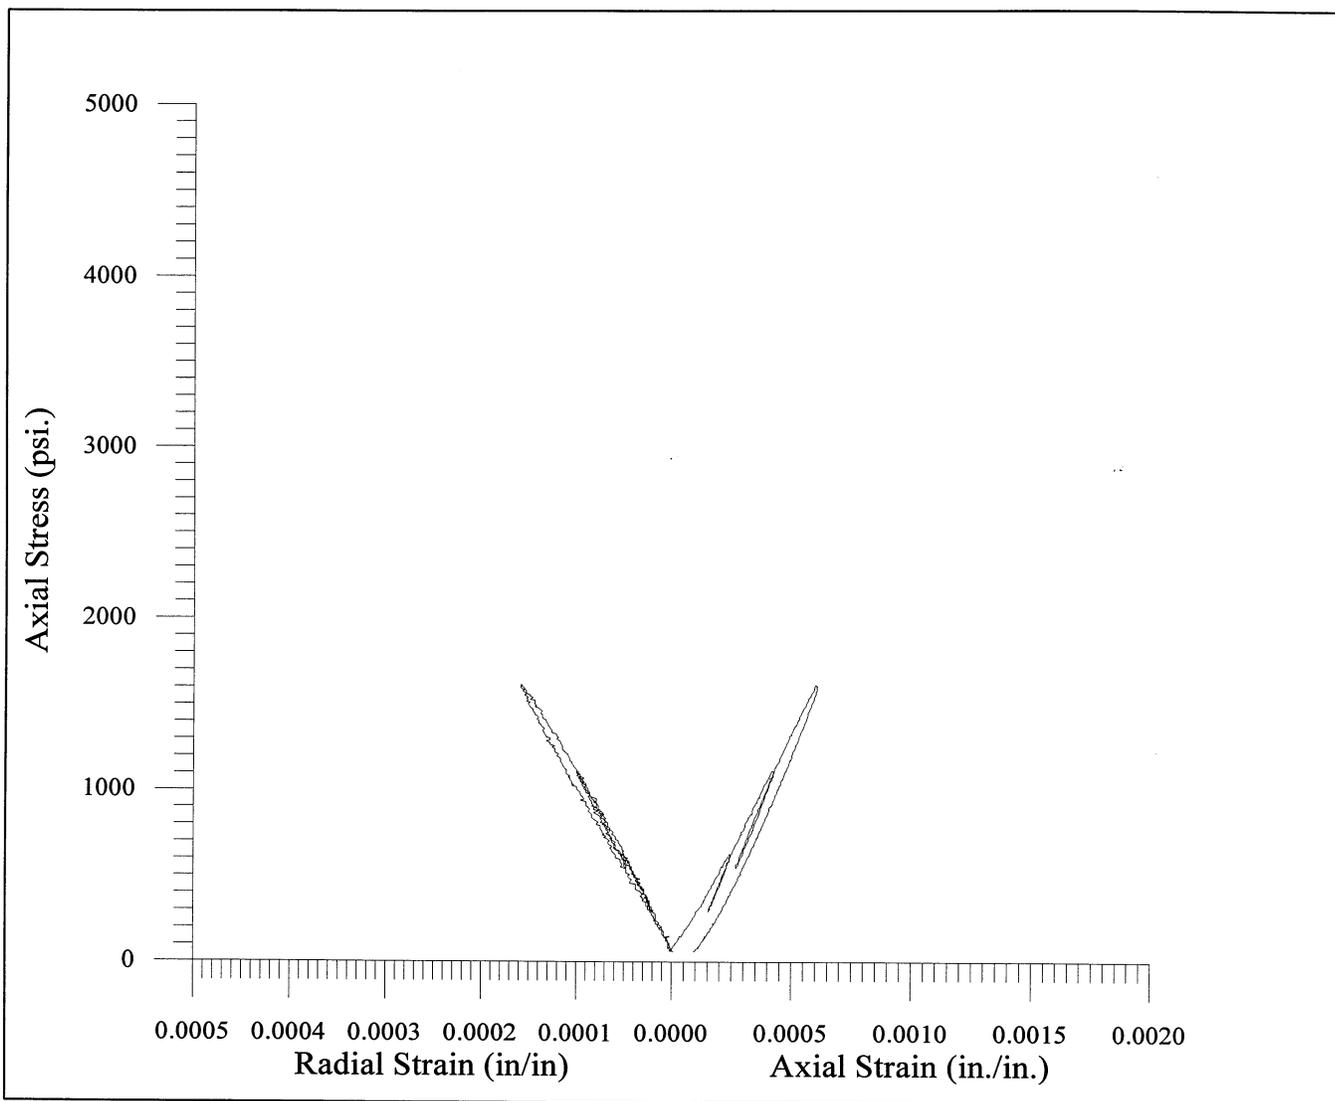
**ELASTIC MODULUS TEST**  
**Axial Stress vs. Axial & Radial Strain**

<p><b>SAMPLE ID:</b> Boring: 98-22  Sample: 31a  Depth: 124'</p> <p align="center"><b>DESCRIPTION</b></p> <p>Dark gray claystone interbedded with sandy siltstone, with many hairline fractures parallel to the bedding (60 degrees to the core axis) and one calcite healed axial fracture.</p> <p><b>MODULUS:</b> 3,530,000 psi  <b>POISSON'S RATIO:</b> .31</p>	<p align="center"> <i>Geo</i>

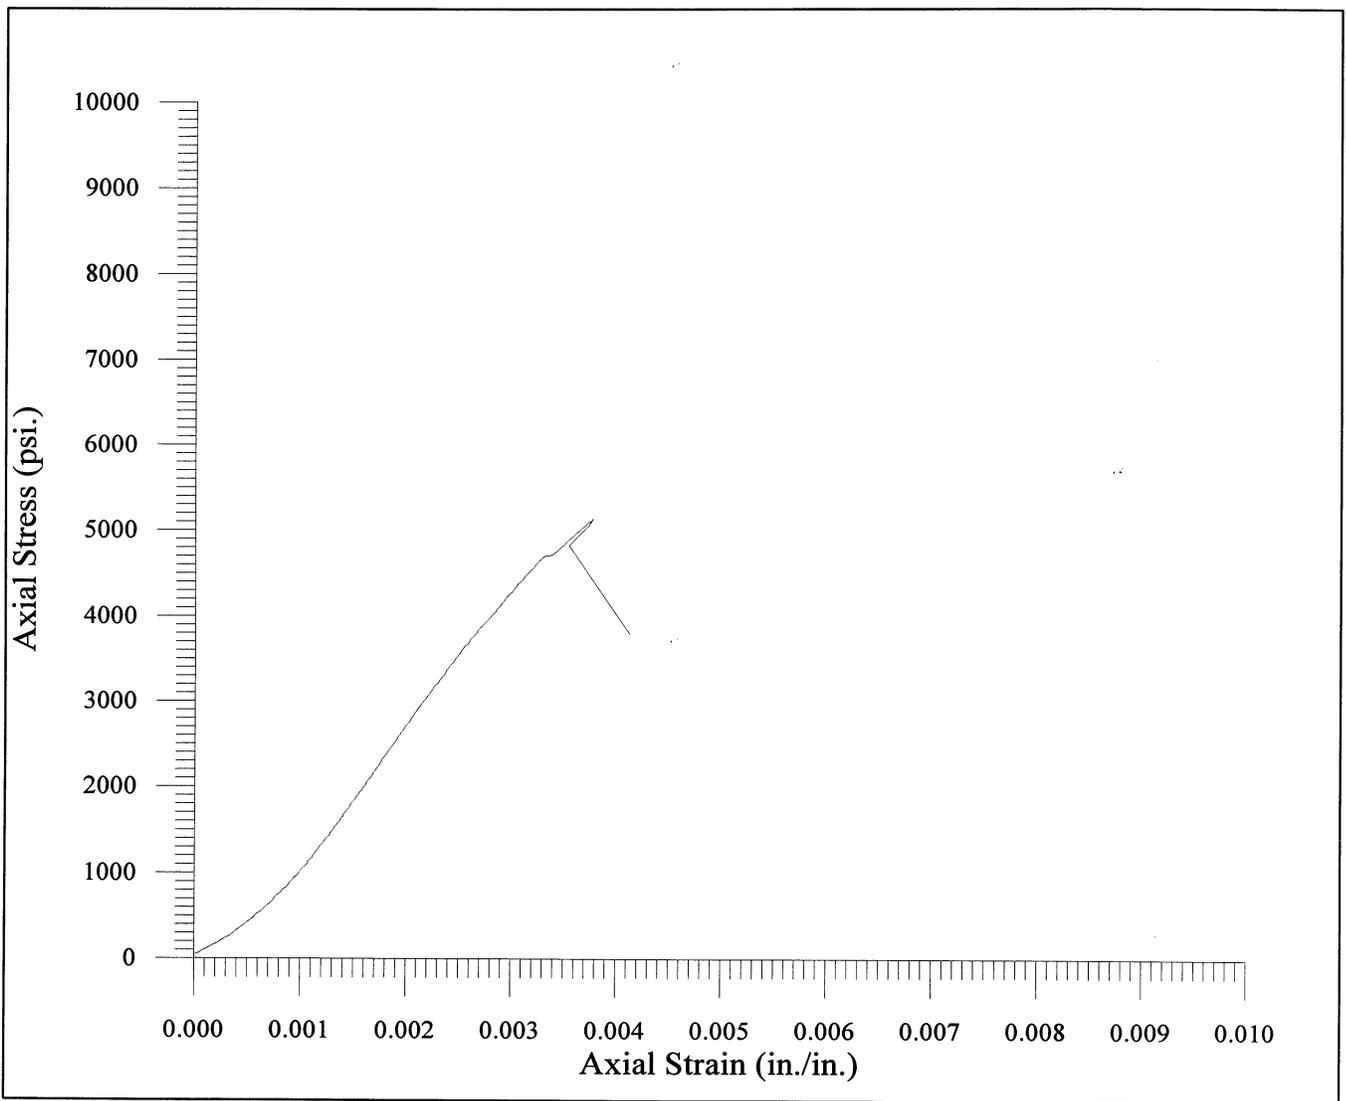
**UNCONFINED COMPRESSION TEST**  
**Axial Stress vs. Axial Strain**

**SAMPLE ID:** Boring : 98-22  
 Sample: 31a  
 Depth: 124'

Dark gray claystone interbedded with sandy siltstone, with many hairline fractures parallel to the bedding (60 degrees to the core axis) and one calcite healed axial fracture.

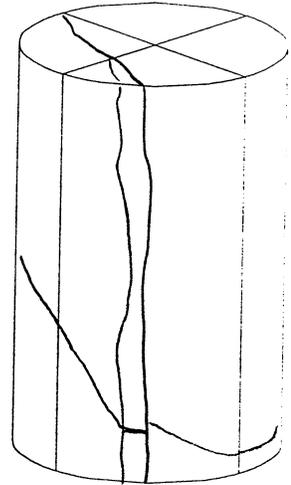
Sample Description: medium gray sandy siltstone with two calcite healed fractures, 0° and 50° to the core axis

Comments: on retest note that axial gauges across the healed joint - and that on unloading E<sub>a</sub> is much stiffer than on loading... due to joint closure?

Failed by axial splitting and conical shear at one end.

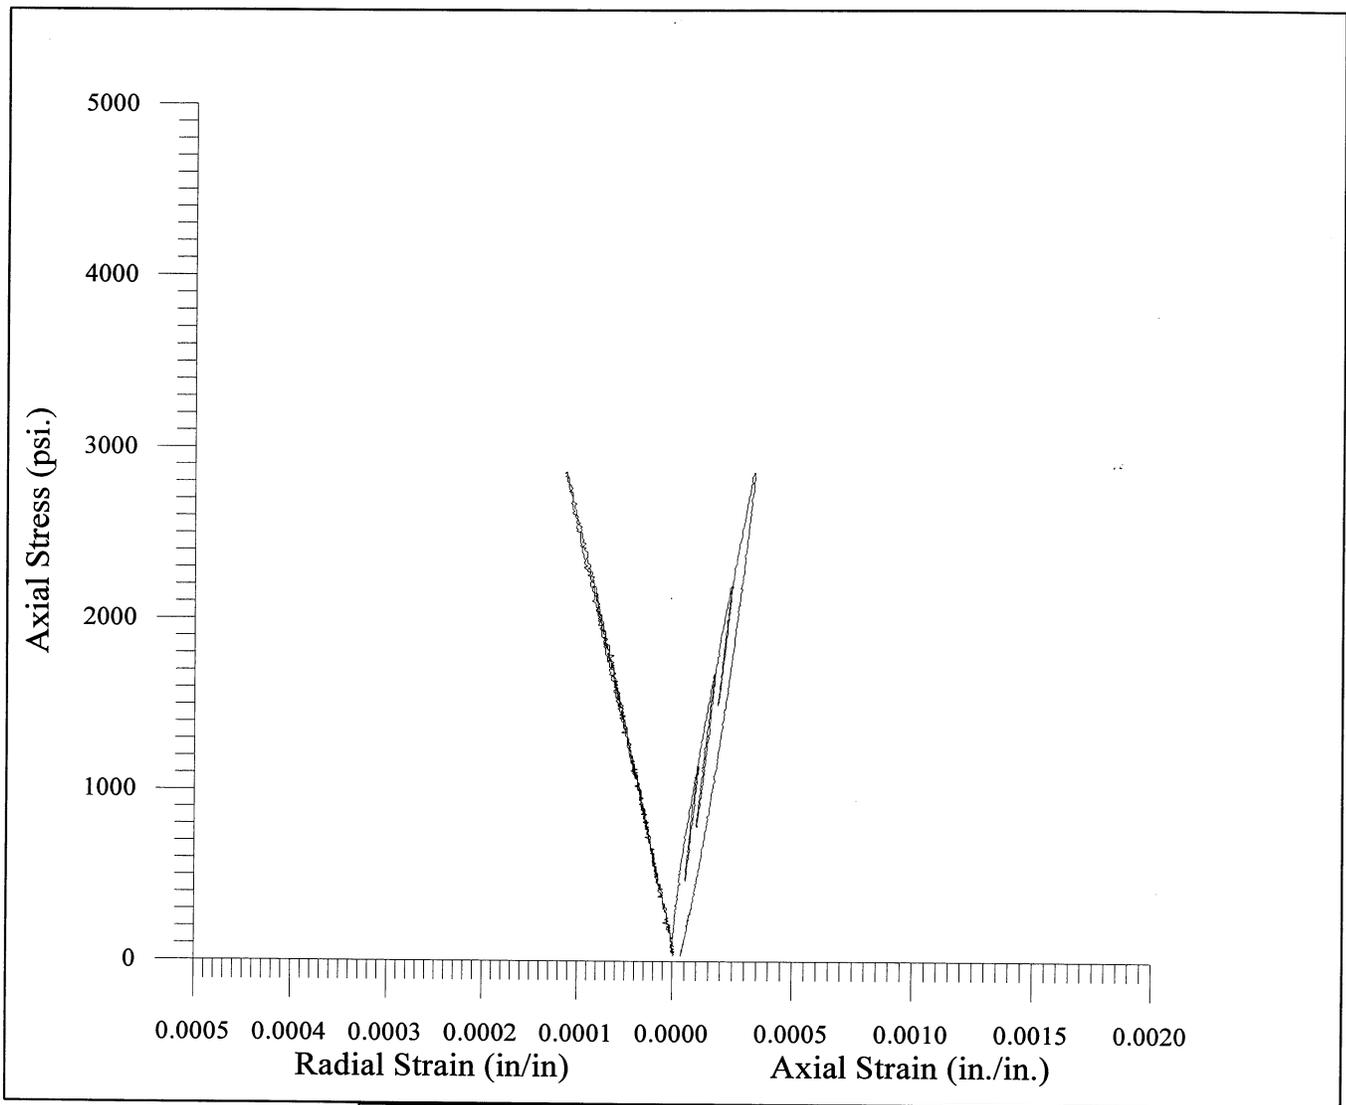
**ELASTIC MODULUS TEST**  
**Axial Stress vs. Axial & Radial Strain**

<p><b>SAMPLE ID:</b> Boring: 98-22  Sample:32a  Depth: 130'</p> <p><b>DESCRIPTION</b>  Medium gray massive sandy siltstone with two calcite healed fractures, 0 and 50 degrees to the core axis.</p> <p><b>MODULUS:</b> NA (13,890,000 psi)  <b>POISSON'S RATIO:</b> NA (.55)</p>	<p align="center"> <i>Geo</i>

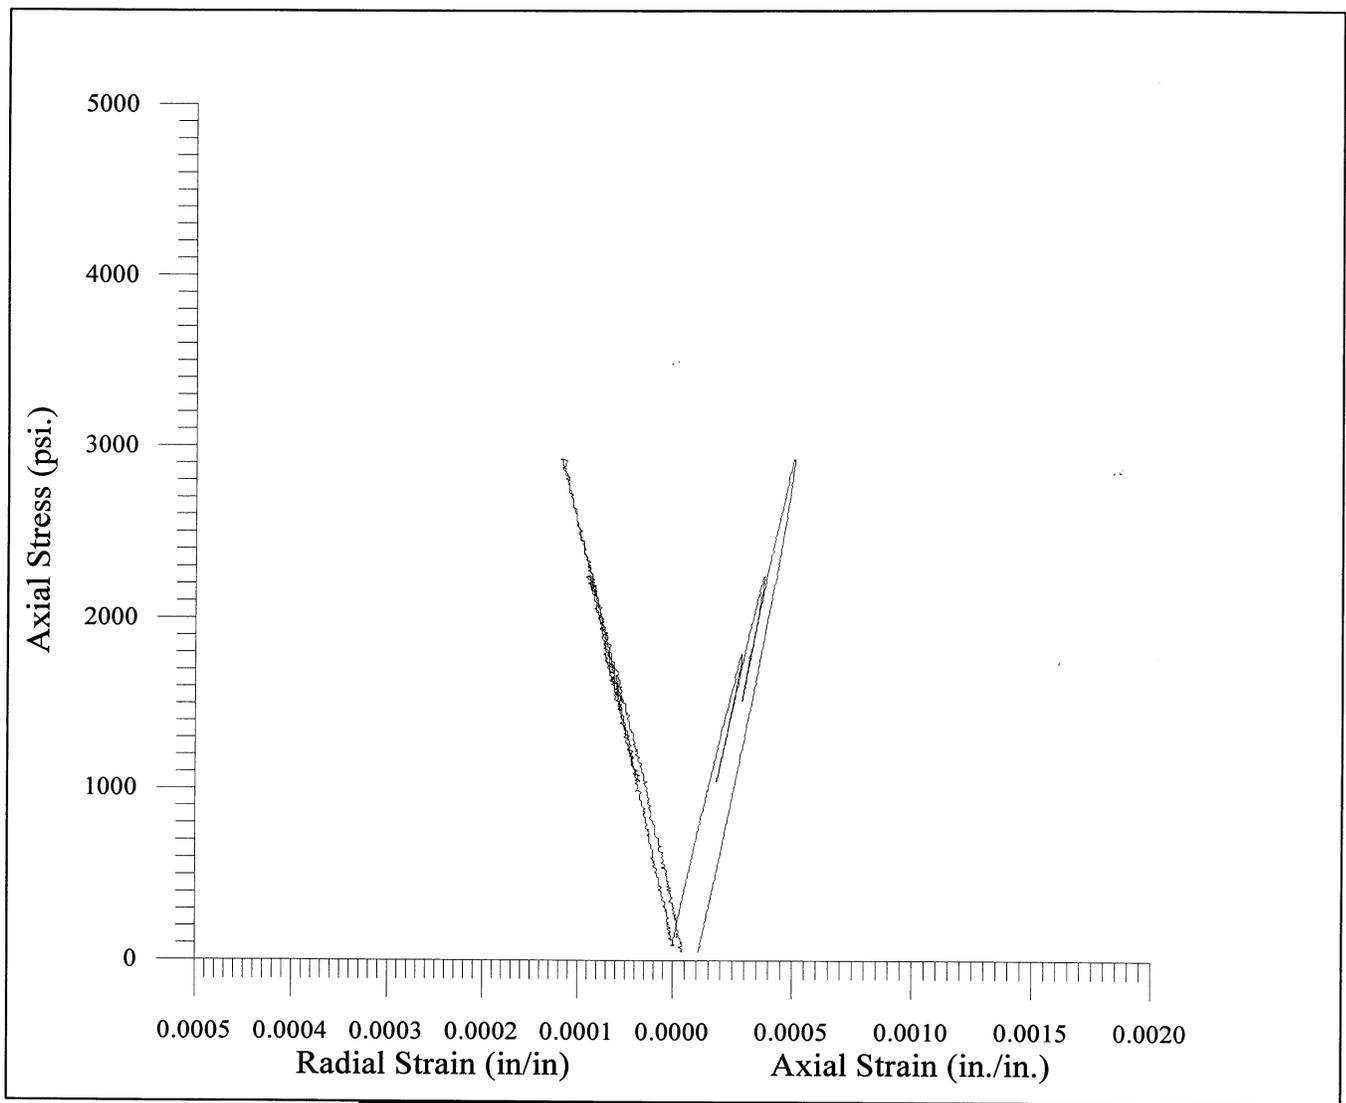
**ELASTIC MODULUS TEST**  
**Axial Stress vs. Axial & Radial Strain**

<p><b>SAMPLE ID:</b> Boring: 98-22  Sample:32a (Retest)  Depth: 130'</p>	<p align="center"><i>Geo</i>

<i>Test</i>  <b>Unlimited</b> 800 Peralta Ave  San Leandro, CA 94577</p>
<p align="center"><b>DESCRIPTION</b></p> <p>Medium gray massive sandy siltstone with two calcite healed fractures, 0 and 50 degrees to the core axis.</p> <p><b>MODULUS:</b> 6,670,000 psi  <b>POISSON'S RATIO:</b> .27</p>	<p><b>Client:</b> Fugro West, Inc.  5855 Olivas Park Dr.  Ventura, CA 93003</p> <p><b>Project:</b> San Francisco Oakland Bay Bridge  East Span Replacement Project</p> <p><b>Job Number:</b> 98-42-0053</p>
	<p><b>Test Date:</b> October 22, 1998</p>

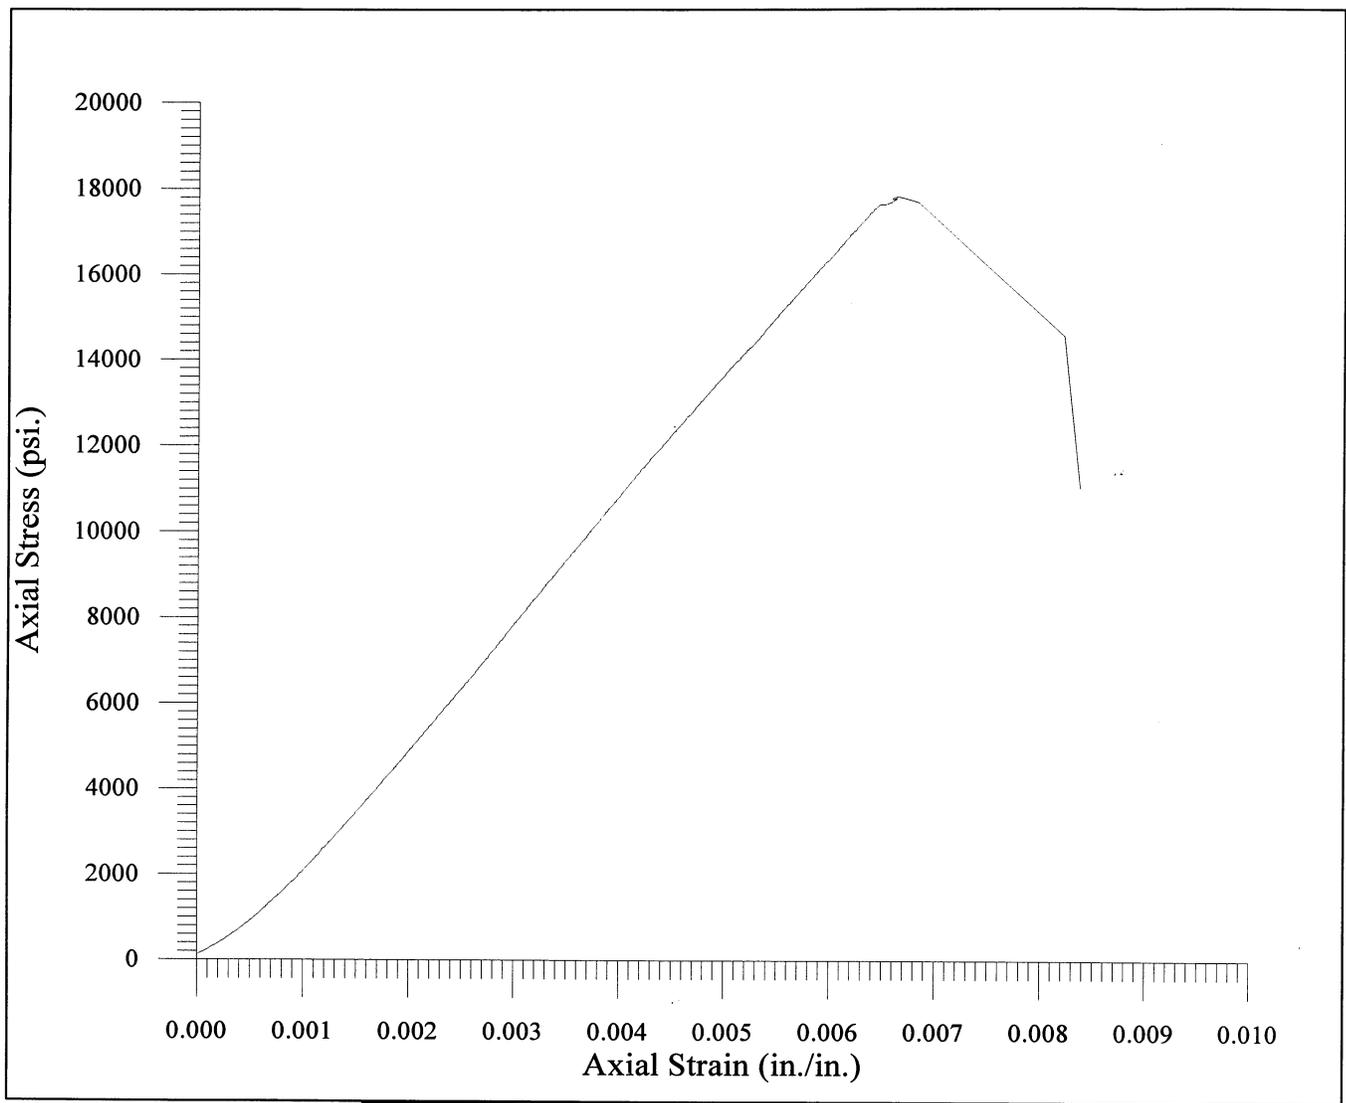
**UNCONFINED COMPRESSION TEST**  
**Axial Stress vs. Axial Strain**

<p><b>SAMPLE ID:</b> Boring : 98-22          Sample: 32a          Depth: 130'</p> <p align="center"><b>DESCRIPTION</b></p> <p>Medium gray massive sandy siltstone with two calcite healed fractures, 0 and 50 degrees to the core axis.</p> <p><b>STRENGTH:</b> 17,808 psi</p>	<p align="center"> <i>Geo</i>

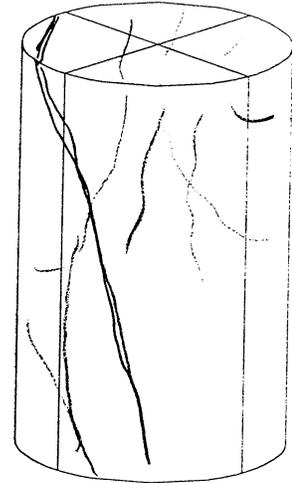
Sample Description: medium gray massive sandstone with  
many axial calcite healed hairline fractures.

Comments: Failed by axial splitting along hairline fractures.
