**SUBCONTRACTOR REPORTS  
FINAL GEOTECHNICAL  
SITE CHARACTERIZATION**

**SAN FRANCISCO-OAKLAND BAY BRIDGE  
EAST SPAN SEISMIC SAFETY PROJECT**

**VOLUME 2 OF 3  
(GeoTest Unlimited)**

Letter Report  
San Francisco Oakland Bay Bridge  
East Span Replacement Project  
Rock Testing Program

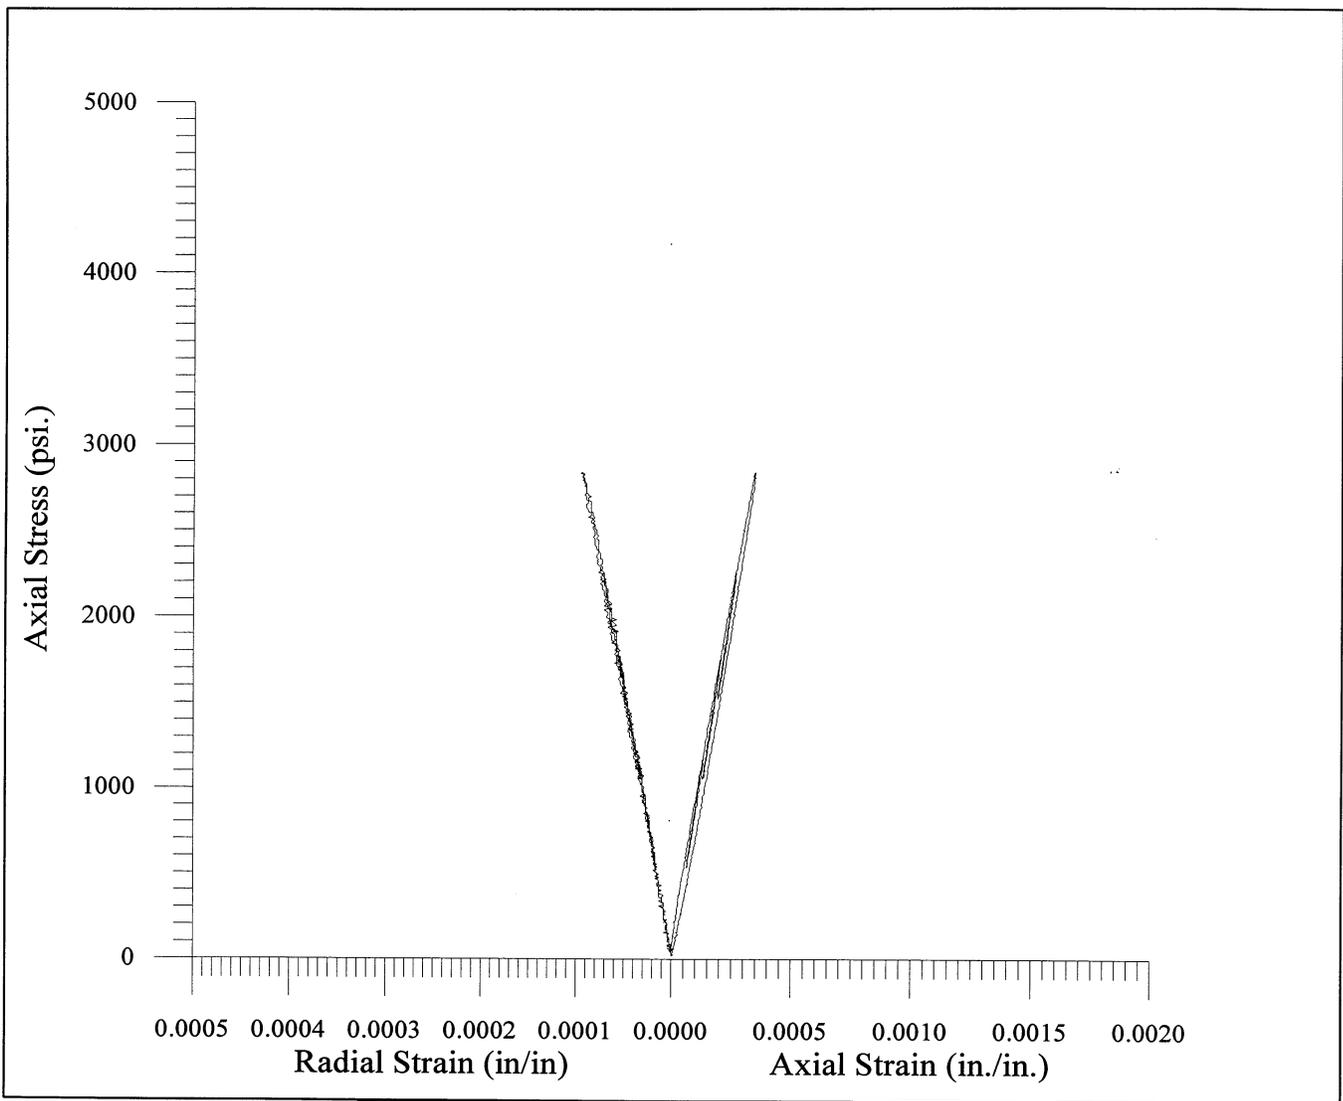
**ELASTIC MODULUS TEST**  
**Axial Stress vs. Axial & Radial Strain**

**SAMPLE ID:** Boring: 98-22  
 Sample: 35a  
 Depth: 149'

**DESCRIPTION**  
 Medium gray massive sandstone with many calcite healed axial hairline fractures.

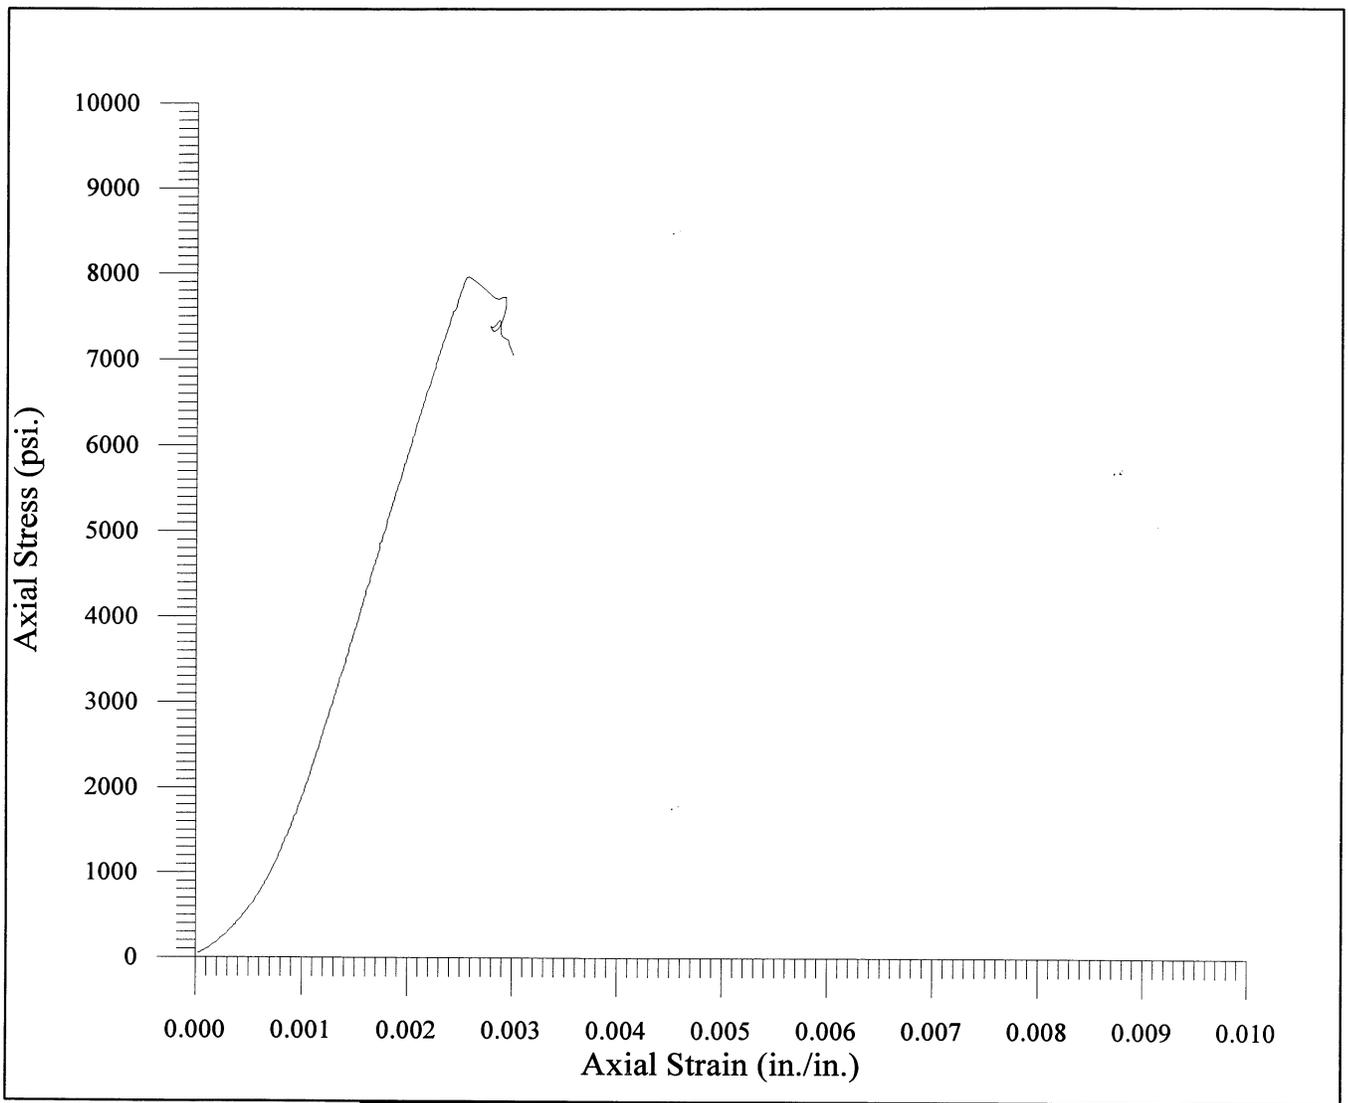
**UNCONFINED COMPRESSION TEST**  
**Axial Stress vs. Axial Strain**

<p><b>SAMPLE ID:</b> Boring : 98-22          Sample: 35a          Depth: 149'</p> <p align="center"><b>DESCRIPTION</b></p> <p>Medium gray massive sandstone with many calcite healed axial hairline fractures.</p> <p><b>STRENGTH:</b> 7962 psi</p>	<p align="center"> <i>Geo</i>

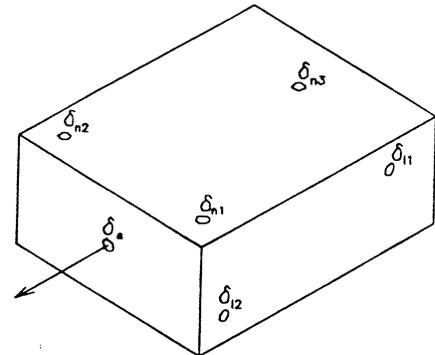
Location of LVDTs on top shear box

Measured Top Box Weight: 15.8 lb

$\sigma_n$	<u>25</u>	<u>75</u>	<u>150 psi</u>
$F_n$	<u>123</u>	<u>369</u>	<u>738 lb</u>
$F_n - W_b$	<u>107</u>	<u>353</u>	<u>722</u>

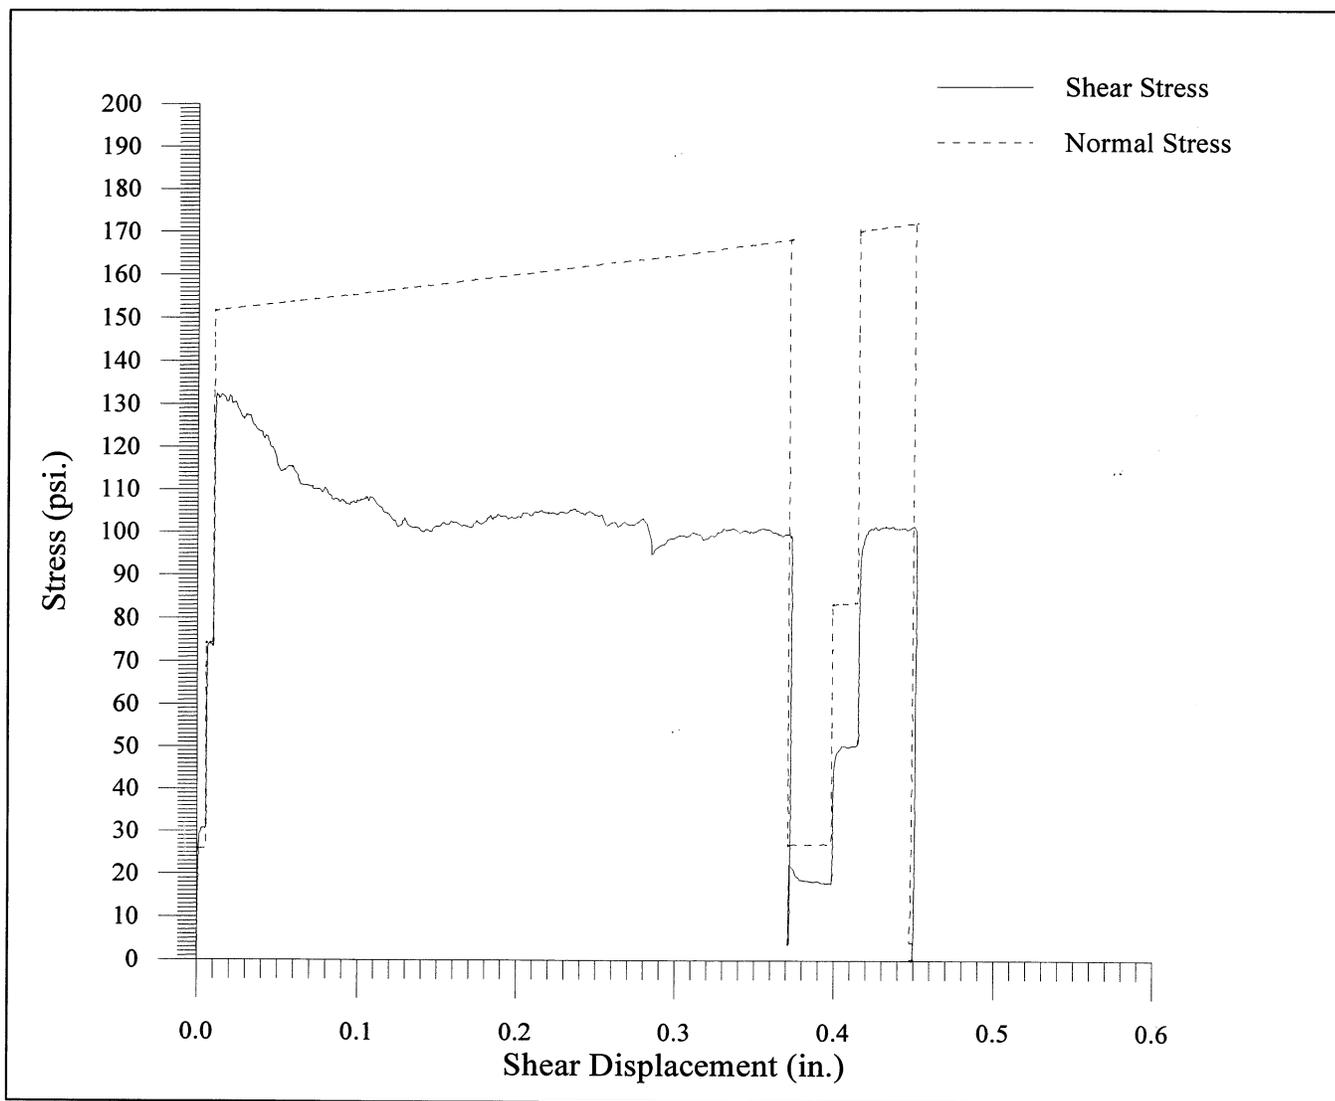
**DIRECT SHEAR TEST**  
**Shear and Normal Stress vs. Shear Displacement**

**SAMPLE ID:** Boring: 98-22  
 Sample: 19a  
 Depth: 51'

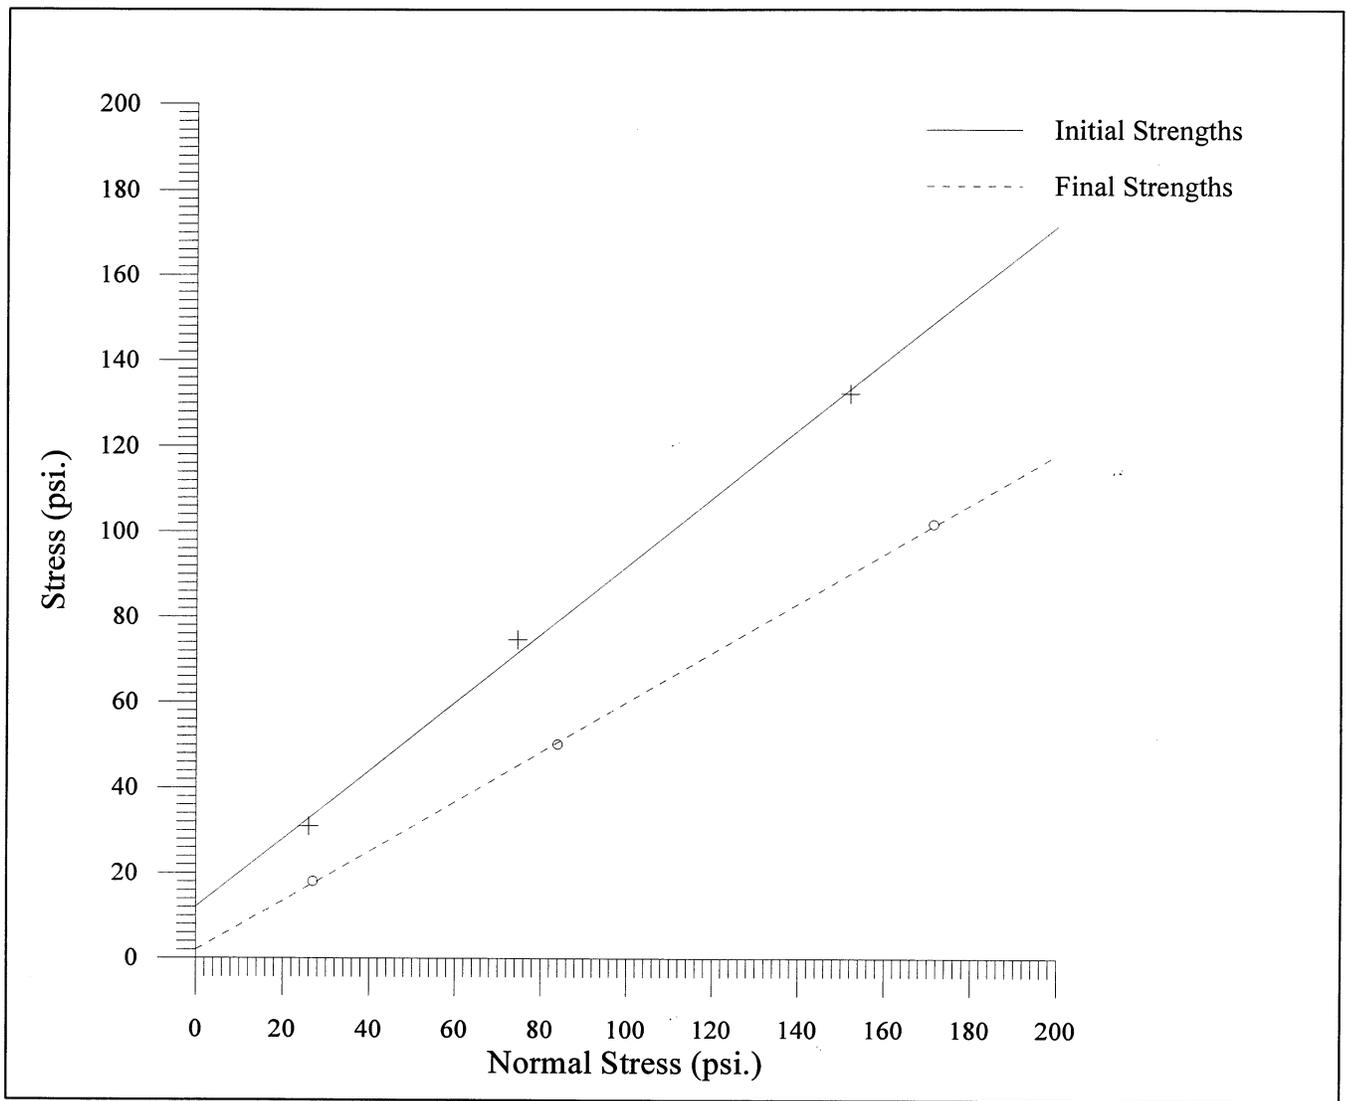
**DIRECT SHEAR TEST  
Failure Envelope**

<p><b>SAMPLE ID:</b> Boring: 98-22 Sample: 19a Depth: 51'</p> <p><b>DESCRIPTION</b></p> <p>Slightly rough, oxide coated joint in medium gray sandstone.</p>

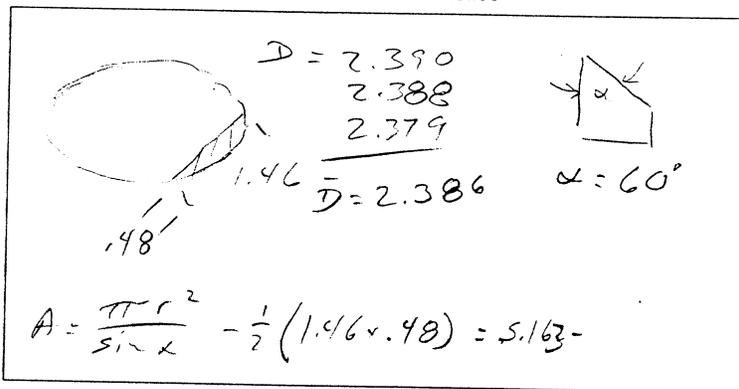
Sketch of Shear Surface

Sample Water Condition: received & tested in moist

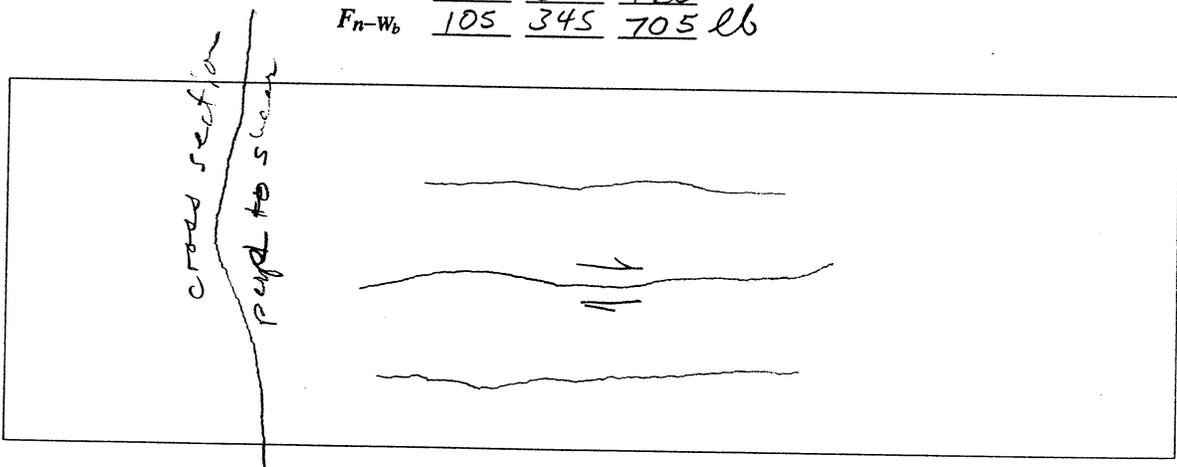
Joint Profiles

$\sigma_n$	<u>25</u>	<u>75</u>	<u>150</u>	psi
$F_n$	<u>120</u>	<u>360</u>	<u>720</u>	lb
$F_n - W_b$	<u>105</u>	<u>345</u>	<u>705</u>	lb

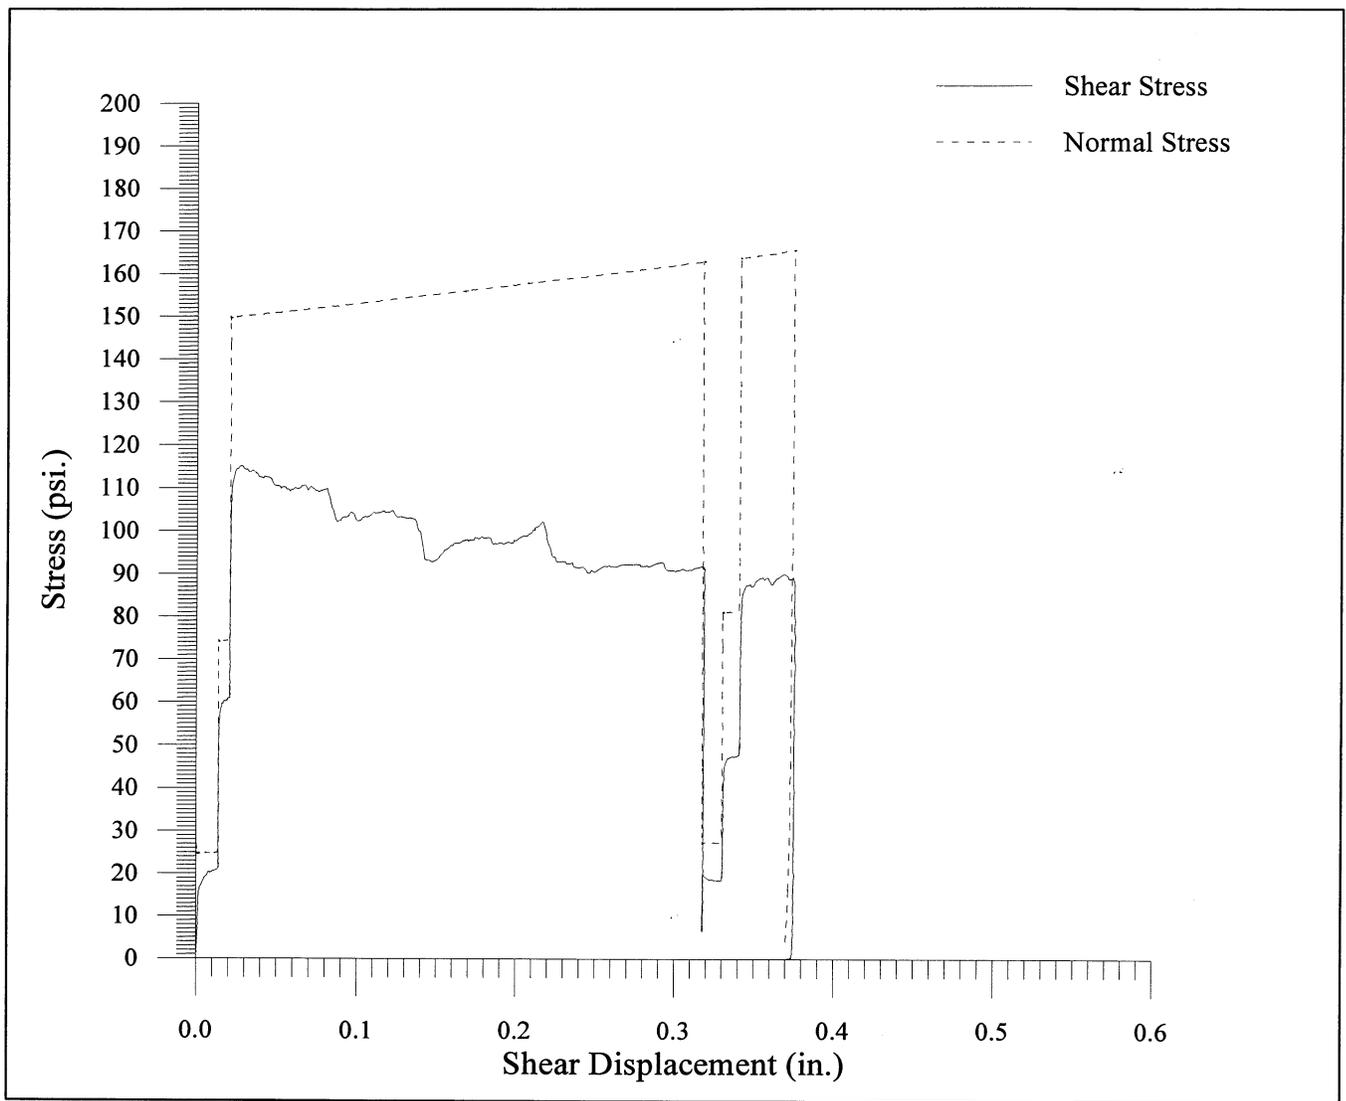
**DIRECT SHEAR TEST**  
**Shear and Normal Stress vs. Shear Displacement**

<p><b>SAMPLE ID:</b> Boring: 98-22  Sample: 19b  Depth: 55'</p> <p align="center"><b>DESCRIPTION</b></p> <p>Irregular Vee shaped joint in dark gray siltstone with a slight oxide coating.</p>

<i>Test</i>  <b>Unlimited</b> </p> <p align="right">800 Peralta Ave  San Leandro, CA 94577</p>
		Normal Stress	Shear Strength															
Initial	25	21.5																
	74	60.5																
	150	115																
Final	27.5	18.5																
	82	48																
	165	89.5																
<p><b>Client:</b> Fugro West, Inc.  5855 Olivas Park Dr.  Ventura, CA 93003</p> <p><b>Project:</b> San Francisco Oakland Bay Bridge  East Span Replacement Project</p> <p><b>Job Number:</b> 98-42-0053</p>	<p><b>Test Date:</b> October 29, 1998</p>

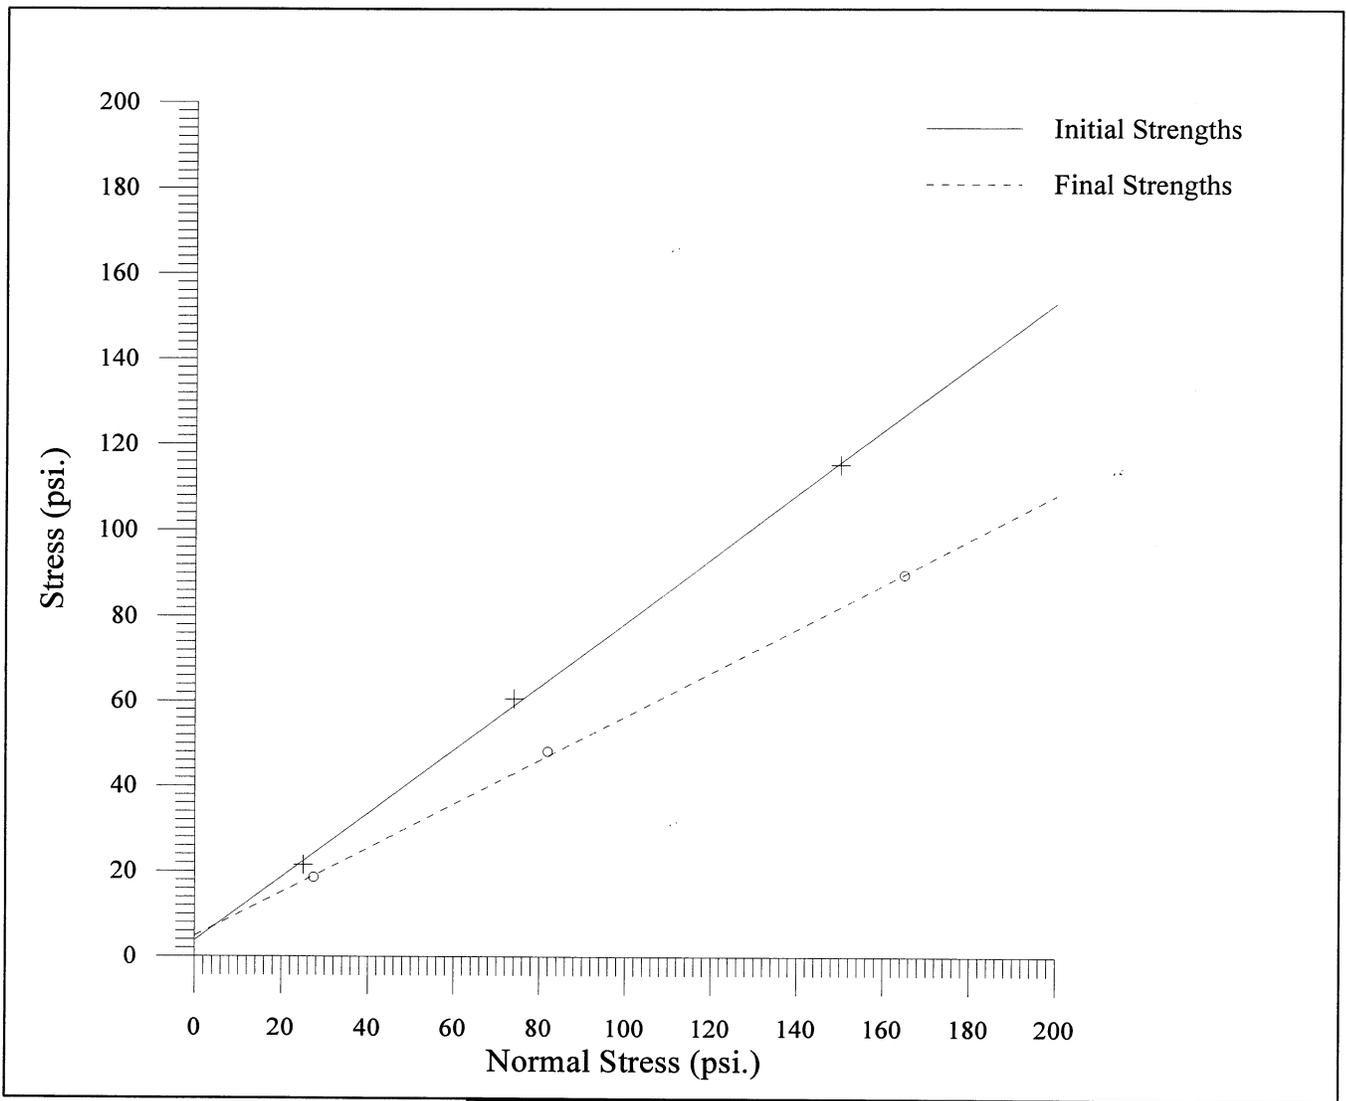
**DIRECT SHEAR TEST  
Failure Envelope**

**SAMPLE ID:** Boring: 98-22  
Sample: 19b  
Depth: 55'

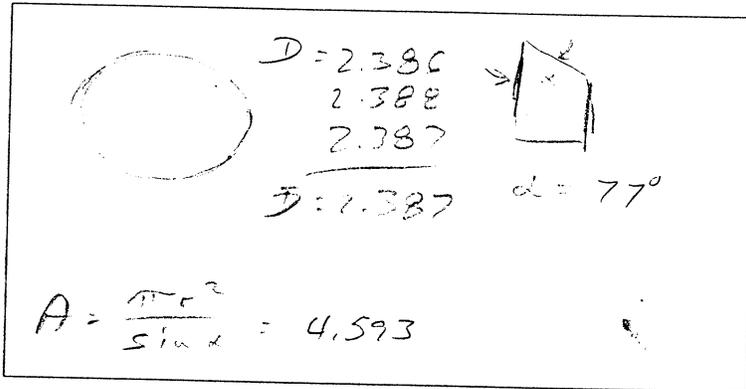
Sketch of Shear Surface

Sample area: 4.593 in<sup>2</sup>

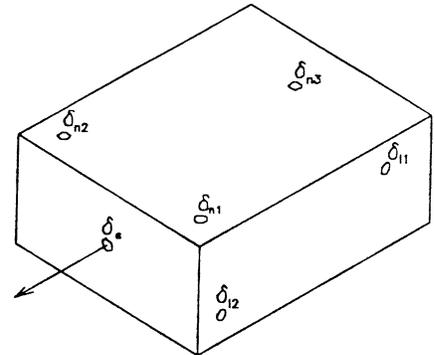
Location of LVDTs on top shear box

Measured Top Box Weight: 15.8 lb

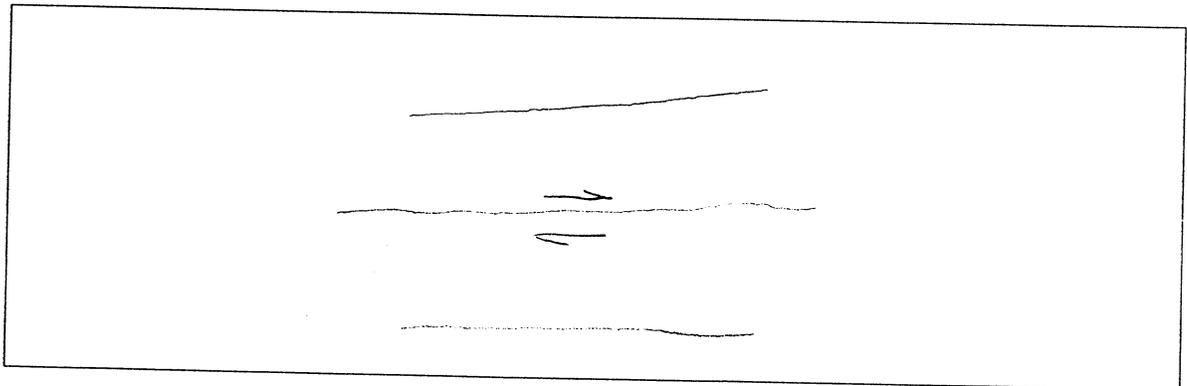
Joint Profiles

$\sigma_n$	<u>25</u>	<u>75</u>	<u>150</u>	<u>psi</u>
$F_n$	<u>115</u>	<u>345</u>	<u>690</u>	<u>lb</u>
$F_n - W_b$	<u>99</u>	<u>329</u>	<u>674</u>	<u>lb</u>

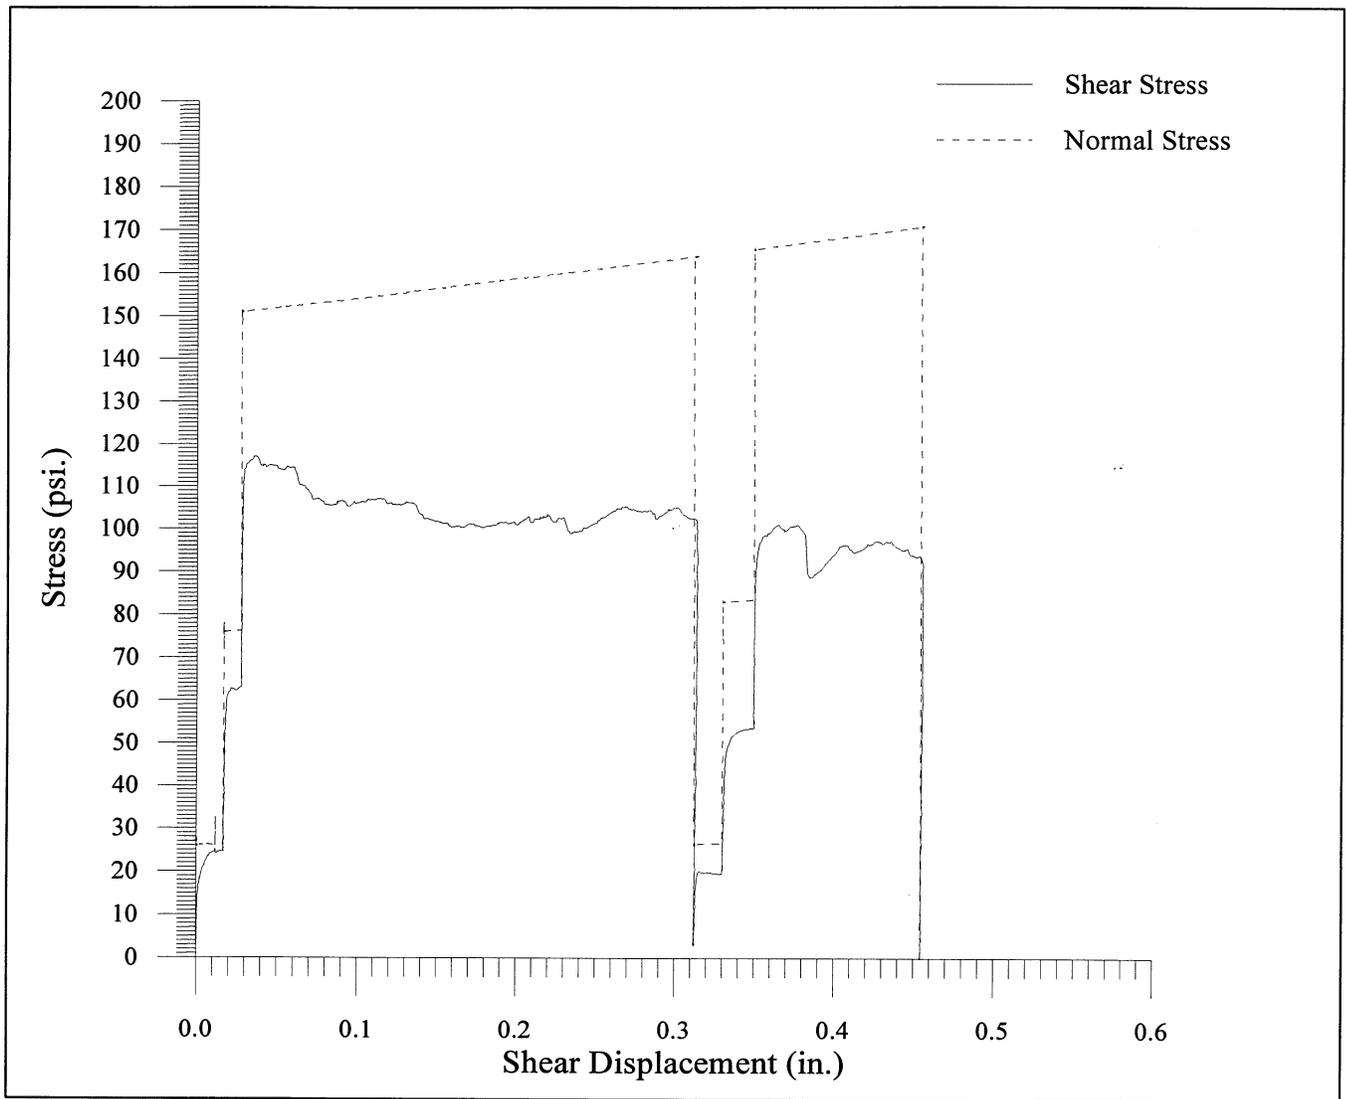
**DIRECT SHEAR TEST**  
**Shear and Normal Stress vs. Shear Displacement**

<b>SAMPLE ID:</b> Boring: 98-22 Sample: 25b Depth: 86'

Normal Stress	Shear Strength	Initial	26	26	76	63	151.5	116	Final	27	19.5	83.5	54	166.5	100.5	<b>Project:</b> San Francisco Oakland Bay Bridge East Span Replacement Project  <b>Job Number:</b> 98-42-0053	
	Normal Stress	Shear Strength																		
Initial	26	26																		
	76	63																		
	151.5	116																		
Final	27	19.5																		
	83.5	54																		
	166.5	100.5																		
		<b>Test Date:</b> October 29, 1998

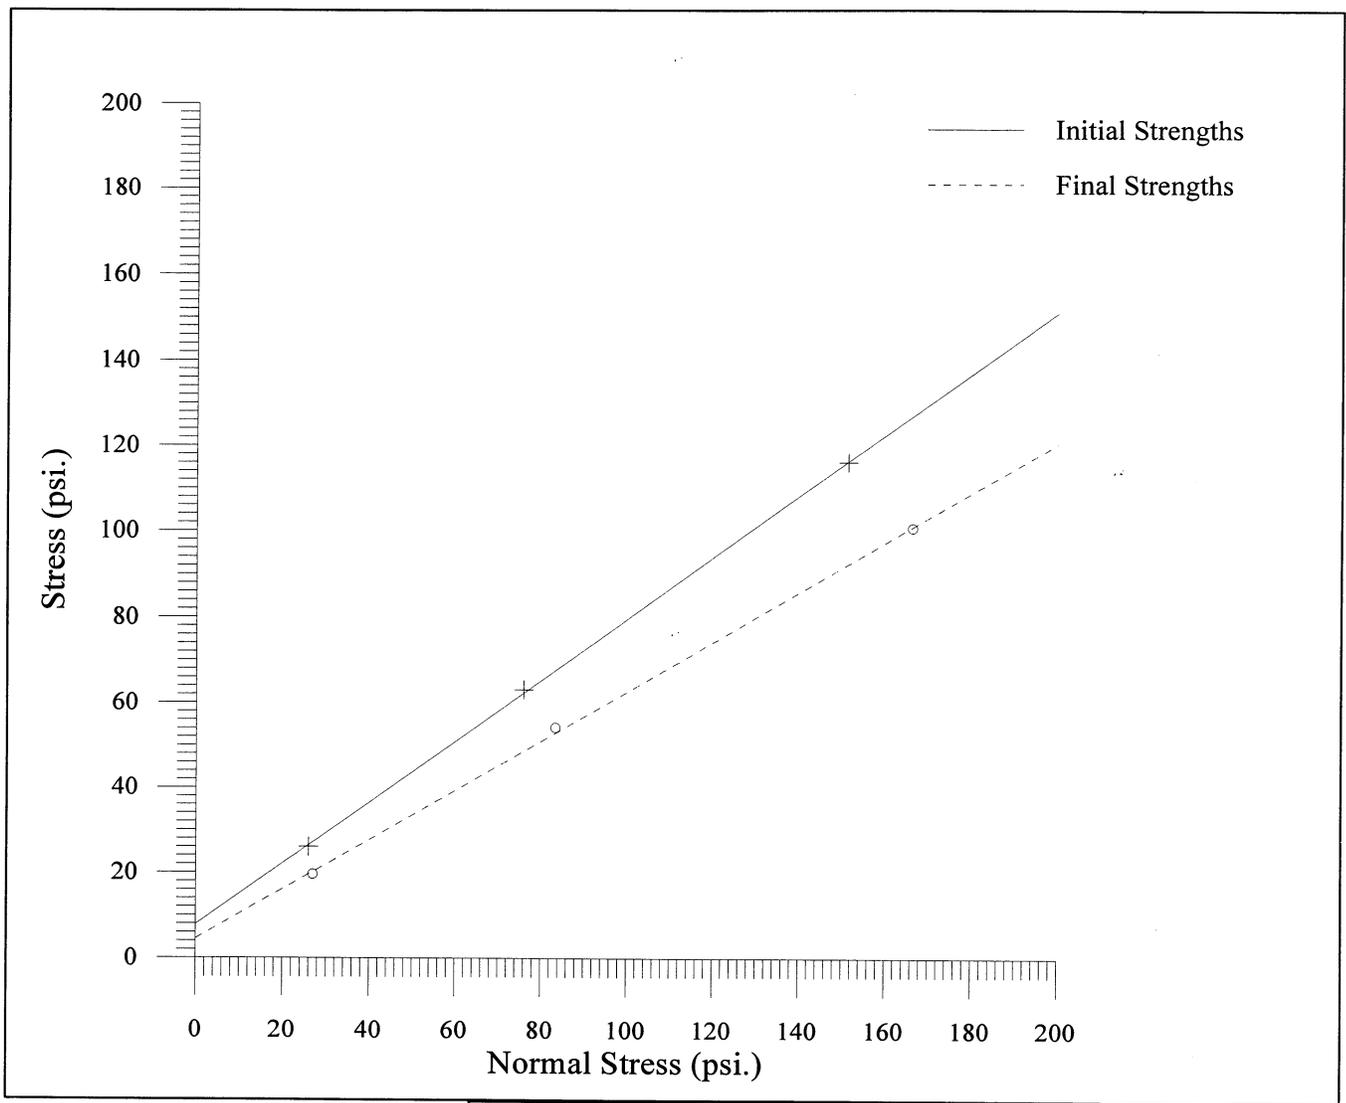
**DIRECT SHEAR TEST  
Failure Envelope**

**SAMPLE ID:** Boring: 98-22  
Sample: 25b  
Depth: 86'

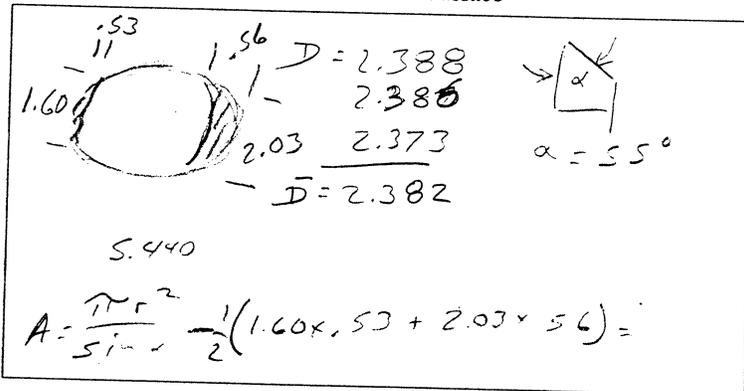
Sketch of Shear Surface

Sample area: 4.448

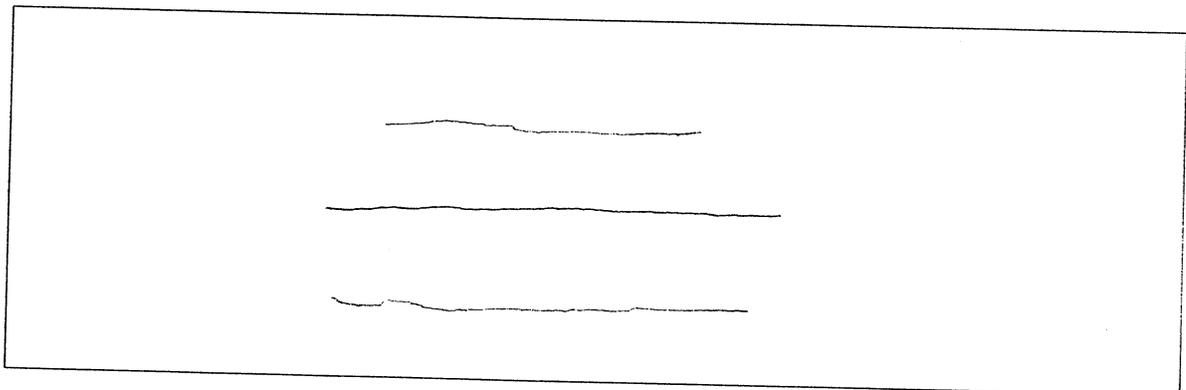
Joint Profiles

$\sigma_n$	<u>25</u>	<u>75</u>	<u>150</u>	psi
$F_n$	<u>111</u>	<u>333</u>	<u>666</u>	lb
$F_n - W_b$	<u>95</u>	<u>317</u>	<u>650</u>	lb

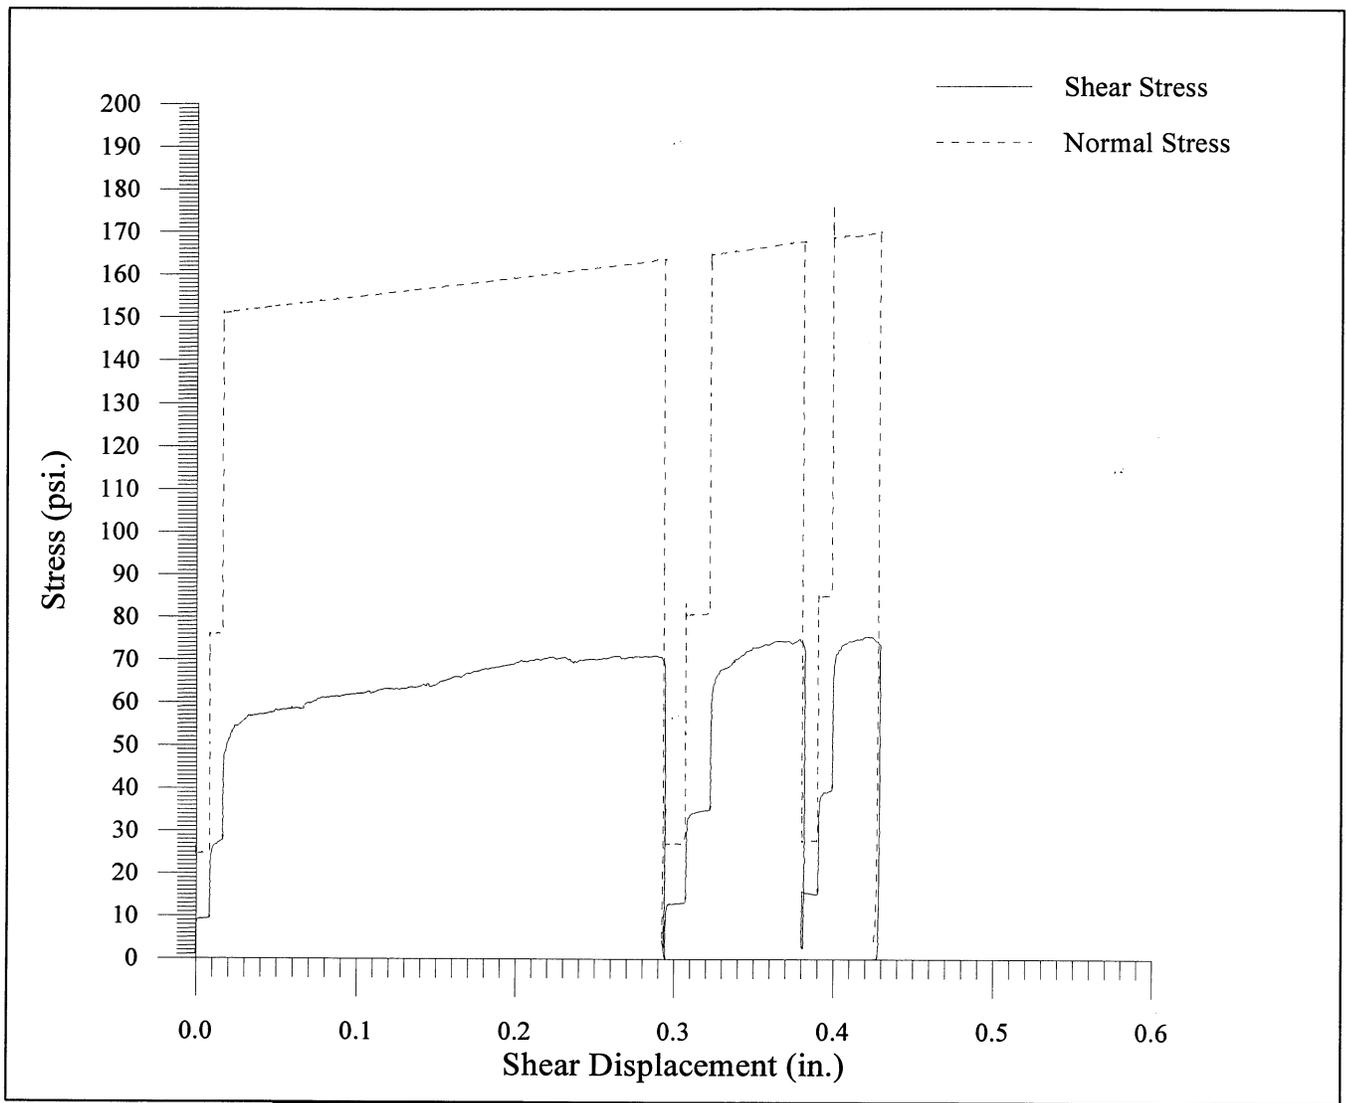
**DIRECT SHEAR TEST**  
**Shear and Normal Stress vs. Shear Displacement**

<p><b>SAMPLE ID:</b> Boring: 98-22          Sample: 25c          Depth: 91.5'</p> <p align="center"><b>DESCRIPTION</b></p> <p>Planar calcite coated bedding plane joint in dark gray claystone adjacent to a claystone/sandstone contact.</p>

Normal Stress	Shear Strength	Initial	24.5	9.5	76	28	152.5	57	Final	28	15	85.5	40	170	75	<p align="center">   <b>Geo Test Unlimited</b>          800 Peralta Ave          San Leandro, CA 94577       </p>
		Normal Stress	Shear Strength															
Initial	24.5	9.5																
	76	28																
	152.5	57																
Final	28	15																
	85.5	40																
	170	75																
<p><b>Client:</b> Fugro West, Inc.          5855 Olivas Park Dr.          Ventura, CA 93003</p> <p><b>Project:</b> San Francisco Oakland Bay Bridge          East Span Replacement Project</p> <p><b>Job Number:</b> 98-42-0053</p>	<p><b>Test Date:</b> October 29, 1998</p>

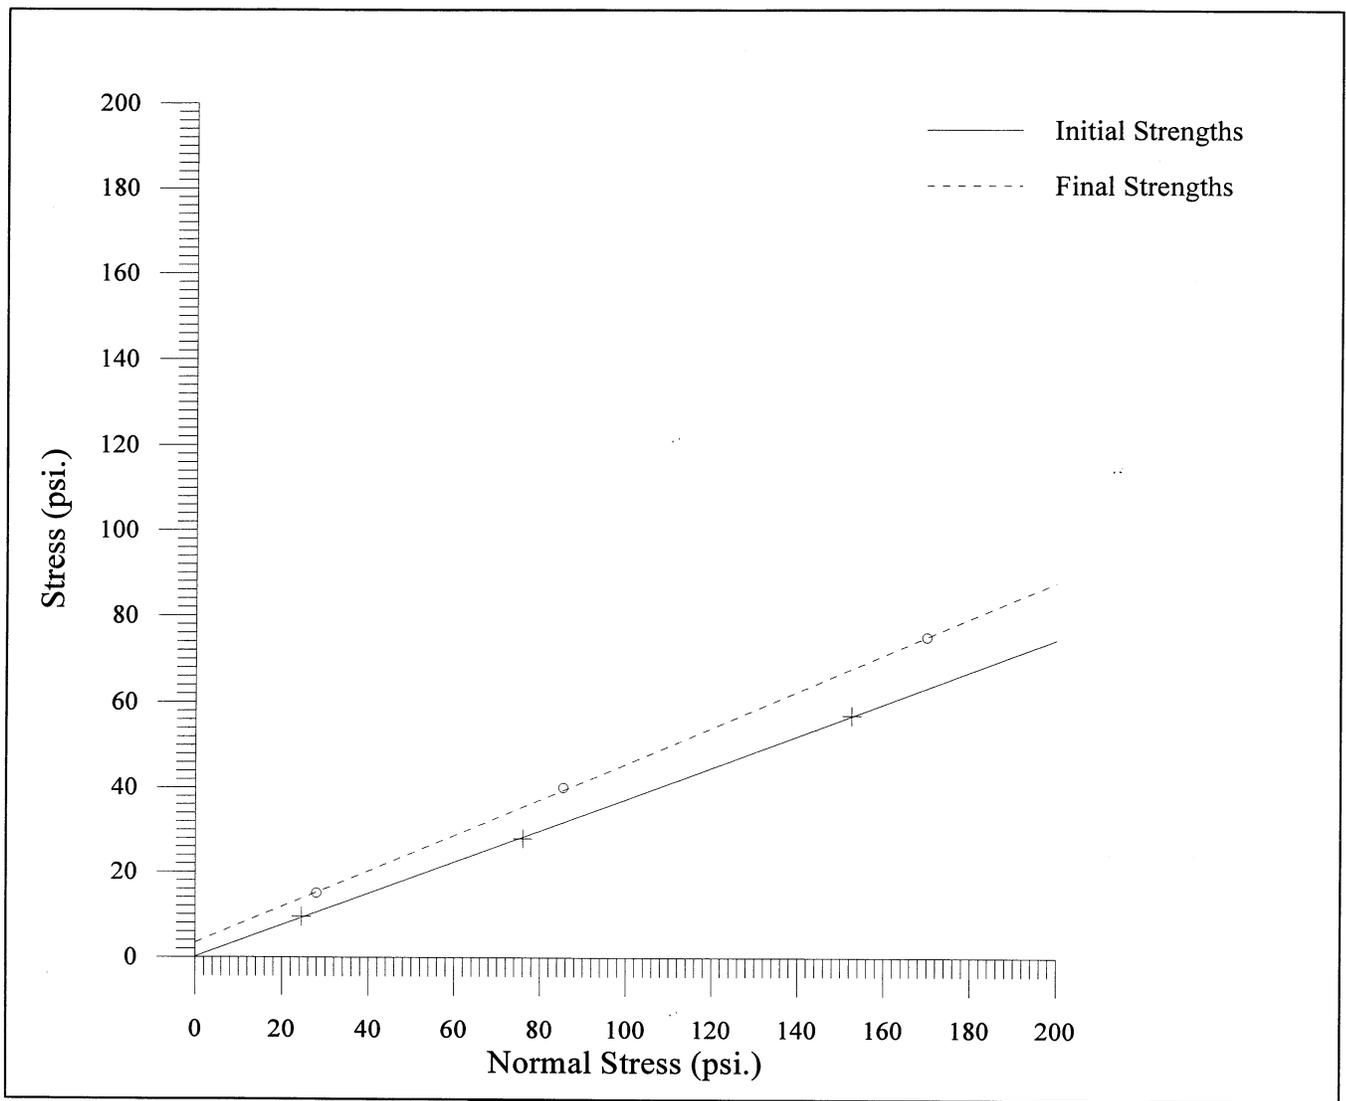
**DIRECT SHEAR TEST  
Failure Envelope**

<p><b>SAMPLE ID:</b> Boring: 98-22 Sample: 25c Depth: 91.5'</p> <p align="center"><b>DESCRIPTION</b></p> <p>Planar calcite coated bedding plane joint in dark gray claystone adjacent to a claystone/sandstone contact.</p>

<i>Test</i>  <b>Unlimited</b> 800 Peralta Ave  San Leandro, CA 94577 </p>
		Shear Intercept (psi)	Friction Angle (degrees)							
Initial	0.2	20.3								
Final	3.5	22.9								
<p><b>Client:</b> Fugro West, Inc. 5855 Olivas Park Dr. Ventura, CA 93003</p> <p><b>Project:</b> San Francisco Oakland Bay Bridge East Span Replacement Project</p> <p><b>Job Number:</b> 98-42-0053</p> <p><b>Test Date:</b> October 29, 1998</p>

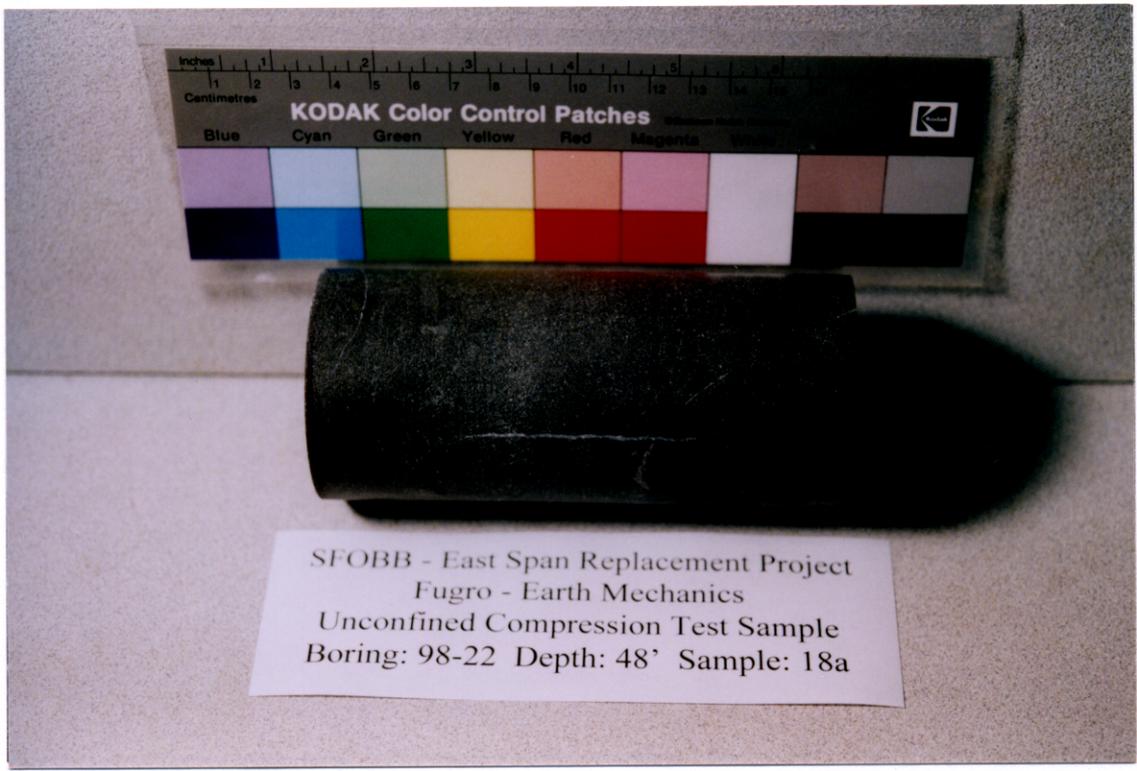
SFOBB - East Span Replacement Project  
Fugro - Earth Mechanics  
Unconfined Compression Test Sample  
Boring: 98-22 Depth: 48' Sample: 18a

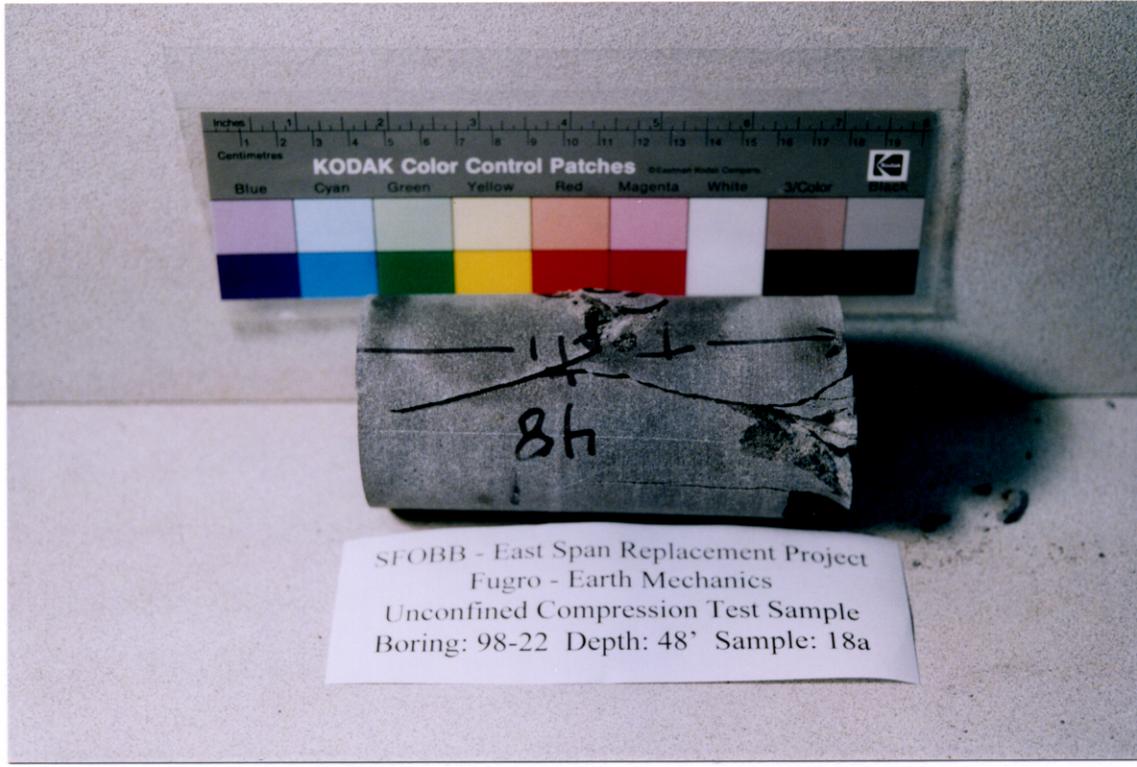
SFOBB - East Span Replacement Project  
Fugro - Earth Mechanics  
Unconfined Compression Test Sample  
Boring: 98-22 Depth: 48' Sample: 18a

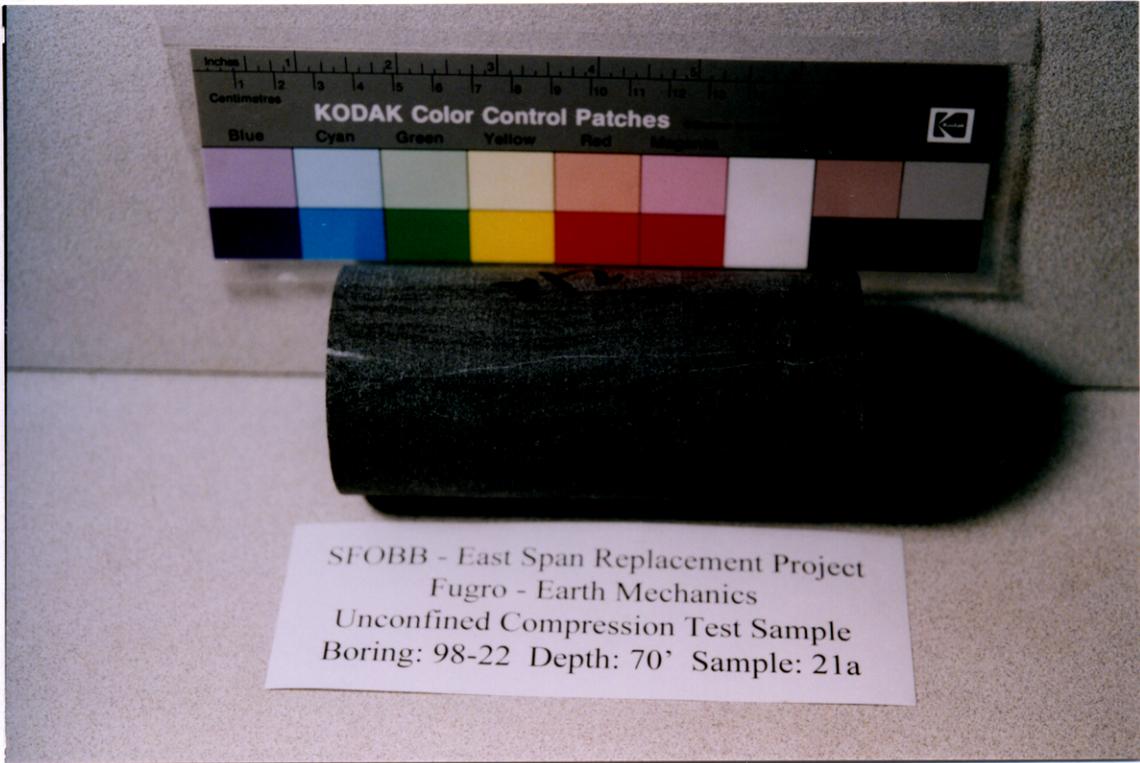
SFOBB - East Span Replacement Project  
Fugro - Earth Mechanics  
Unconfined Compression Test Sample  
Boring: 98-22 Depth: 70' Sample: 21a

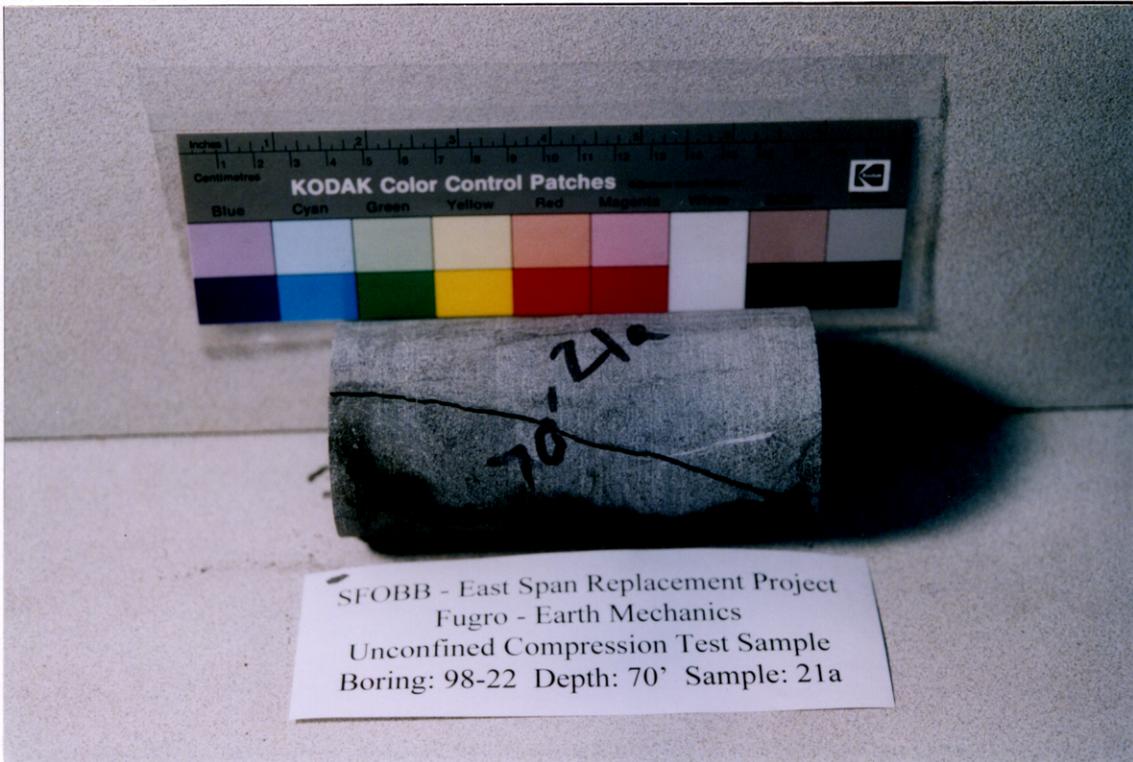
SFOBB - East Span Replacement Project  
Fugro - Earth Mechanics  
Unconfined Compression Test Sample  
Boring: 98-22 Depth: 70' Sample: 21a
