**SUBCONTRACTOR REPORTS  
FINAL GEOTECHNICAL  
SITE CHARACTERIZATION**

**SAN FRANCISCO-OAKLAND BAY BRIDGE  
EAST SPAN SEISMIC SAFETY PROJECT**

**VOLUME 2 OF 3  
(GeoTest Unlimited)**

Letter Report  
San Francisco Oakland Bay Bridge  
East Span Replacement Project  
Rock Testing Program

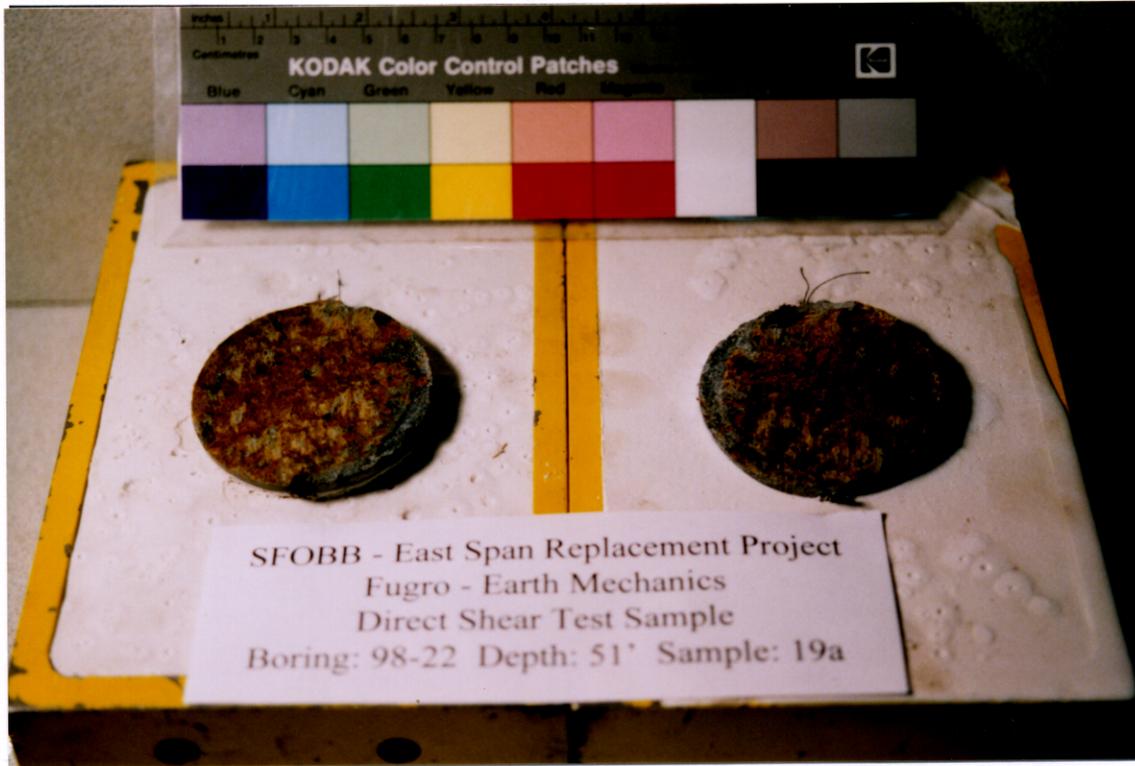
SFOBB - East Span Replacement Project  
Fugro - Earth Mechanics  
Direct Shear Test Sample  
Boring: 98-22 Depth: 51' Sample: 19a

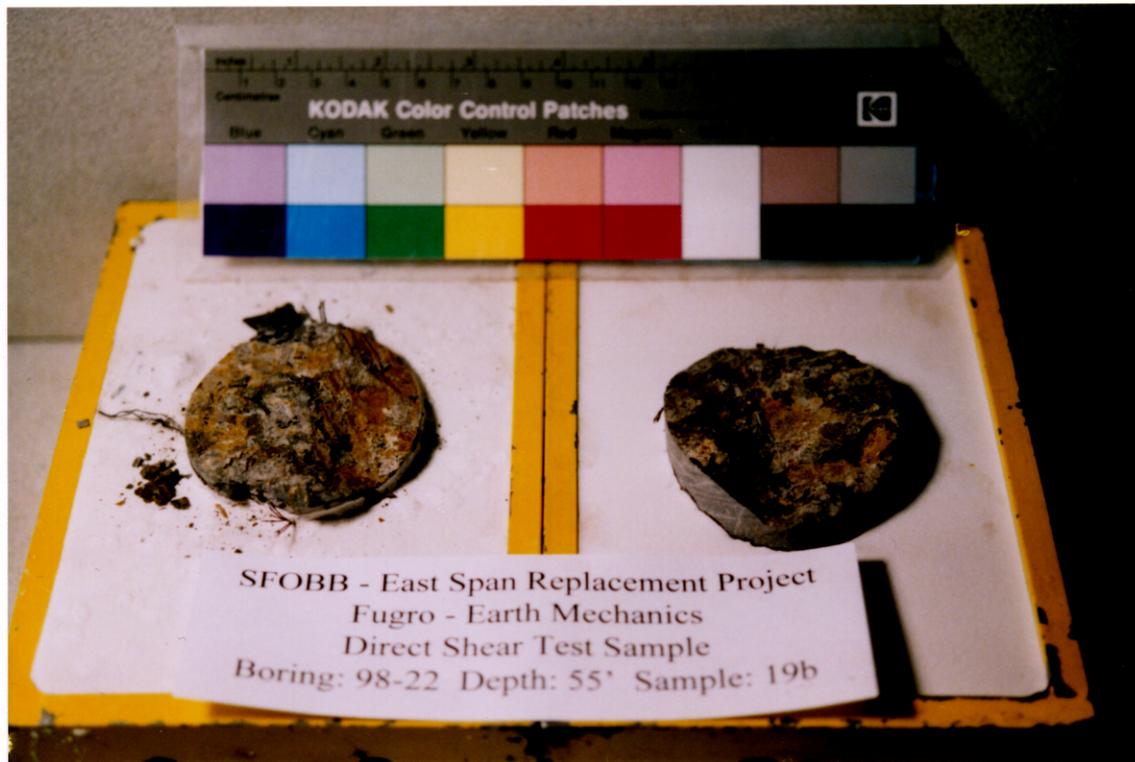
SFOBB - East Span Replacement Project  
Fugro - Earth Mechanics  
Direct Shear Test Sample  
Boring: 98-22 Depth: 55' Sample: 19b

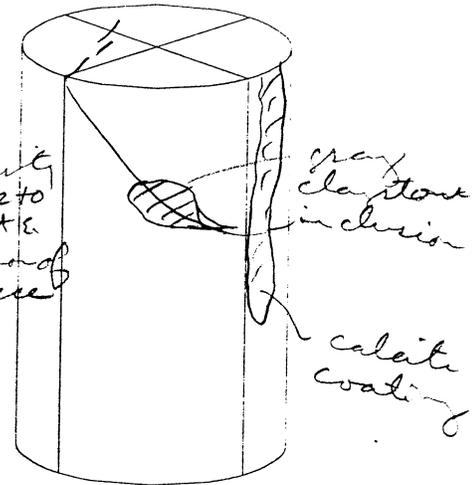
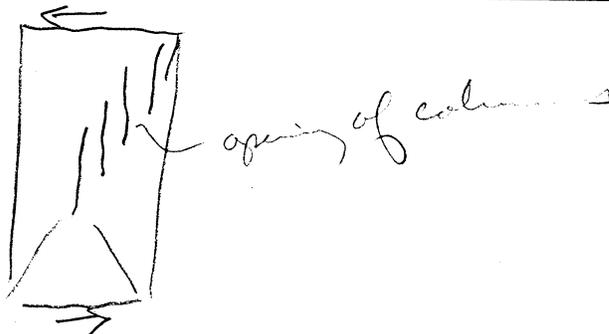
Sample Description: Light brown massive sandstone with a diagonal open fracture 32° to the core axis and a calcite coating on one side

non planar due to joint & rotation of top piece

Comments: edge of joint lightly glued to maintain sample integrity.

Failed by shear/axial splitting

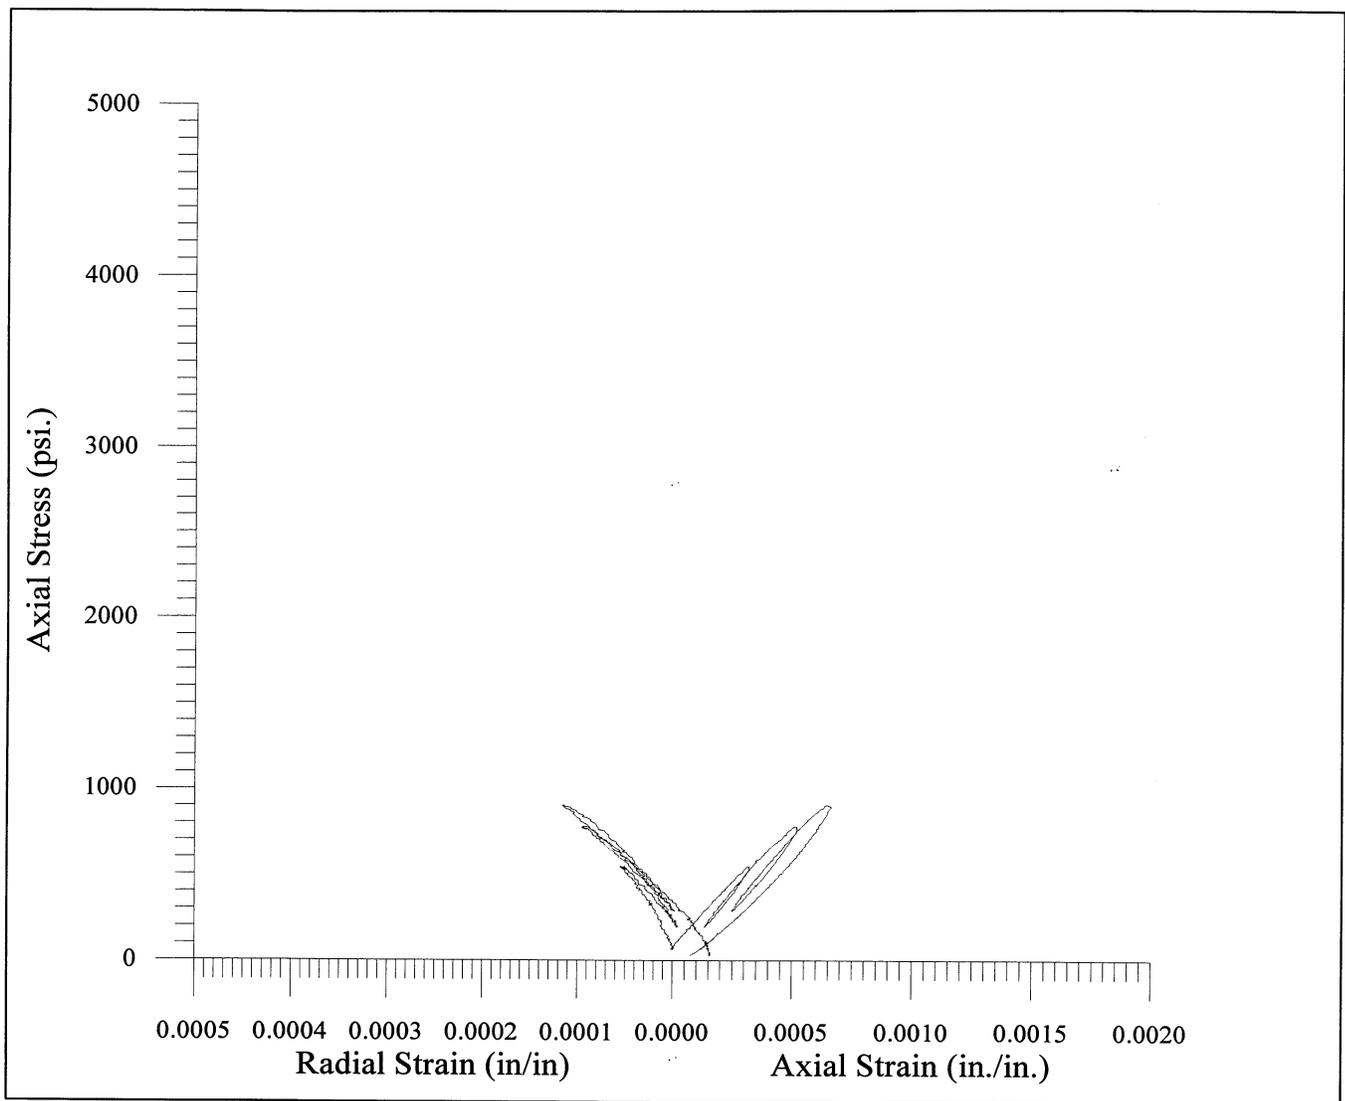
**ELASTIC MODULUS TEST**  
**Axial Stress vs. Axial & Radial Strain**

<p><b>SAMPLE ID:</b> Boring: 98-23  Sample: 6a  Depth: 14.5'</p> <p><b>DESCRIPTION</b>  Light brown massive sandstone with an open fracture near the core end, 32 degrees to the core axis, and a calcite coating on one side.</p> <p><b>MODULUS:</b> 1,770,000 psi  <b>POISSON'S RATIO:</b> .30</p>	<p align="center"> <i>Geo</i>

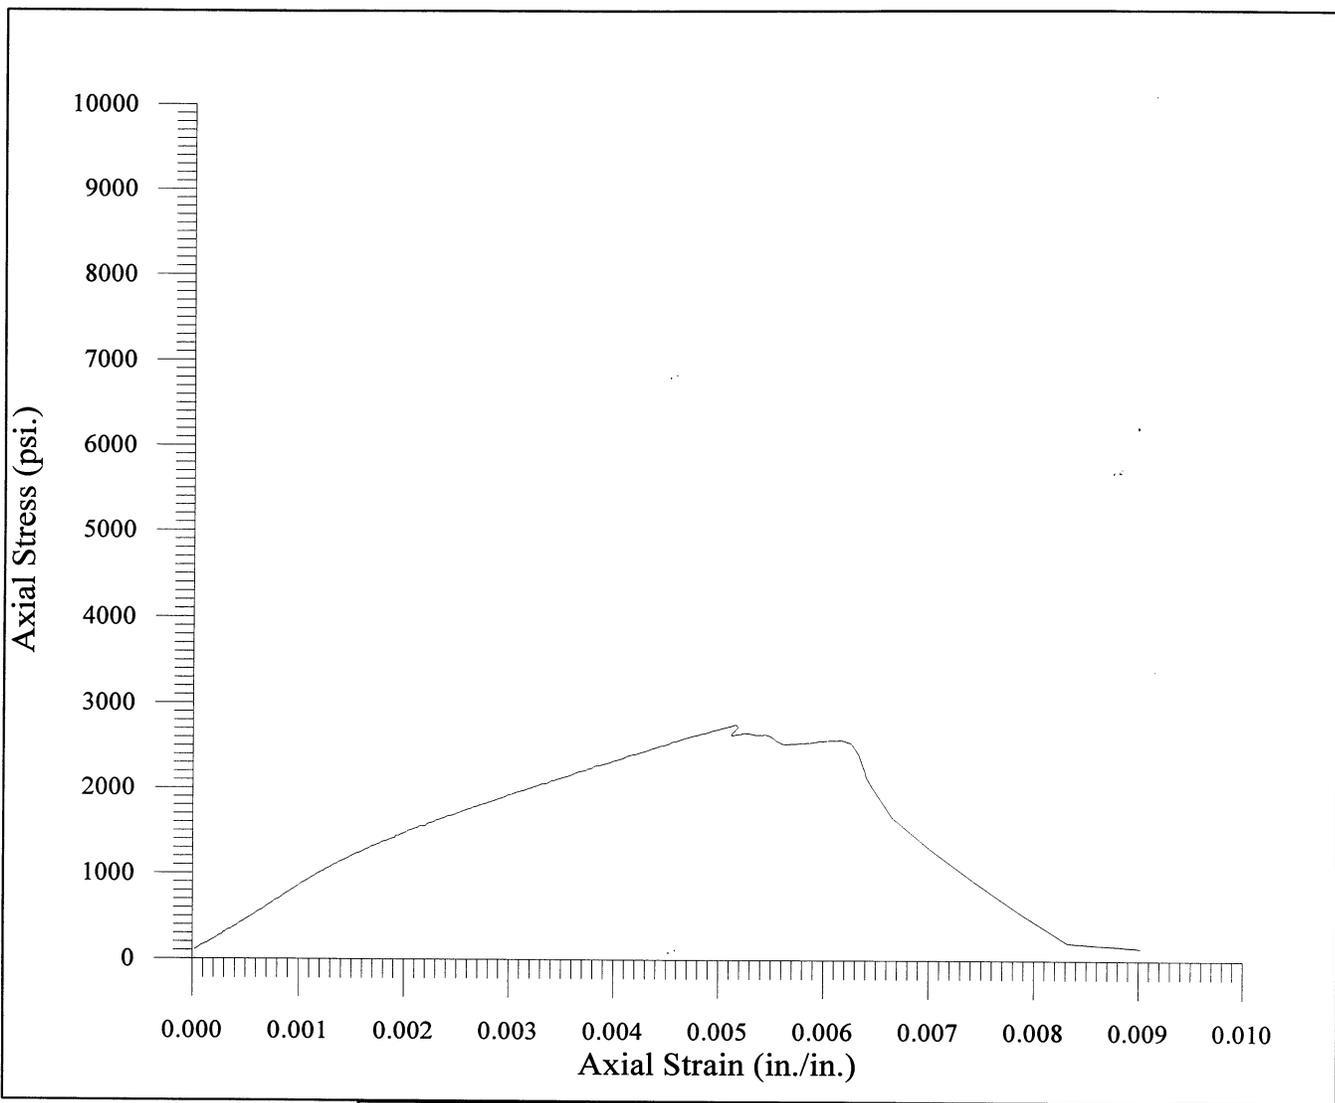
**UNCONFINED COMPRESSION TEST  
Axial Stress vs. Axial Strain**

**SAMPLE ID:** Boring : 98-23  
 Sample: 6a  
 Depth: 14.5'

**DESCRIPTION**  
 Light brown massive sandstone with an open fracture near the core end, 32 degrees to the core axis, and a calcite coating on one side.

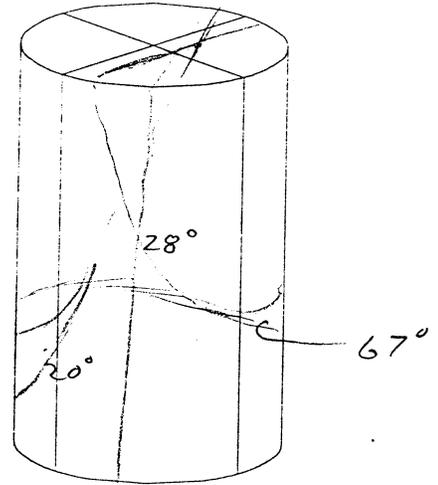
Sample Description: Medium gray sandstone with a few calcite healed hairline fractures 0°, 20°, 28°, 67° to the core axis

Comments: Failed by axial splitting & shear on 28° healed joint.

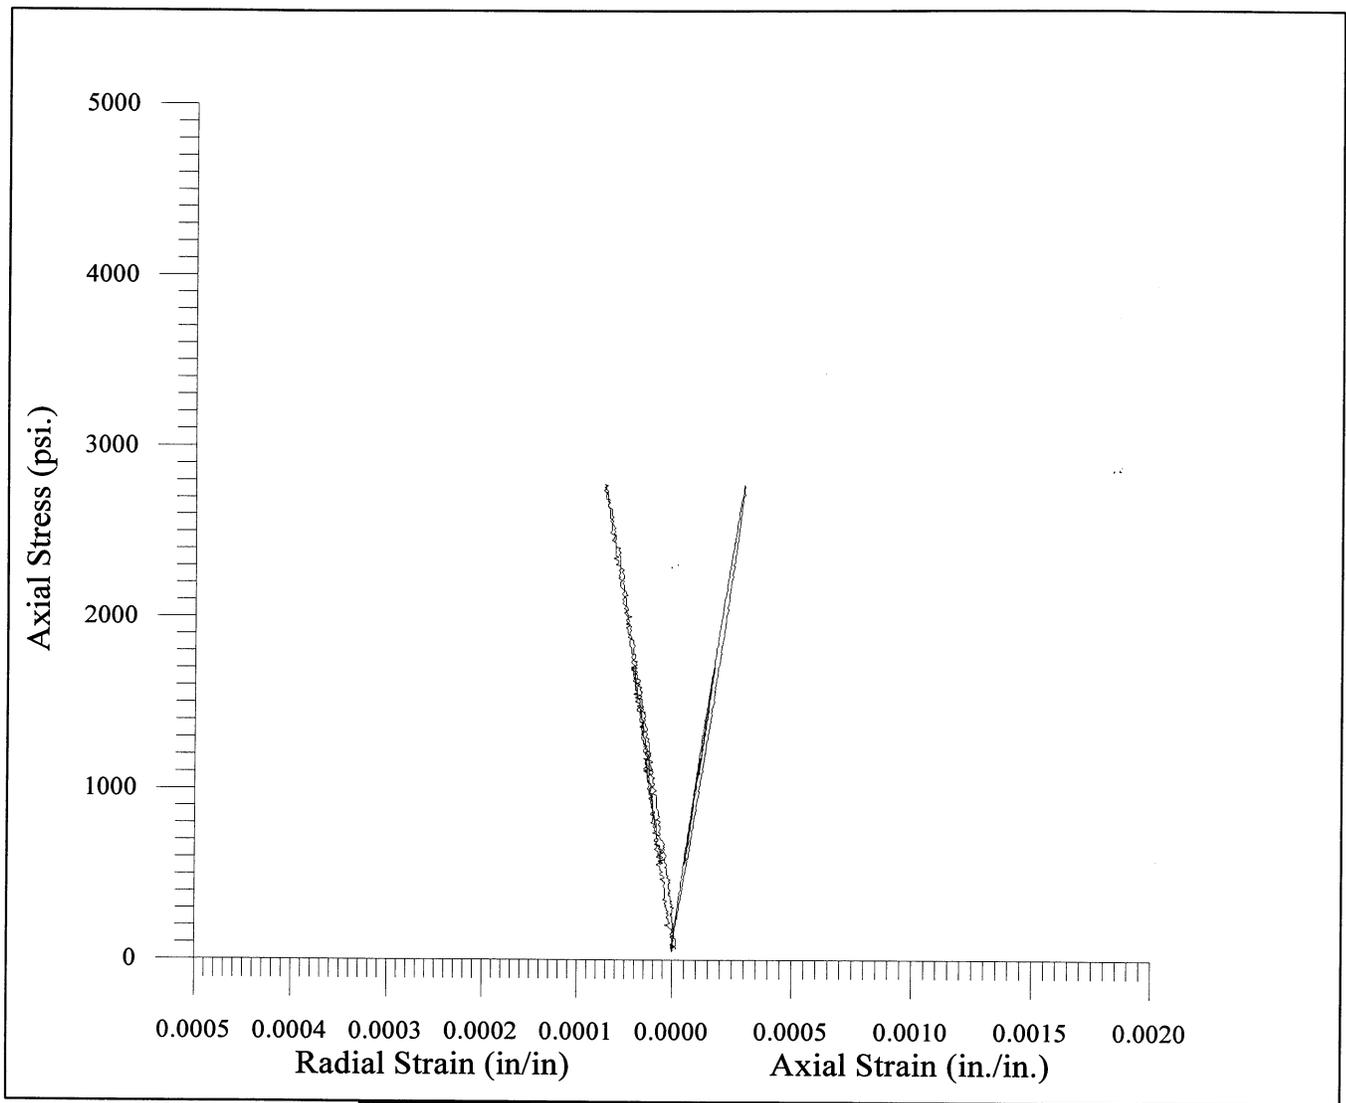
**ELASTIC MODULUS TEST**  
**Axial Stress vs. Axial & Radial Strain**

**SAMPLE ID:** Boring: 98-23  
 Sample: 11a  
 Depth: 34'

**DESCRIPTION**  
 Medium gray sandstone with a few calcite healed hairline fractures, 0, 20, 28, and 67 degrees to the core axis.

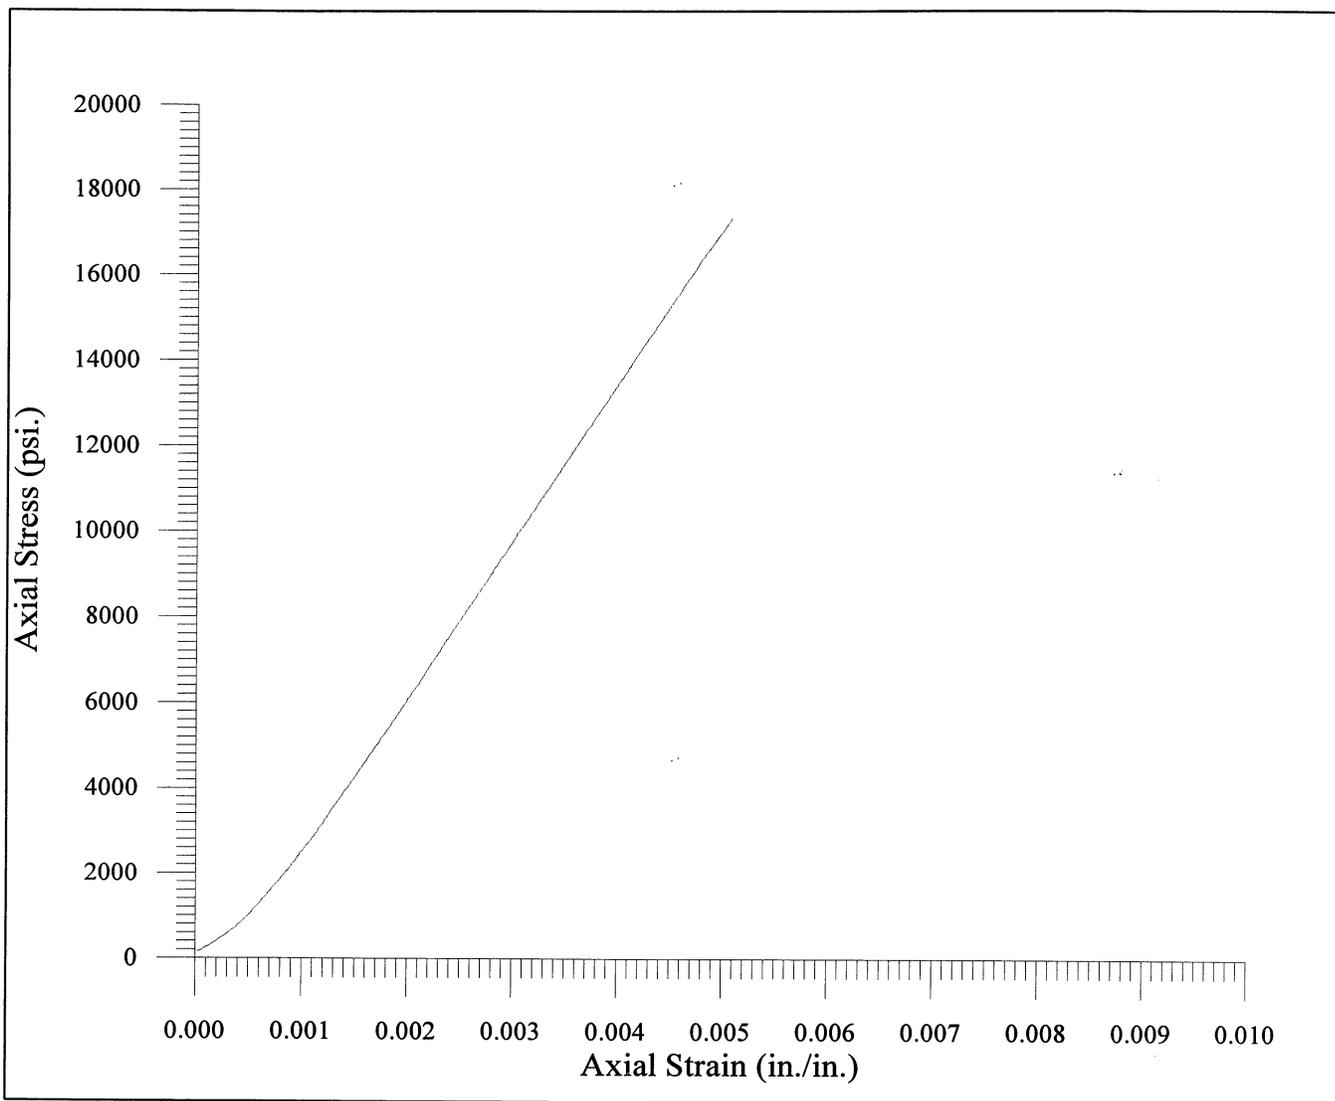
**UNCONFINED COMPRESSION TEST  
Axial Stress vs. Axial Strain**

<p><b>SAMPLE ID:</b> Boring : 98-23 Sample: 11a Depth: 34'</p> <p align="center"><b>DESCRIPTION</b></p> <p>Medium gray sandstone with a few calcite healed hairline fractures, 0, 20, 28, and 67 degrees to the core axis.</p> <p><b>STRENGTH:</b> 17,330 psi</p>	<div style="text-align: center;">

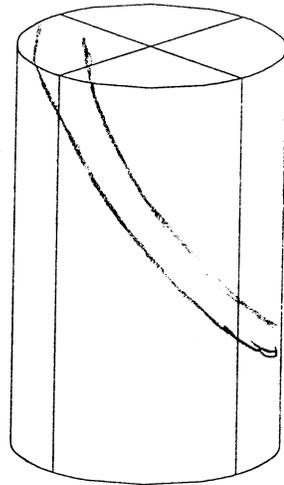
Sample Description: medium gray sandstone with two calcite healed hairline fractures 33° to the core axis.

Comments: Failed by shear on existing fracture

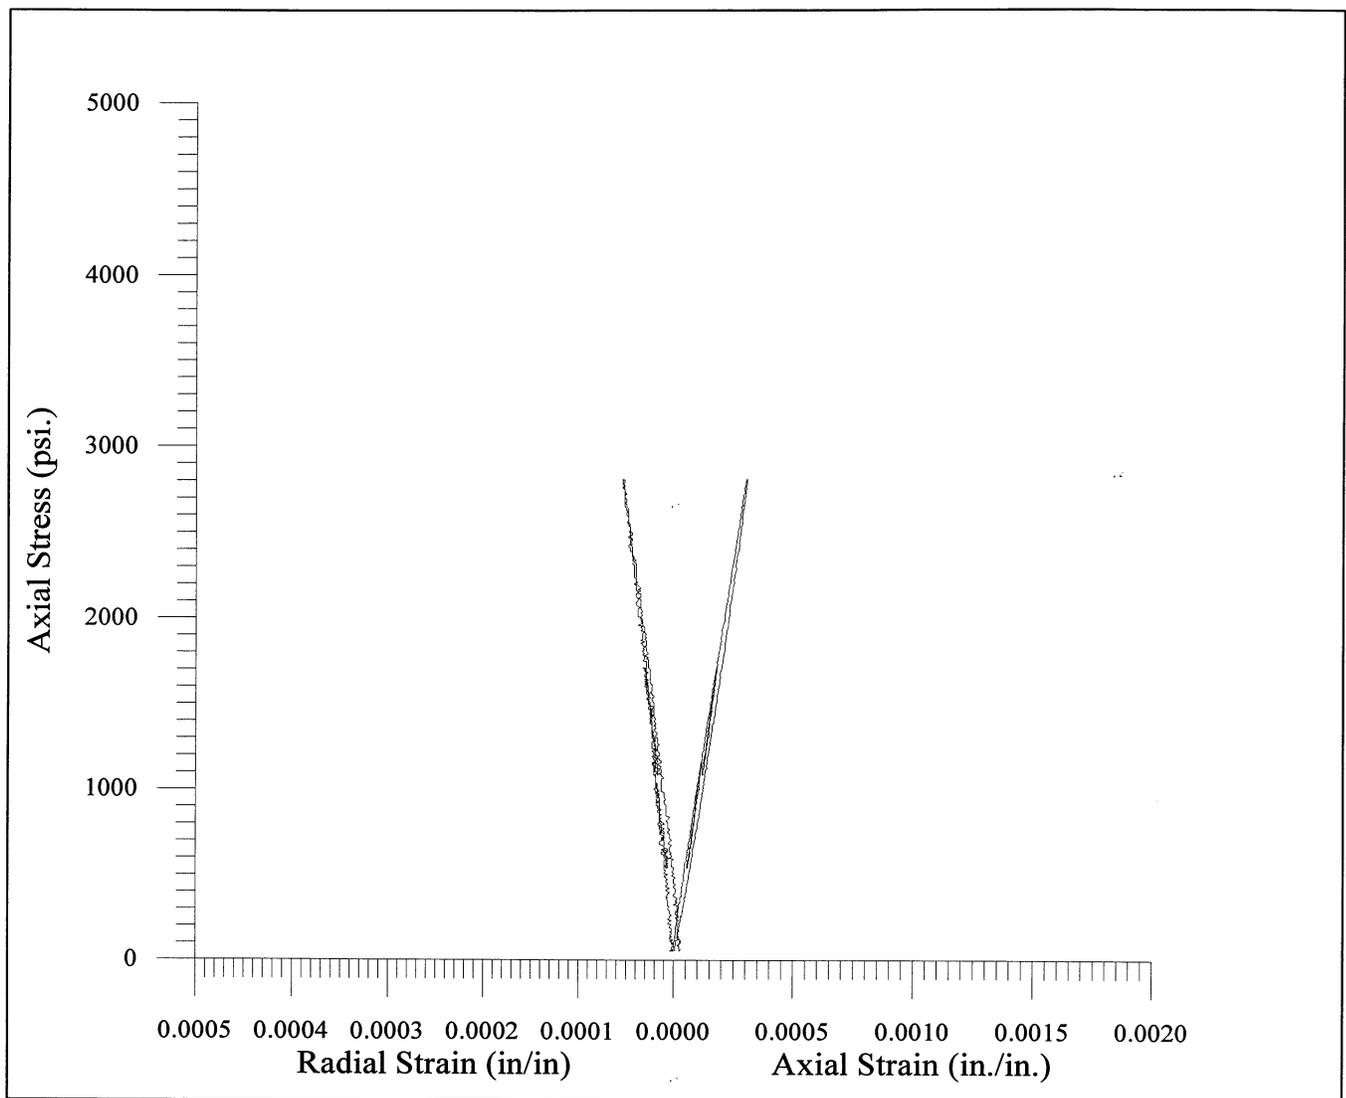
**ELASTIC MODULUS TEST**  
**Axial Stress vs. Axial & Radial Strain**

<p><b>SAMPLE ID:</b> Boring: 98-23  Sample: 14a  Depth: 46.5'</p>	<p align="center"><i>Geo</i>

<i>Test</i>  <b>Unlimited</b> 800 Peralta Ave  San Leandro, CA 94577</p>
<p align="center"><b>DESCRIPTION</b></p> <p>Medium gray sandstone with two calcite healed hairline fractures, 33 degrees to the core axis.</p> <p><b>MODULUS:</b> 11,630,000 psi  <b>POISSON'S RATIO:</b> .26</p>	<p><b>Client:</b> Fugro West, Inc.  5855 Olivas Park Dr.  Ventura, CA 93003</p> <p><b>Project:</b> San Francisco Oakland Bay Bridge  East Span Replacement Project</p> <p><b>Job Number:</b> 98-42-0053</p>
	<p><b>Test Date:</b> October 22, 1998</p>

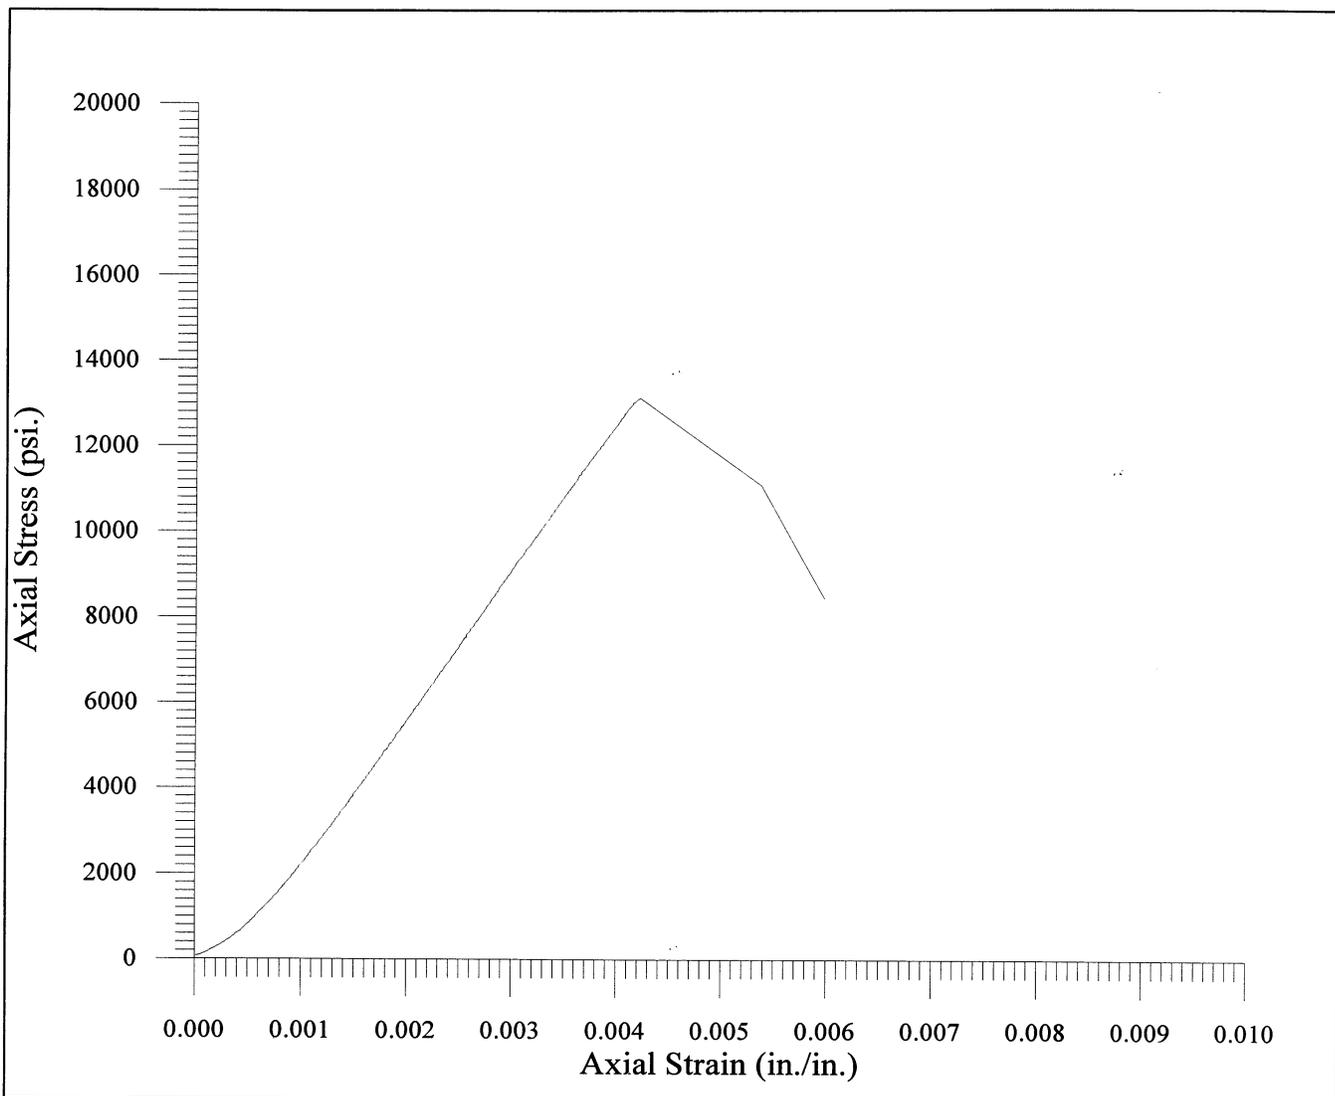
**UNCONFINED COMPRESSION TEST**  
**Axial Stress vs. Axial Strain**

<p><b>SAMPLE ID:</b> Boring : 98-23          Sample: 14a          Depth: 46.5'</p>	<p><i>Geo</i>

<i>Test</i>  <b>Unlimited</b> 800 Peralta Ave          San Leandro, CA 94577</p>
<p><b>DESCRIPTION</b>          Medium gray sandstone with two calcite          healed hairline fractures, 33 degrees          to the core axis.</p>	<p><b>Client:</b> Fugro West, Inc.          5855 Olivas Park Dr.          Ventura, CA 93003</p>
<p><b>STRENGTH:</b> 13,109 psi</p>	<p><b>Project:</b> San Francisco Oakland Bay Bridge          East Span Replacement Project</p>
	<p><b>Job Number:</b> 98-42-0053</p>
	<p><b>Test Date:</b> October 23, 1998</p>

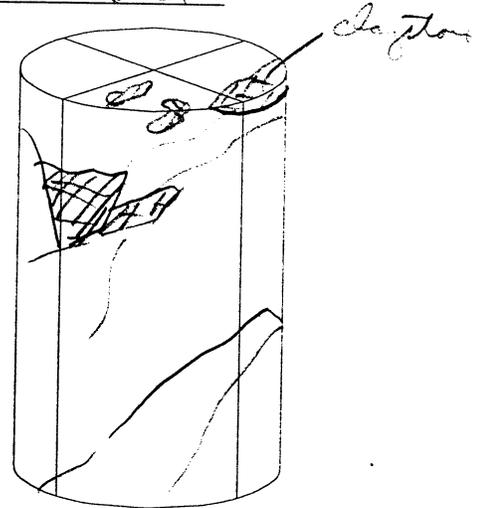
Sample Description: Dark gray fine sandy siltstone with claystone inclusions. Also contains many calcite healed fracture features between 30° & 50° to the core axis.

Comments: Failed by axial splitting and shear

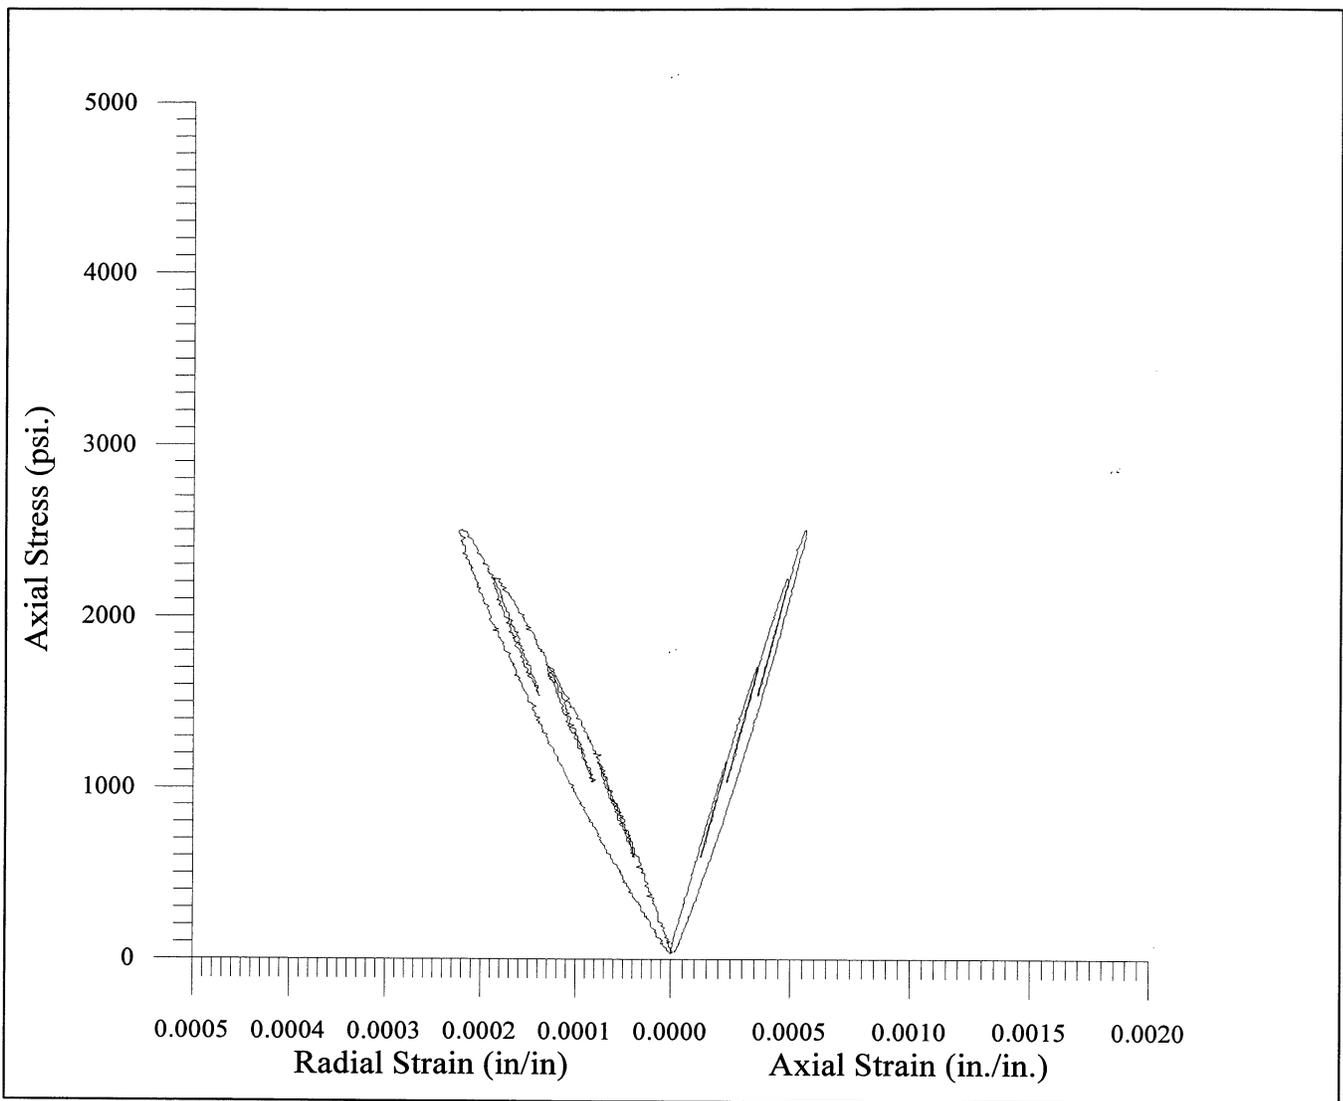
**ELASTIC MODULUS TEST**  
**Axial Stress vs. Axial & Radial Strain**

**SAMPLE ID:** Boring: 98-23  
 Sample: 17a  
 Depth: 57.5'

**DESCRIPTION**  
 Dark gray fine sandy siltstone with claystone inclusions and many calcite healed hairline fractures, 30 and 50 degrees to the core axis.

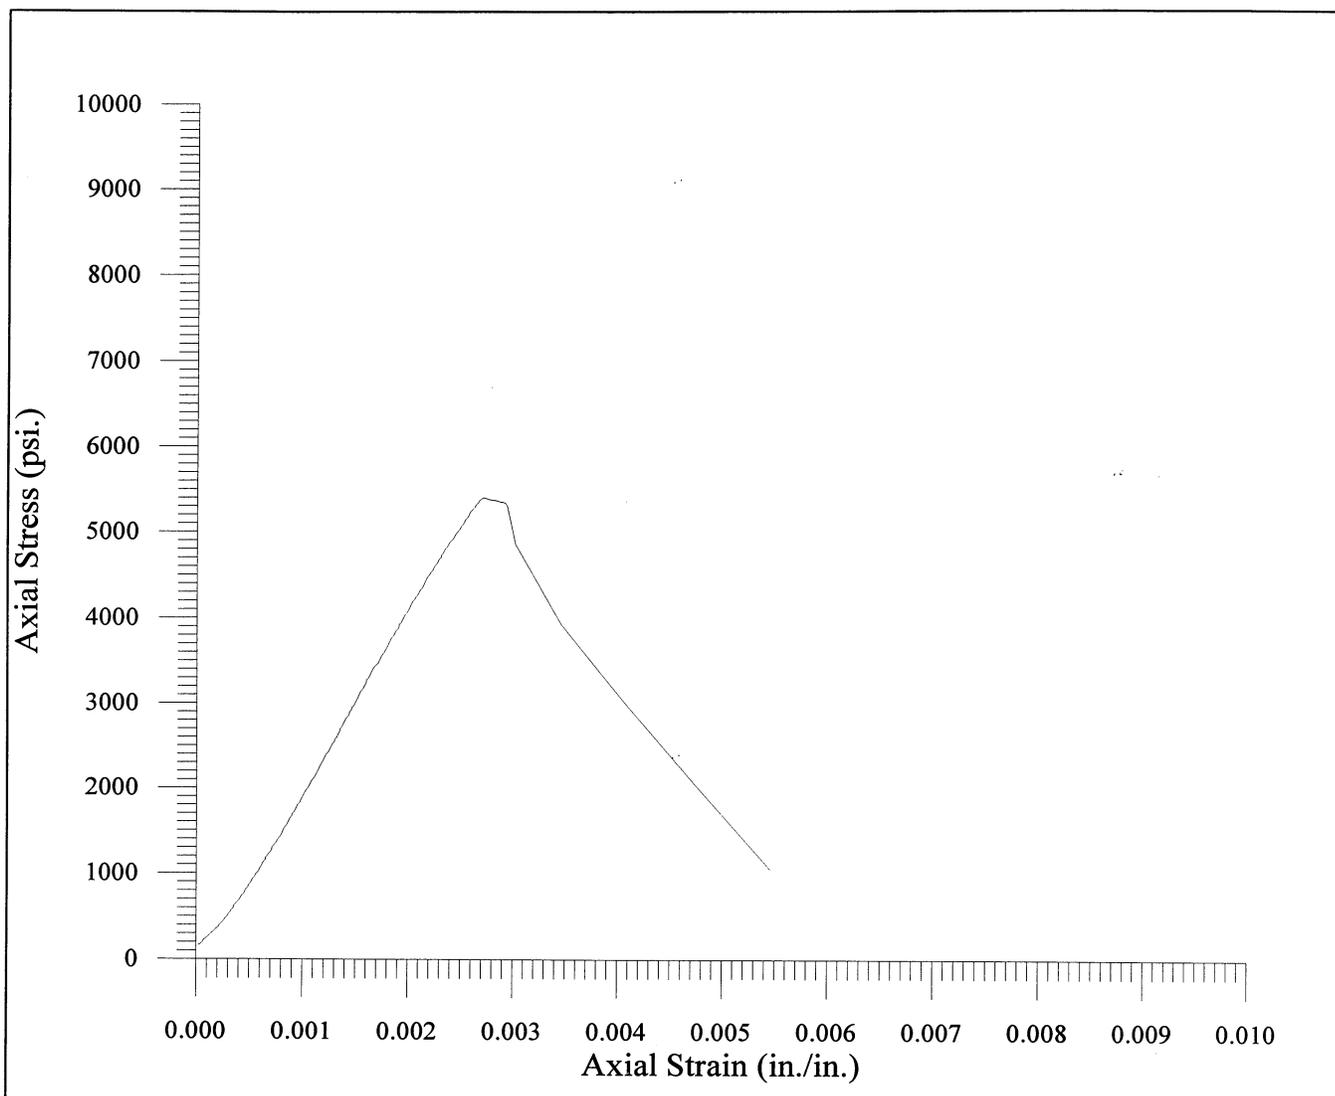
**UNCONFINED COMPRESSION TEST**  
**Axial Stress vs. Axial Strain**

<p><b>SAMPLE ID:</b> Boring : 98-23          Sample: 17a          Depth: 57.5'</p> <p align="center"><b>DESCRIPTION</b></p> <p>Dark gray fine sandy siltstone with claystone inclusions and many calcite healed hairline fractures, 30 and 50 degrees to the core axis.</p> <p><b>STRENGTH:</b> 5398 psi</p>	<div align="center">

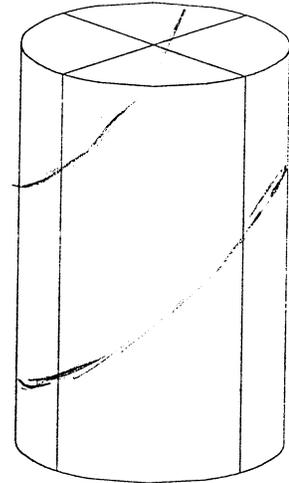
Sample Description: borderline dark gray sandstone to fine sandy siltstone with two calcite healed hairline fractures, 41° to the core axis

Comments: Failed by shear on existing joints and axial splitting

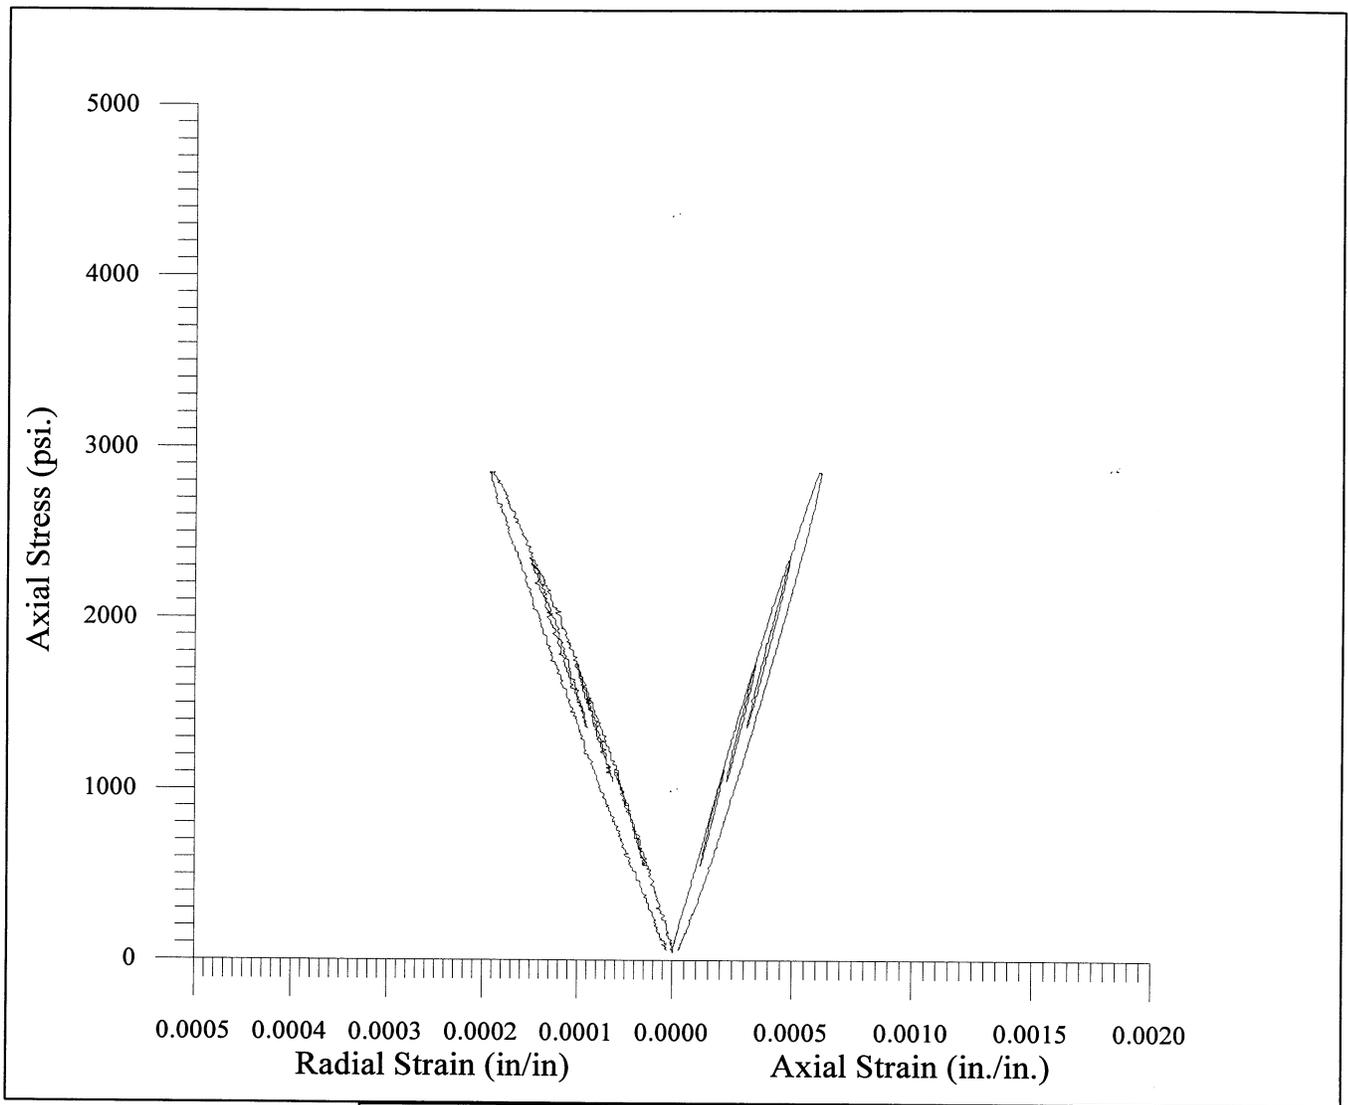
**ELASTIC MODULUS TEST**  
**Axial Stress vs. Axial & Radial Strain**

**SAMPLE ID:** Boring: 98-23  
 Sample: 18a  
 Depth: 63'

**DESCRIPTION**  
 Dark gray sandstone to fine sandy siltstone with two calcite healed hairline fractures, 41 degrees to the core axis.

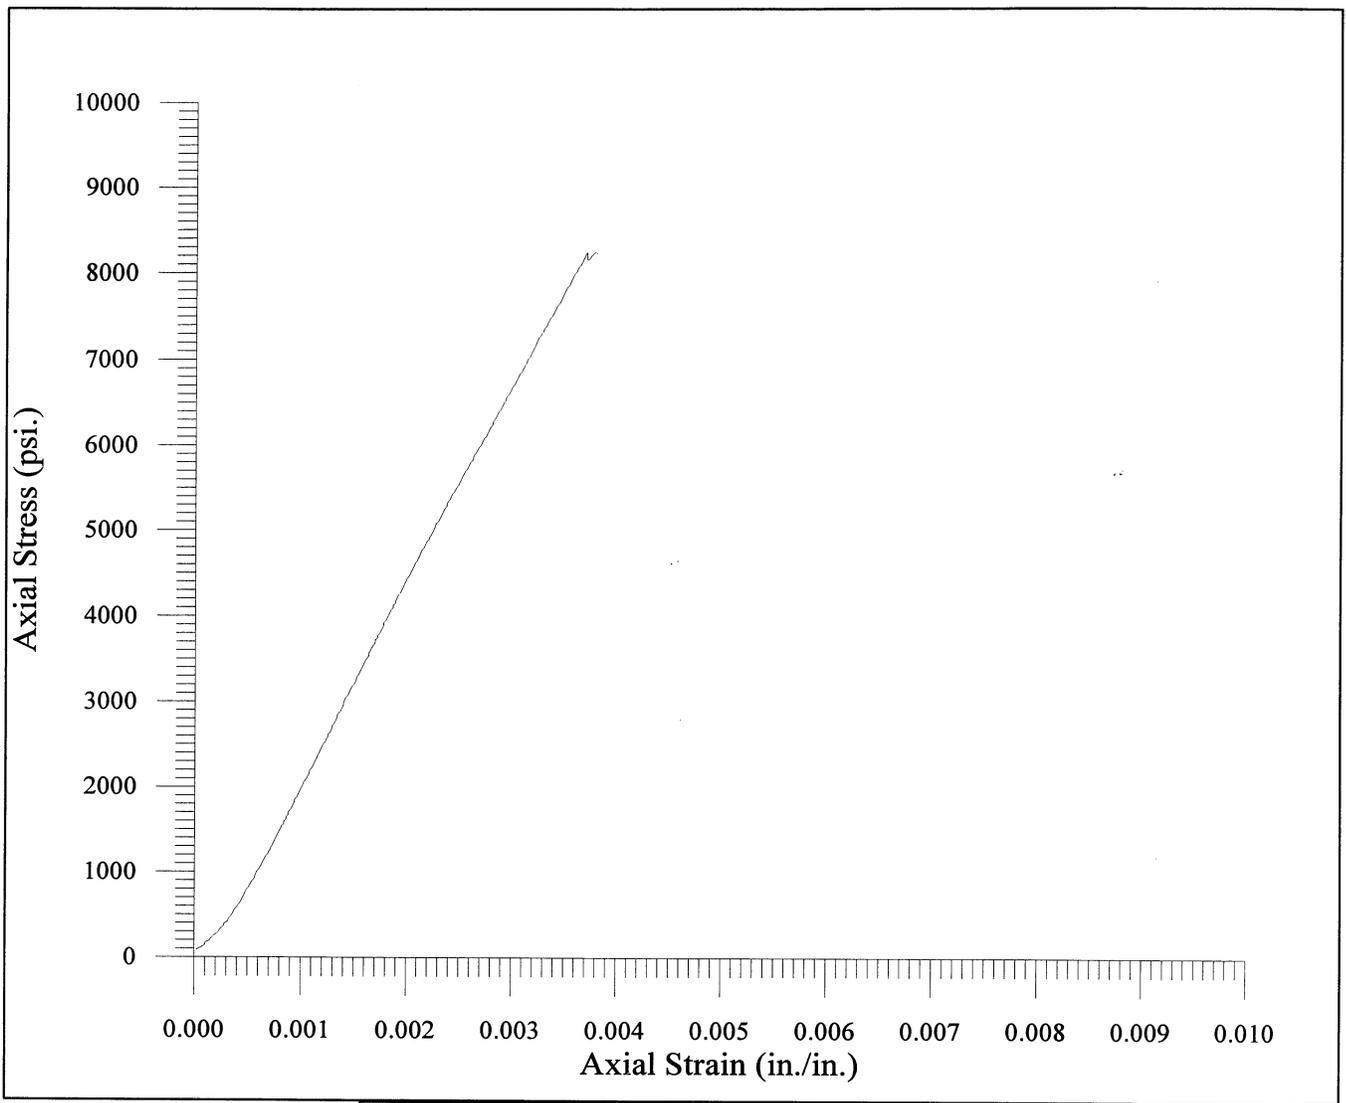
**UNCONFINED COMPRESSION TEST  
Axial Stress vs. Axial Strain**

<p><b>SAMPLE ID:</b> Boring : 98-23 Sample: 18a Depth: 63'</p>	<p align="center"><i>Geo</i>

<i>Test</i> <b>Unlimited</b> 800 Peralta Ave San Leandro, CA 94577</p>
<p align="center"><b>DESCRIPTION</b></p> <p>Dark gray sandstone to fine sandy siltstone with two calcite healed hairline fractures, 41 degrees to the core axis.</p> <p><b>STRENGTH:</b> 8249 psi</p>	<p><b>Client:</b> Fugro West, Inc. 5855 Olivas Park Dr. Ventura, CA 93003</p> <p><b>Project:</b> San Francisco Oakland Bay Bridge East Span Replacement Project</p> <p><b>Job Number:</b> 98-42-0053</p>
	<p><b>Test Date:</b> October 23, 1998</p>

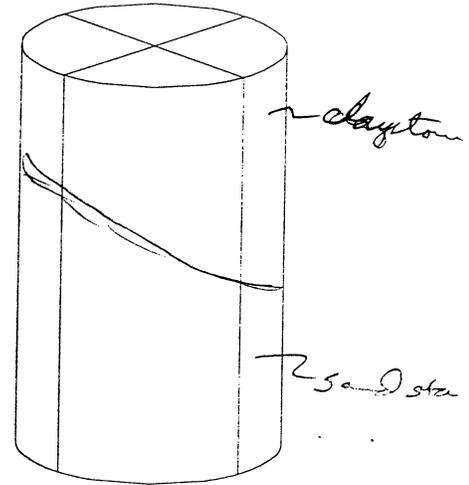
Sample Description: medium gray sandstone with fine interbeds of claystone / siltstone. Other sample half is dark gray claystone / siltstone, separated by calcite healed joint. 63° to core axis. Numerous calcite healed hairline fractures in the claystone half.

ν<sub>act</sub> → started to fail @ 2<sup>nd</sup> reload test stopped.

α<sub>c</sub> → Failure by splitting & shear in claystone.

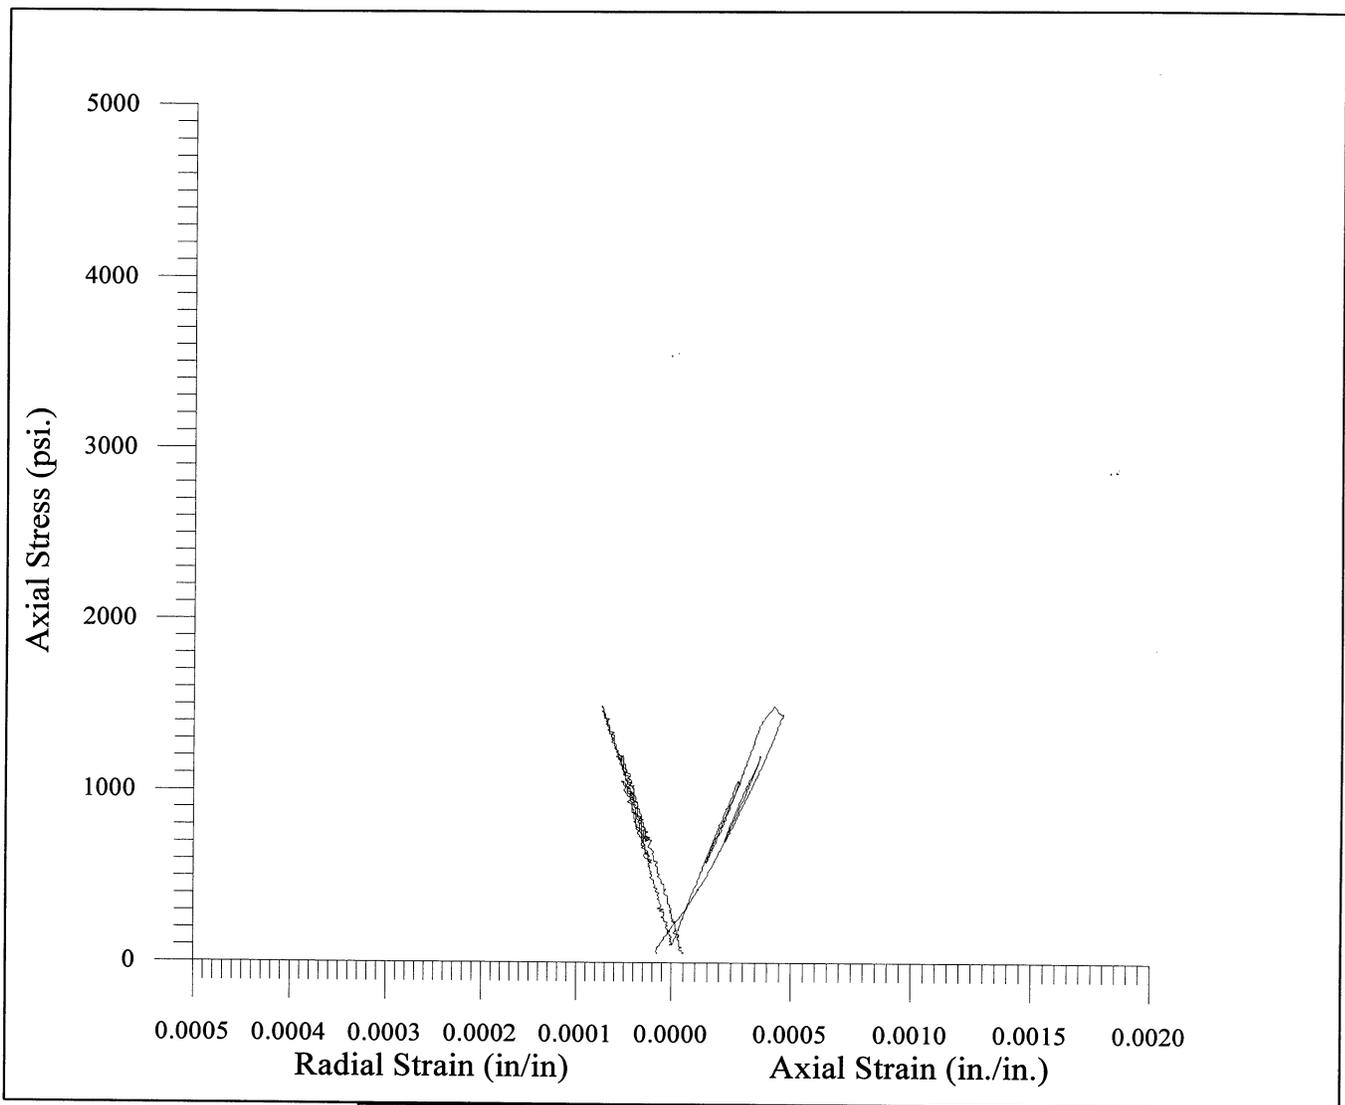
**ELASTIC MODULUS TEST**  
**Axial Stress vs. Axial & Radial Strain**

**SAMPLE ID:** Boring: 98-23  
 Sample: 20a  
 Depth: 74'

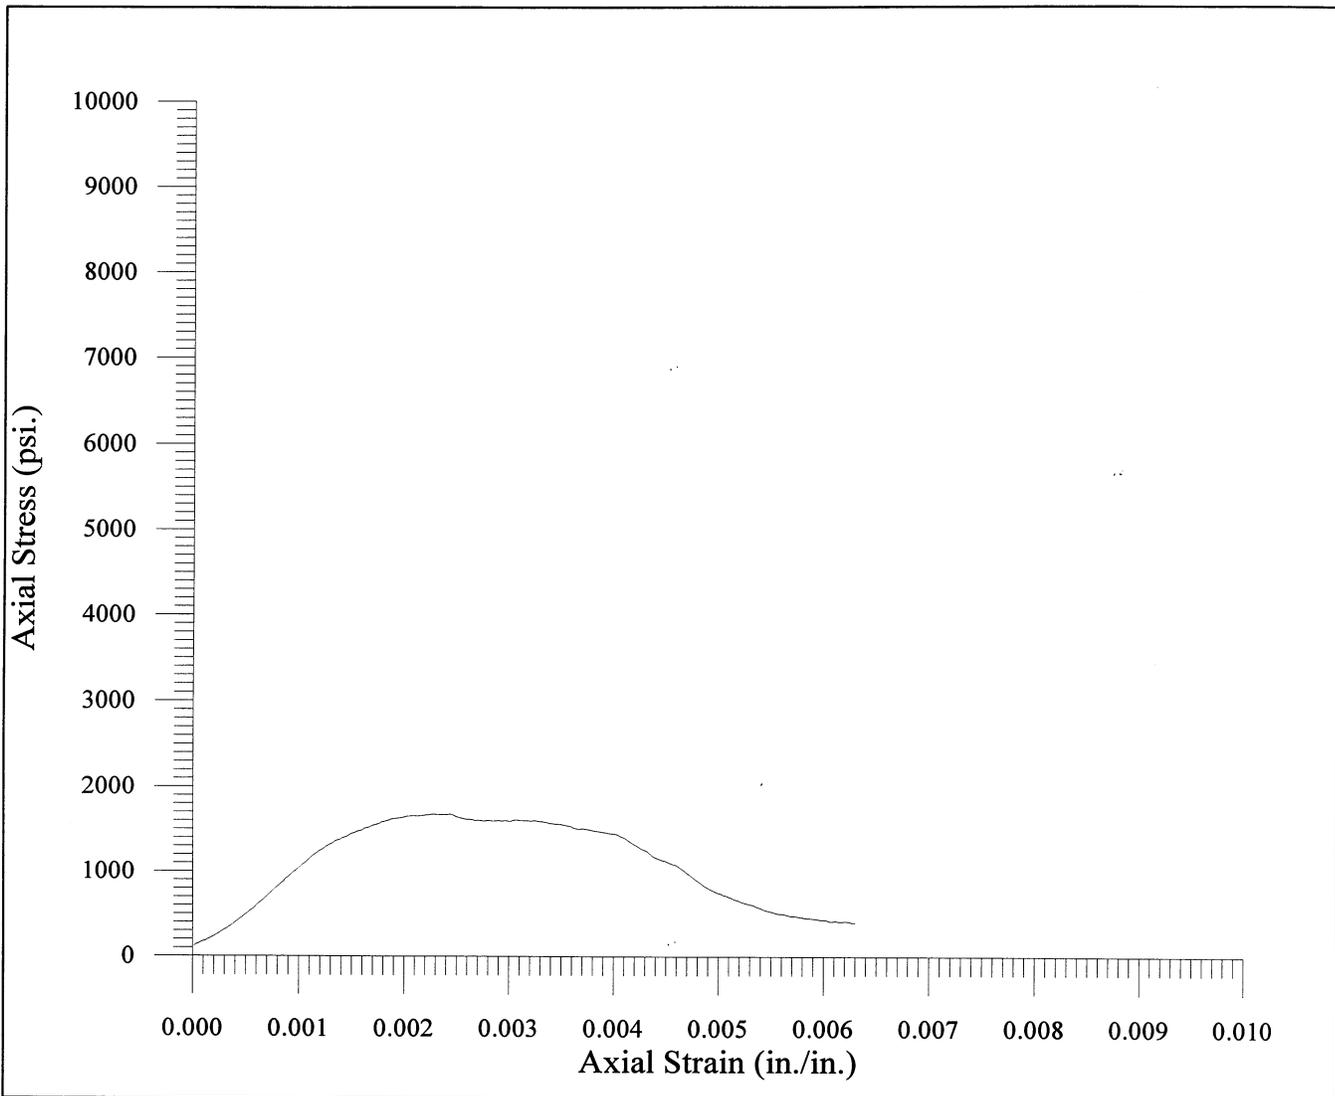
**UNCONFINED COMPRESSION TEST  
Axial Stress vs. Axial Strain**

<p><b>SAMPLE ID:</b> Boring : 98-23 Sample: 20a Depth: 74'</p> <p align="center"><b>DESCRIPTION</b></p> <p>Medium gray sandstone finely interbedded with claystone and siltstone in one sample half, claystone and siltstone in the other half, separated by a calcite healed joint 63 degrees to the core axis.</p> <p><b>STRENGTH:</b> 1678 psi</p>	<p align="center"> <i>Geo</i>

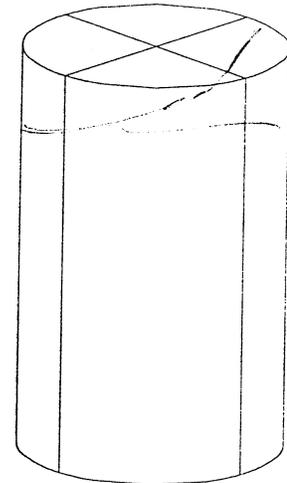
Sample Description: Dark gray silt-stn. (claystone) with  
innumerable calcite healed hair line fractures  
parallel to bedding, ~62° to the core axis

*diagonal joint*

Comments: Failed by "shear" (crack) along partially  
healed joints
